# Headworks Division of Mahaweli Authority

## Victoria Dam Sri Lanka

Eng.S.R.K.Aruppola

November 2014

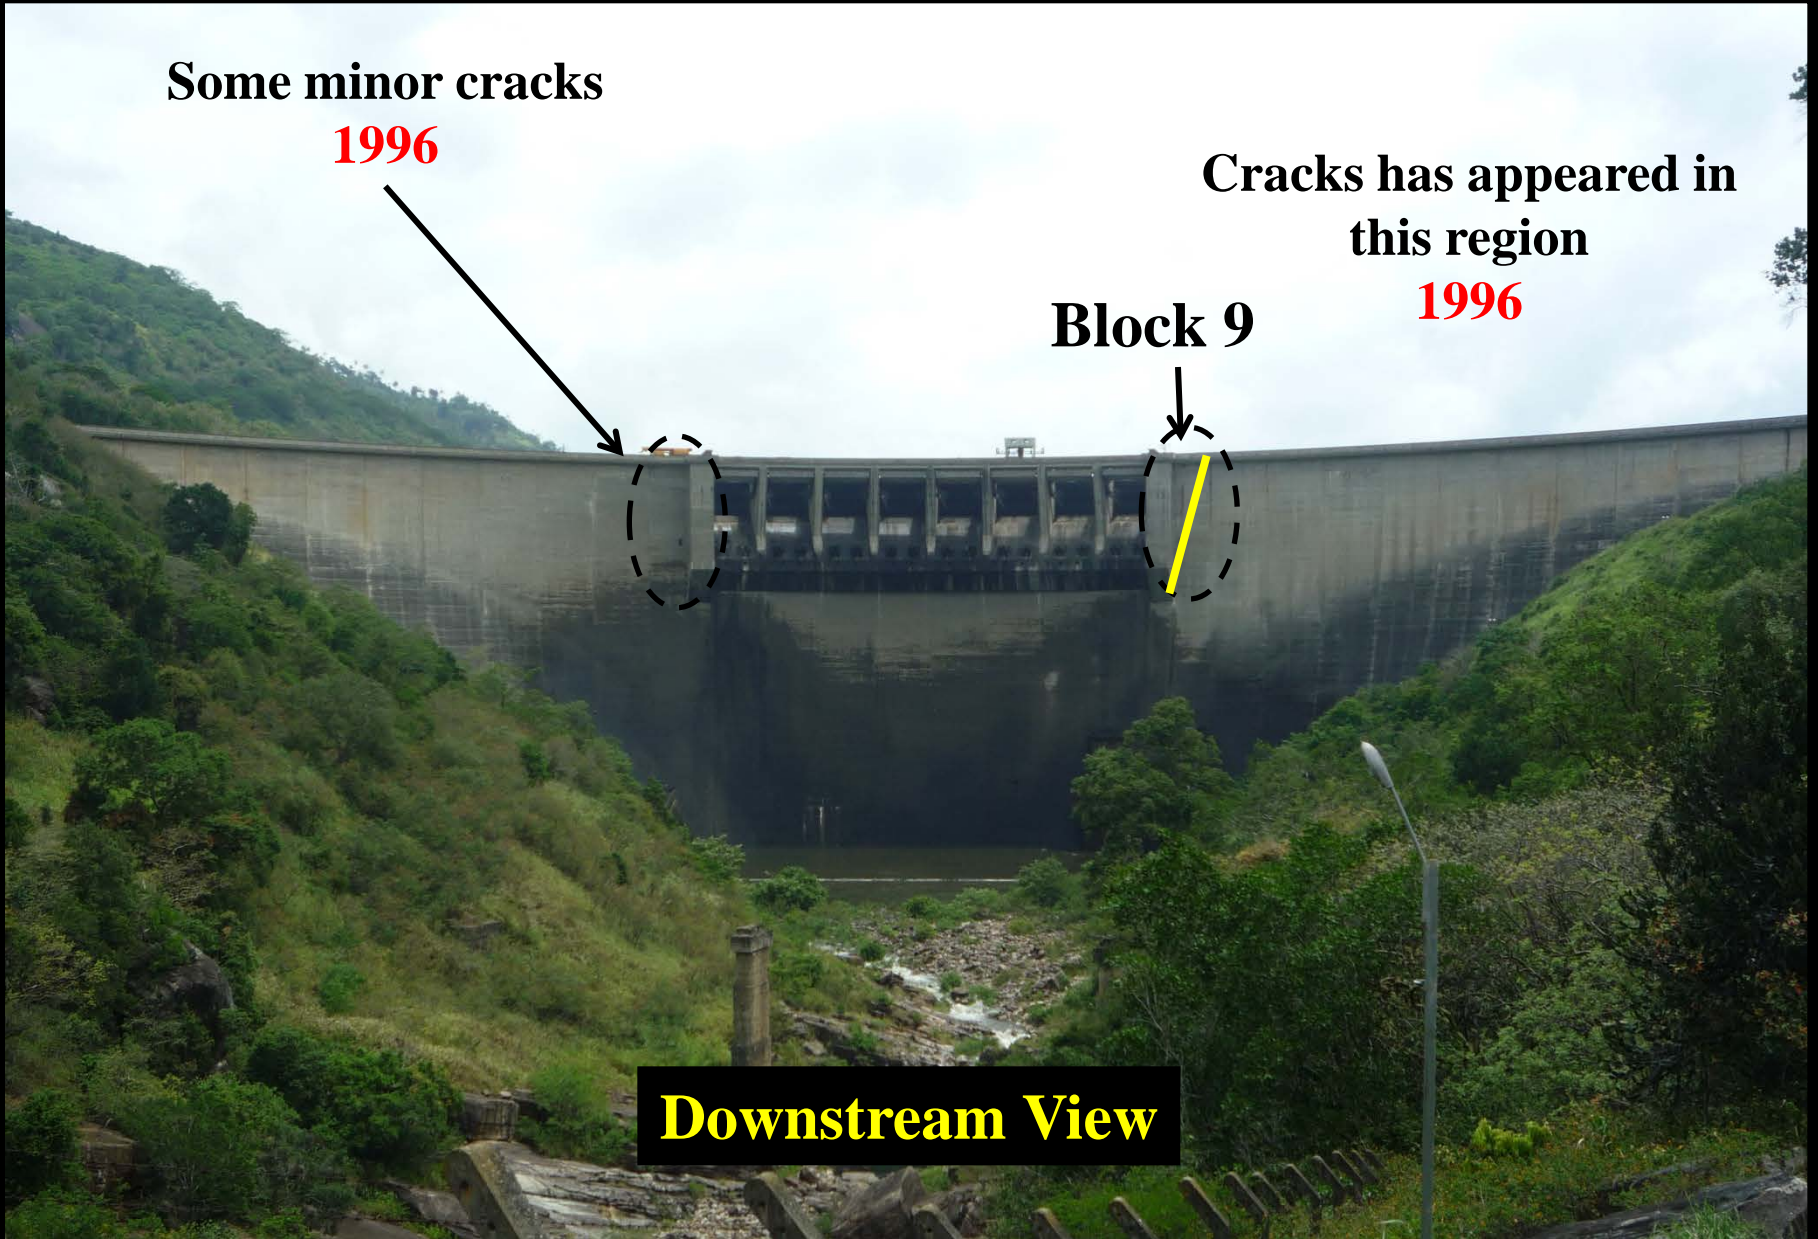
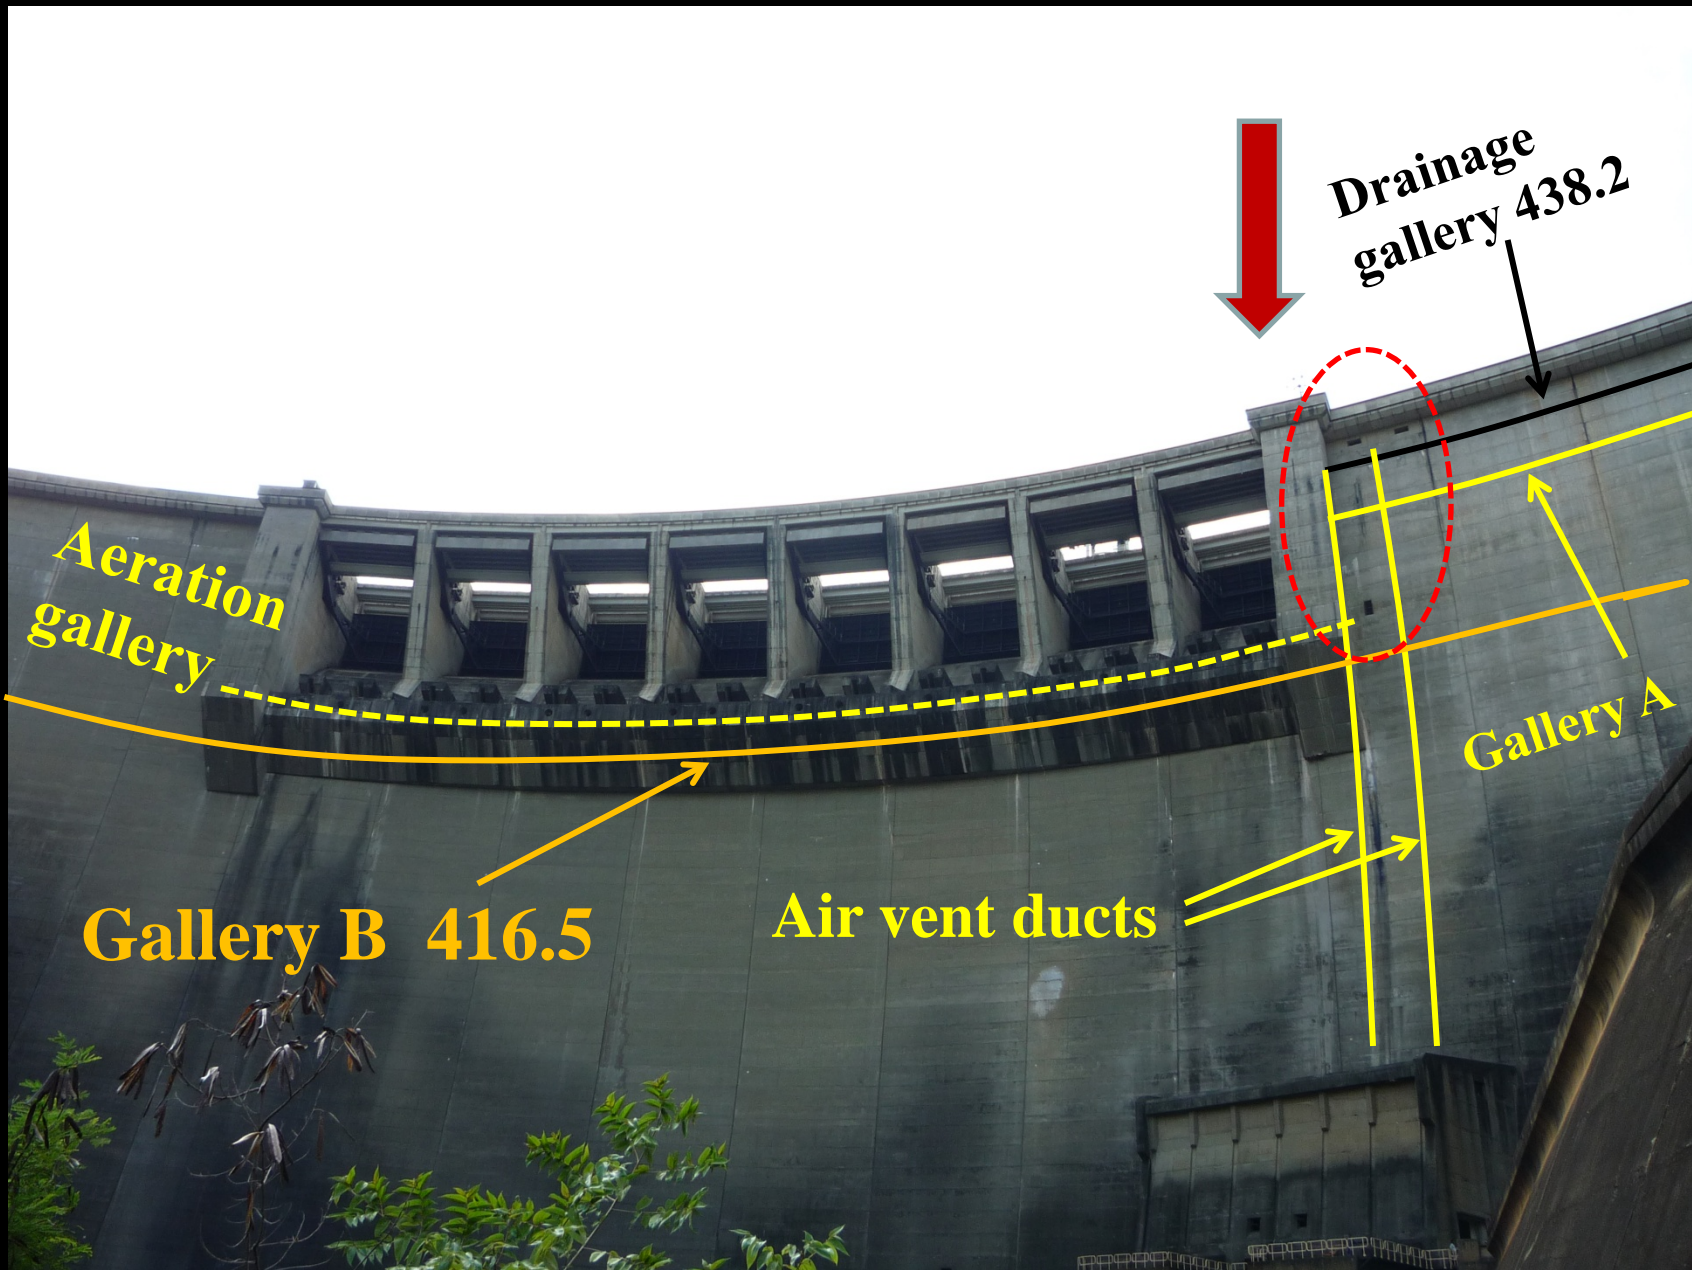
Block 9

Some minor cracks

Cracks has appeared in  
this region

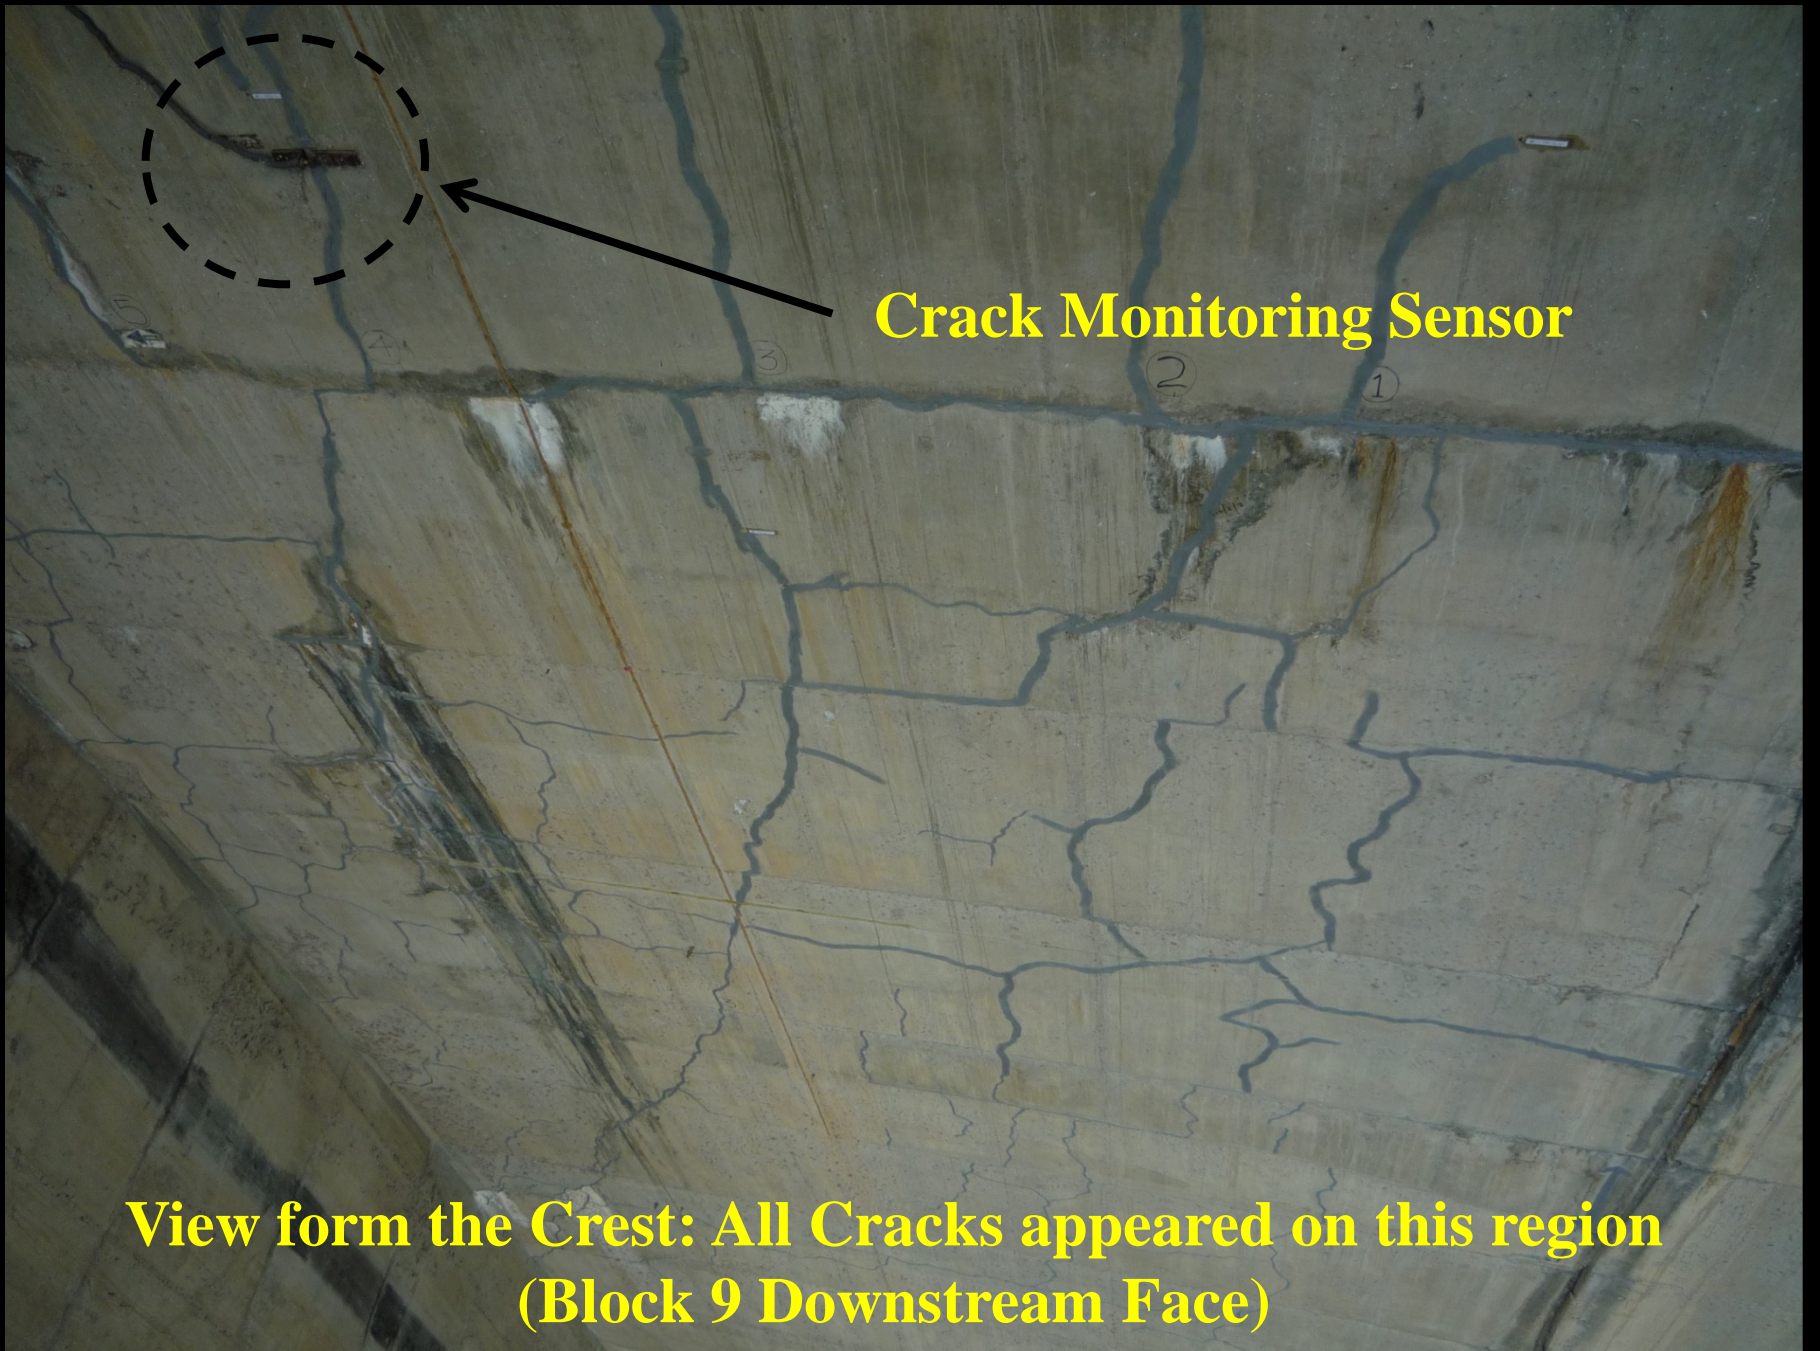
**Crack Monitoring Sensor**

**View form the Crest: All Cracks appeared on this region  
(Block 9 Downstream Face)**

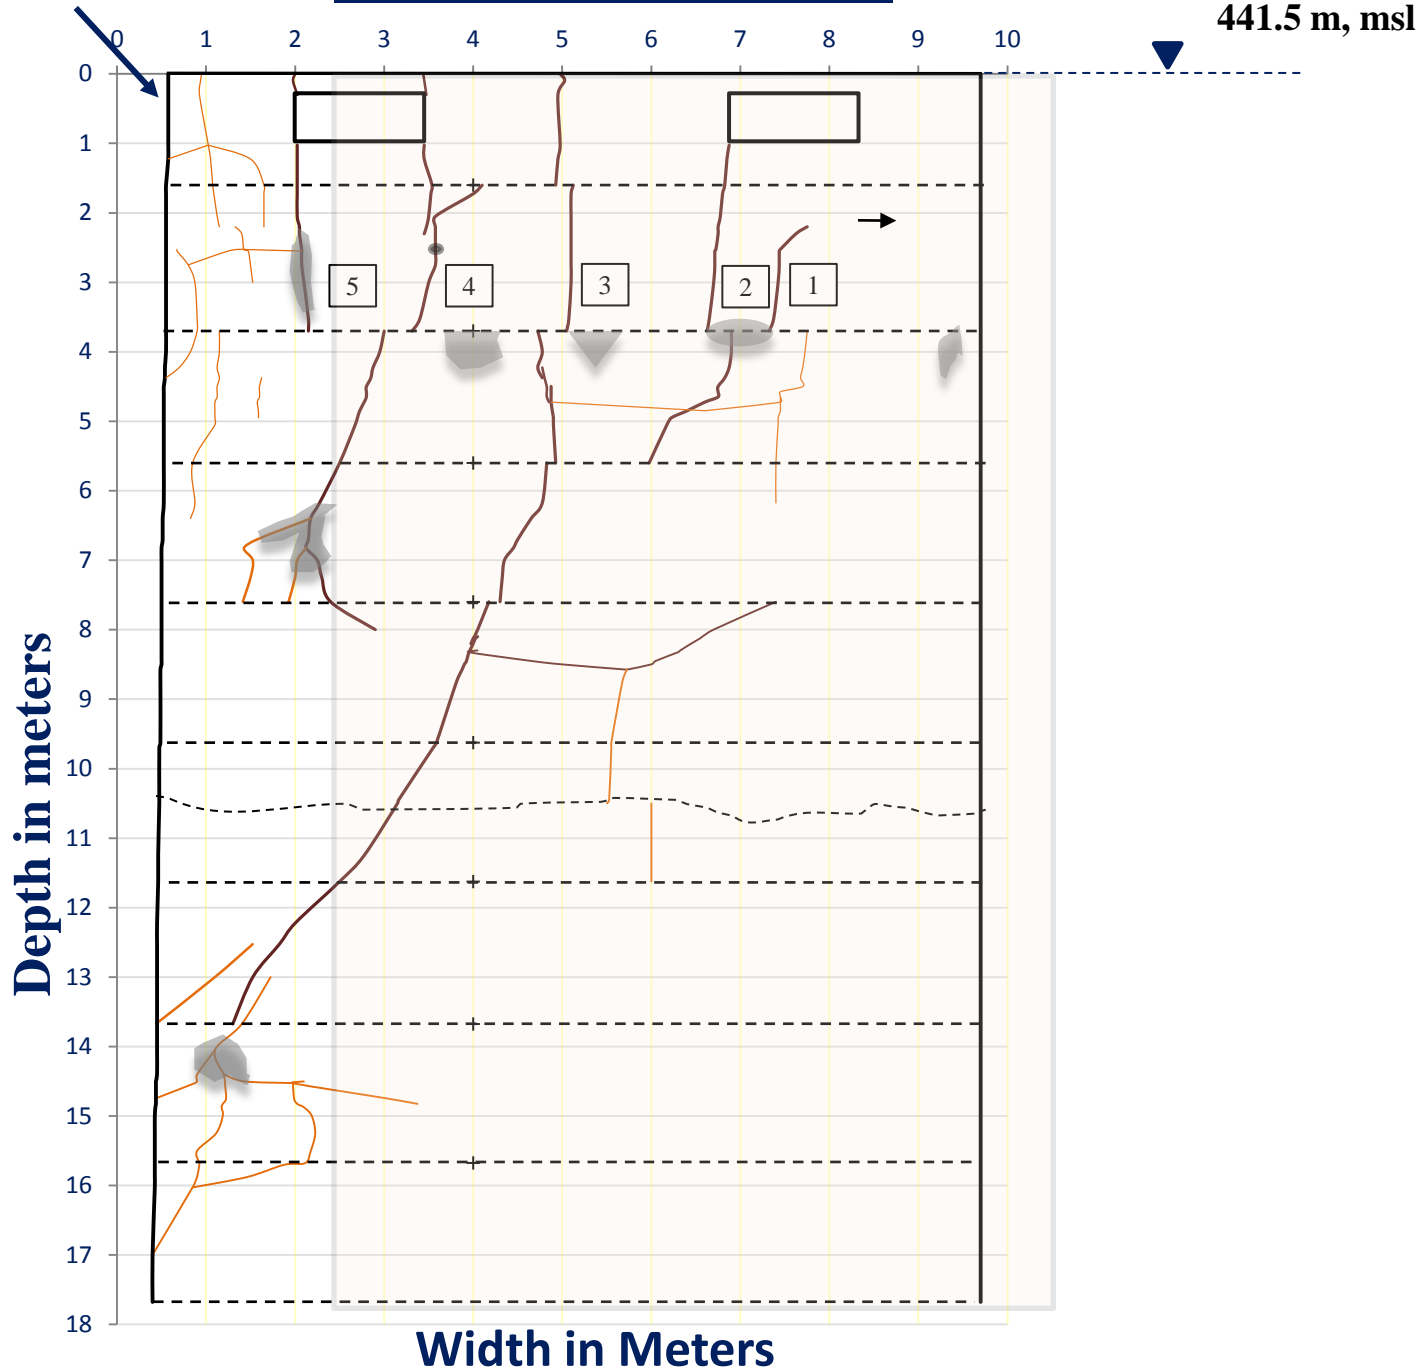
# Crack appeared on Block 9

441.5 m, msl

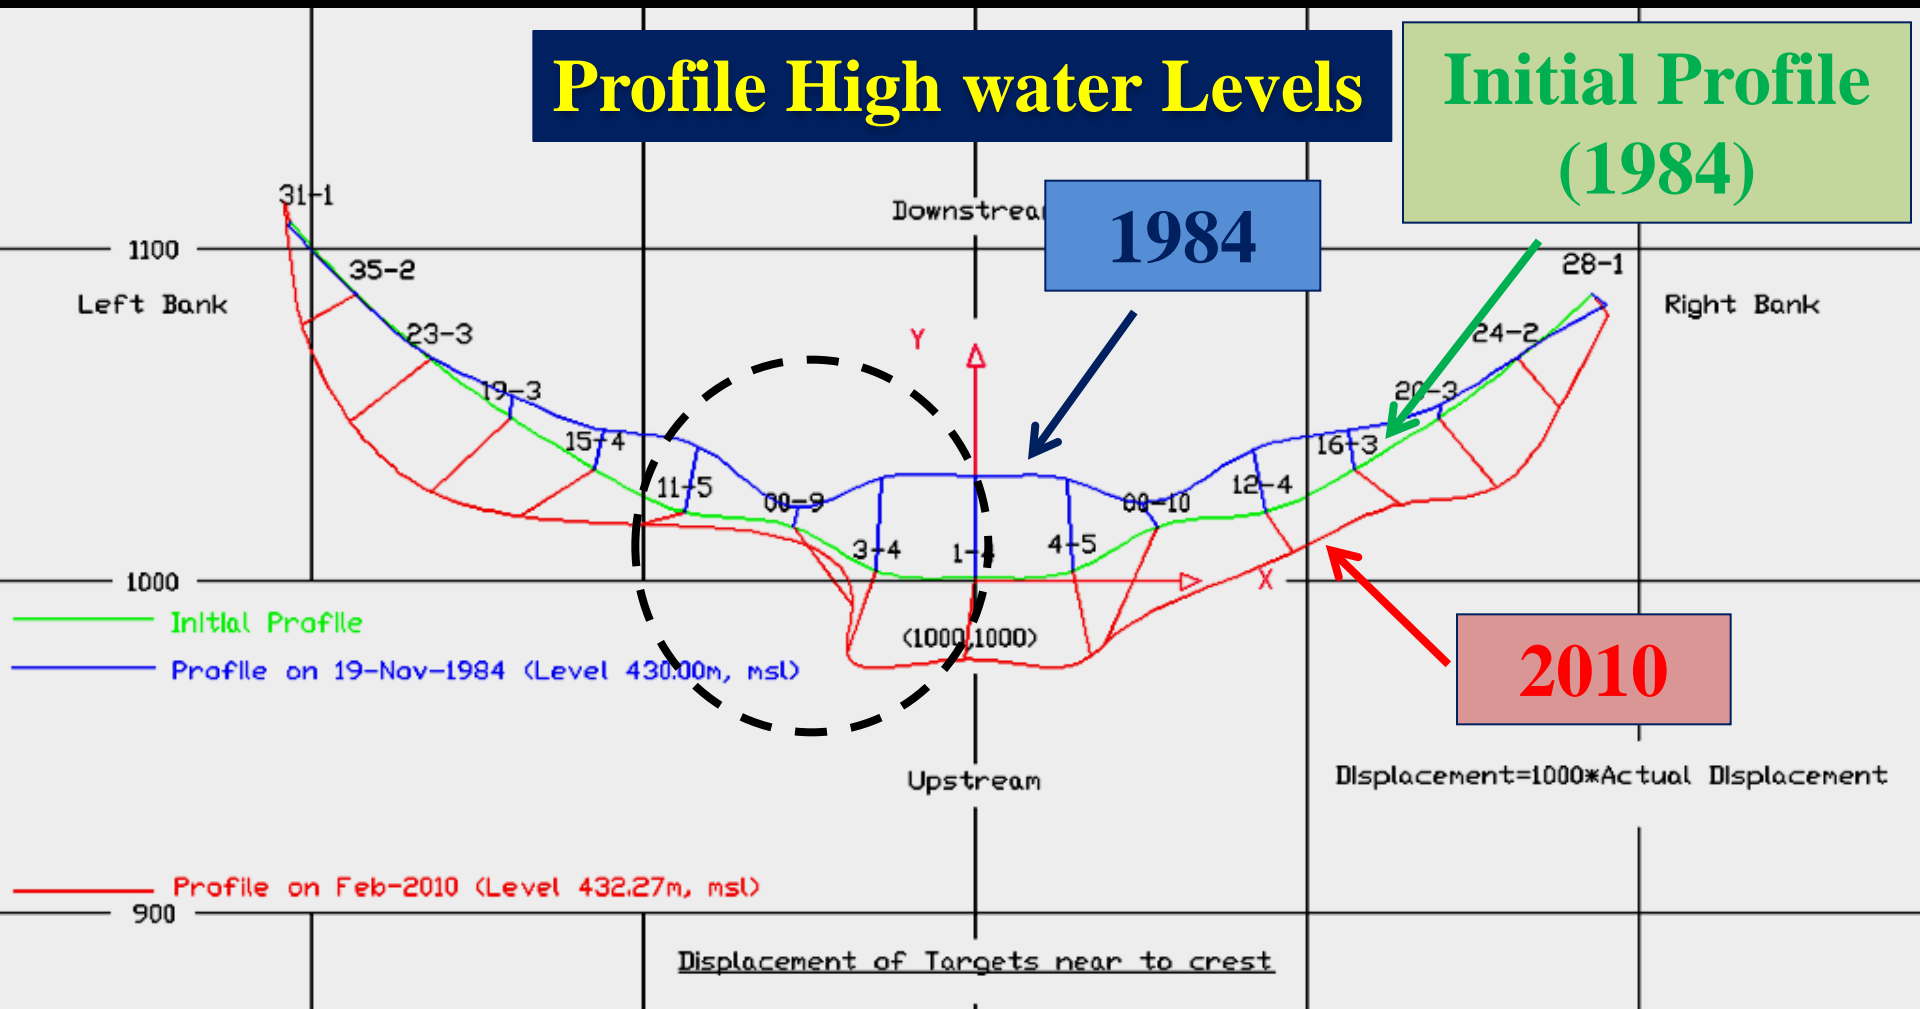
# Changing the Crest Profile of the Dam for High water levels (Survey Targets close to dam crest)

Profile on 19-Nov-1984 (Water level 430.00 m, msl)

Profile on Feb-2010 (Water level 432.27 m, msl)

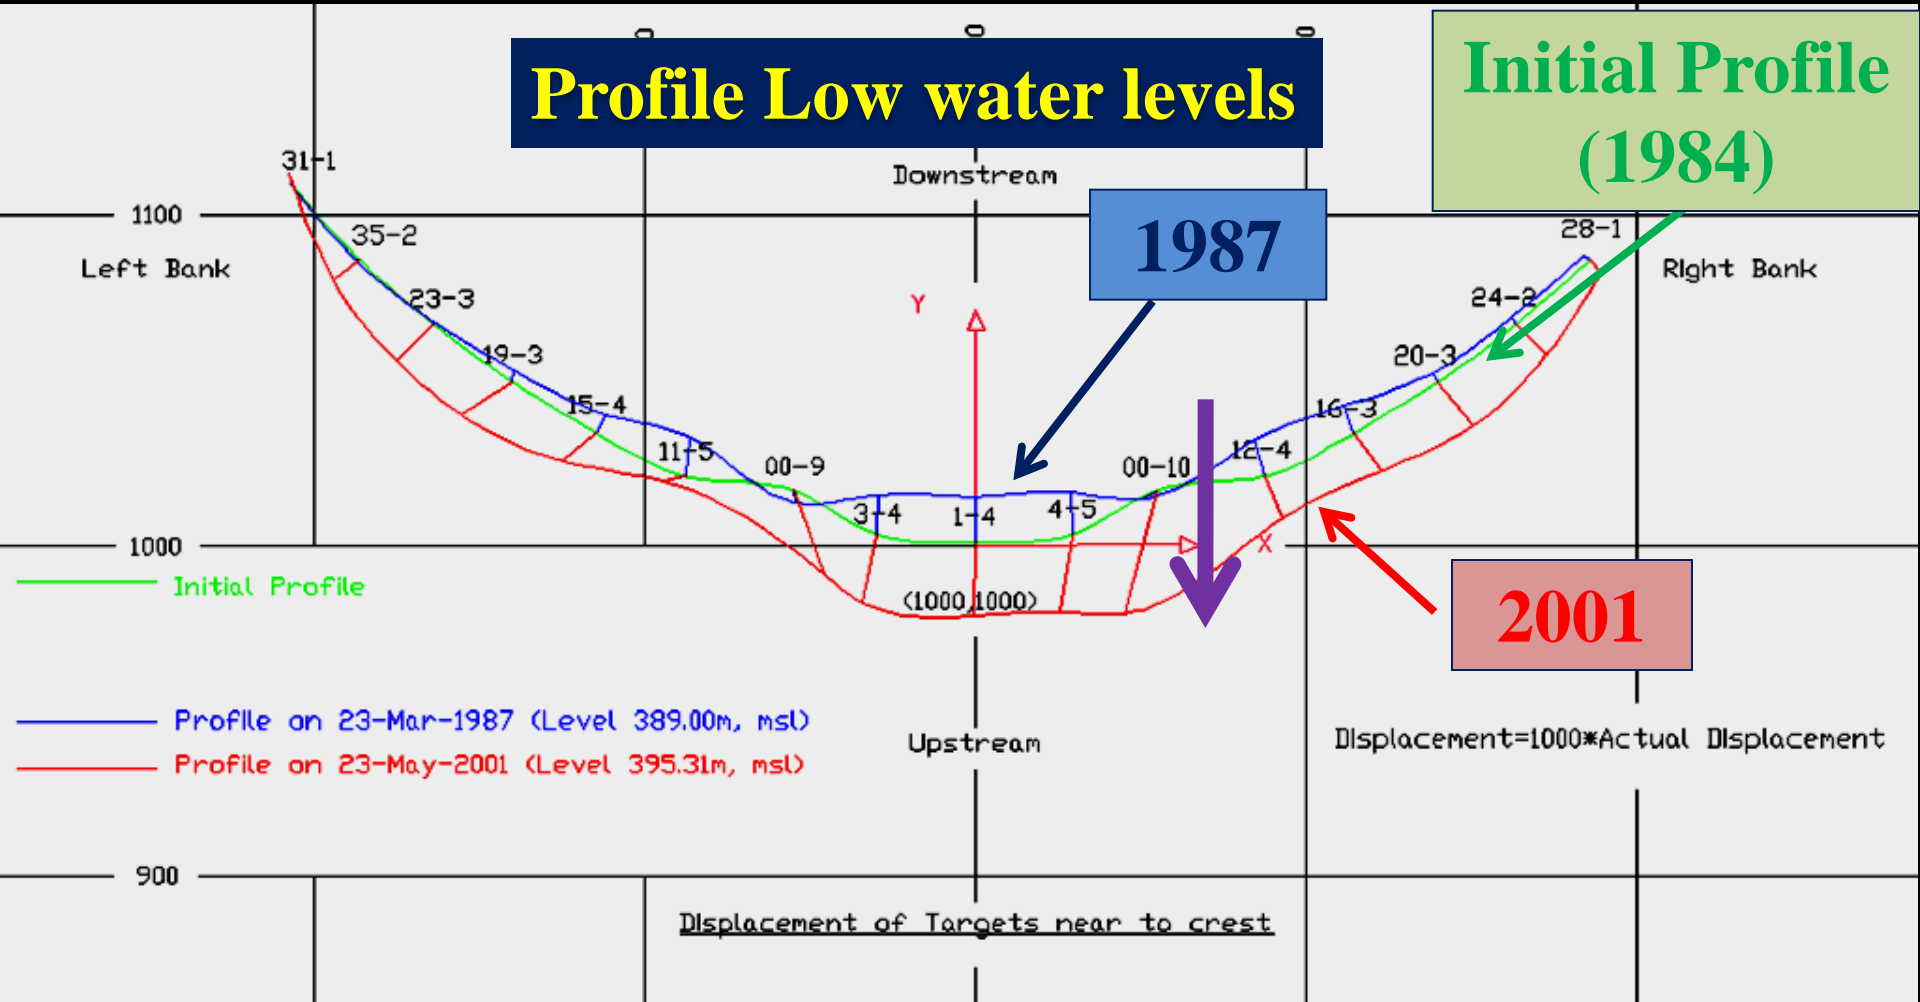
# Crest Profile of the Dam in plan for low water levels (Survey Targets close to dam crest)

- Initial Profile
- Profile on 23-Mar-1987 (Water level 389.00 m, msl)
- Profile on 23-May-2001 (Water level 395.31 m, msl)

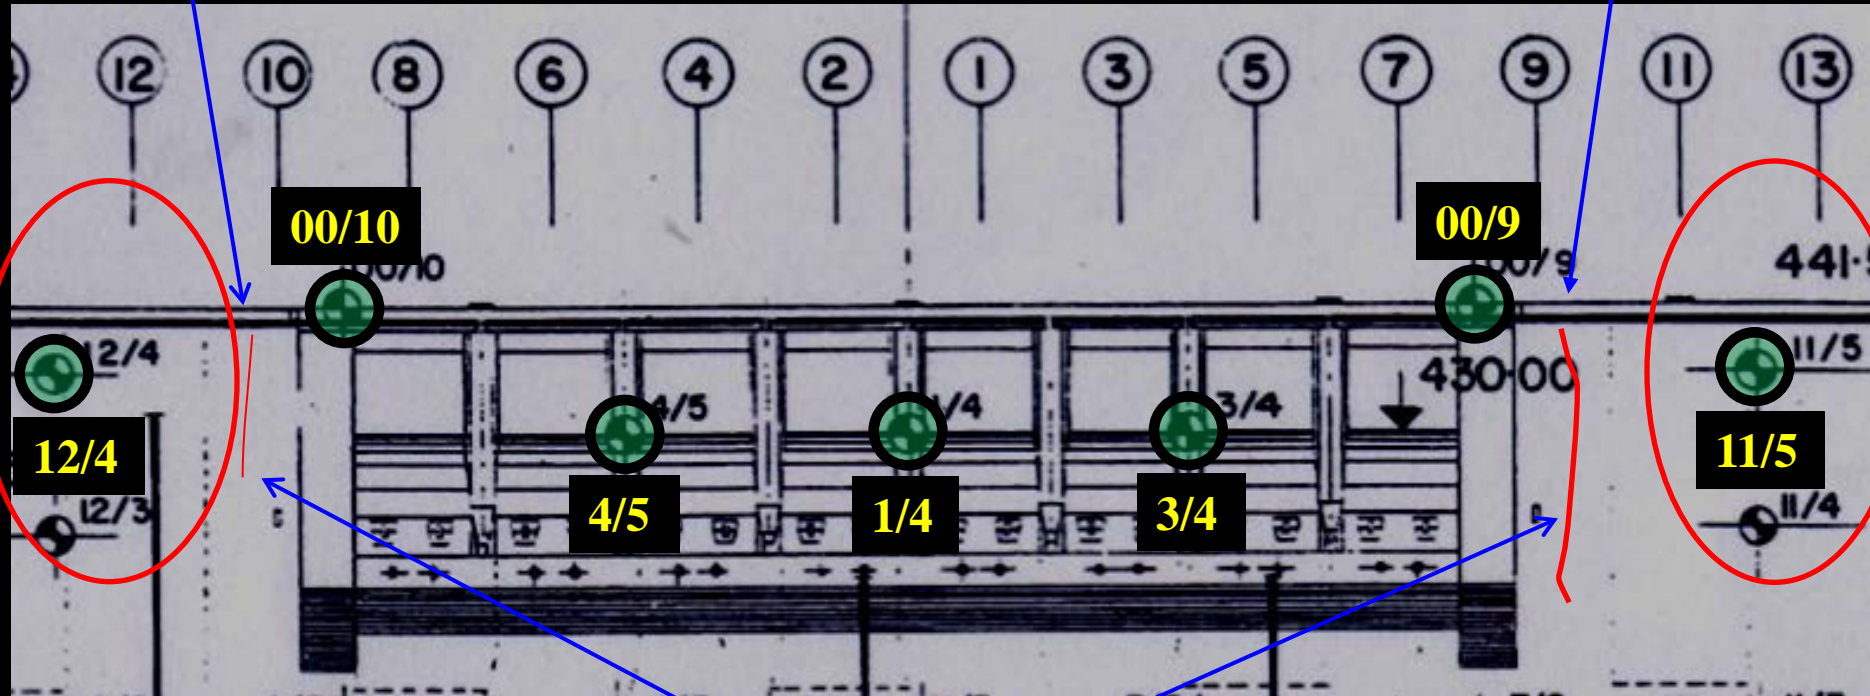
# Face Survey Targets around Spillway Section

**Cracks**

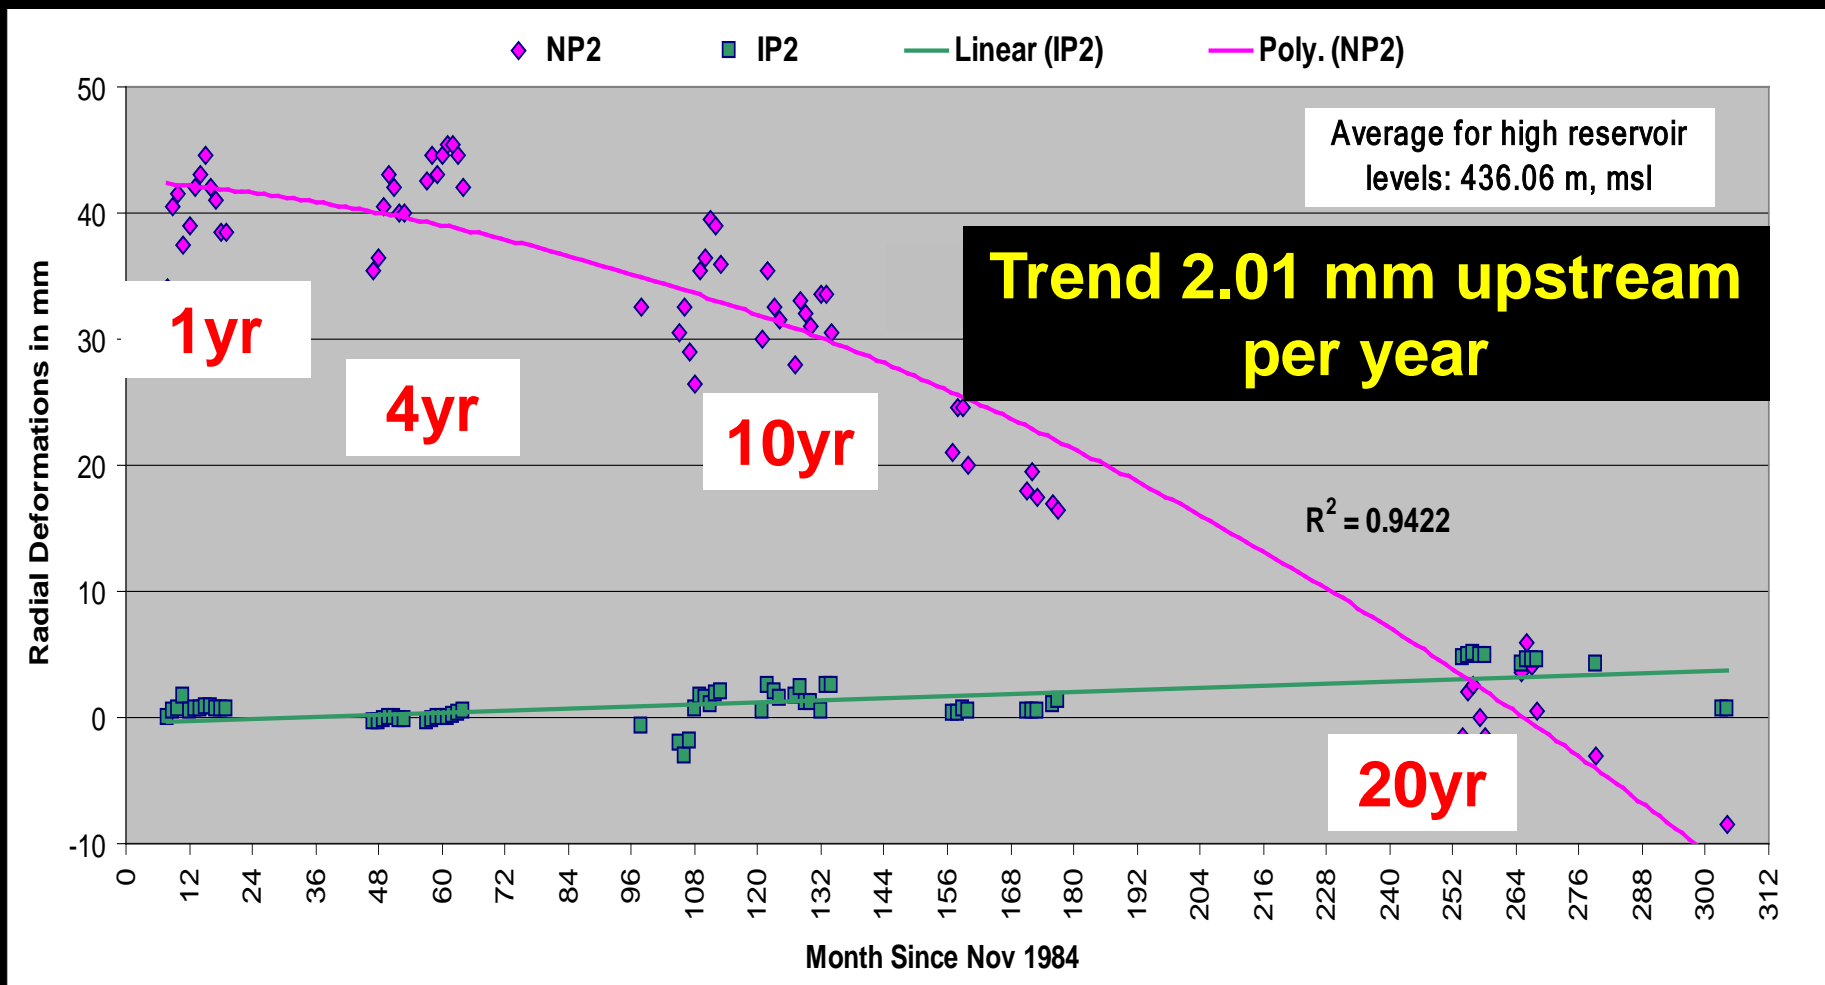
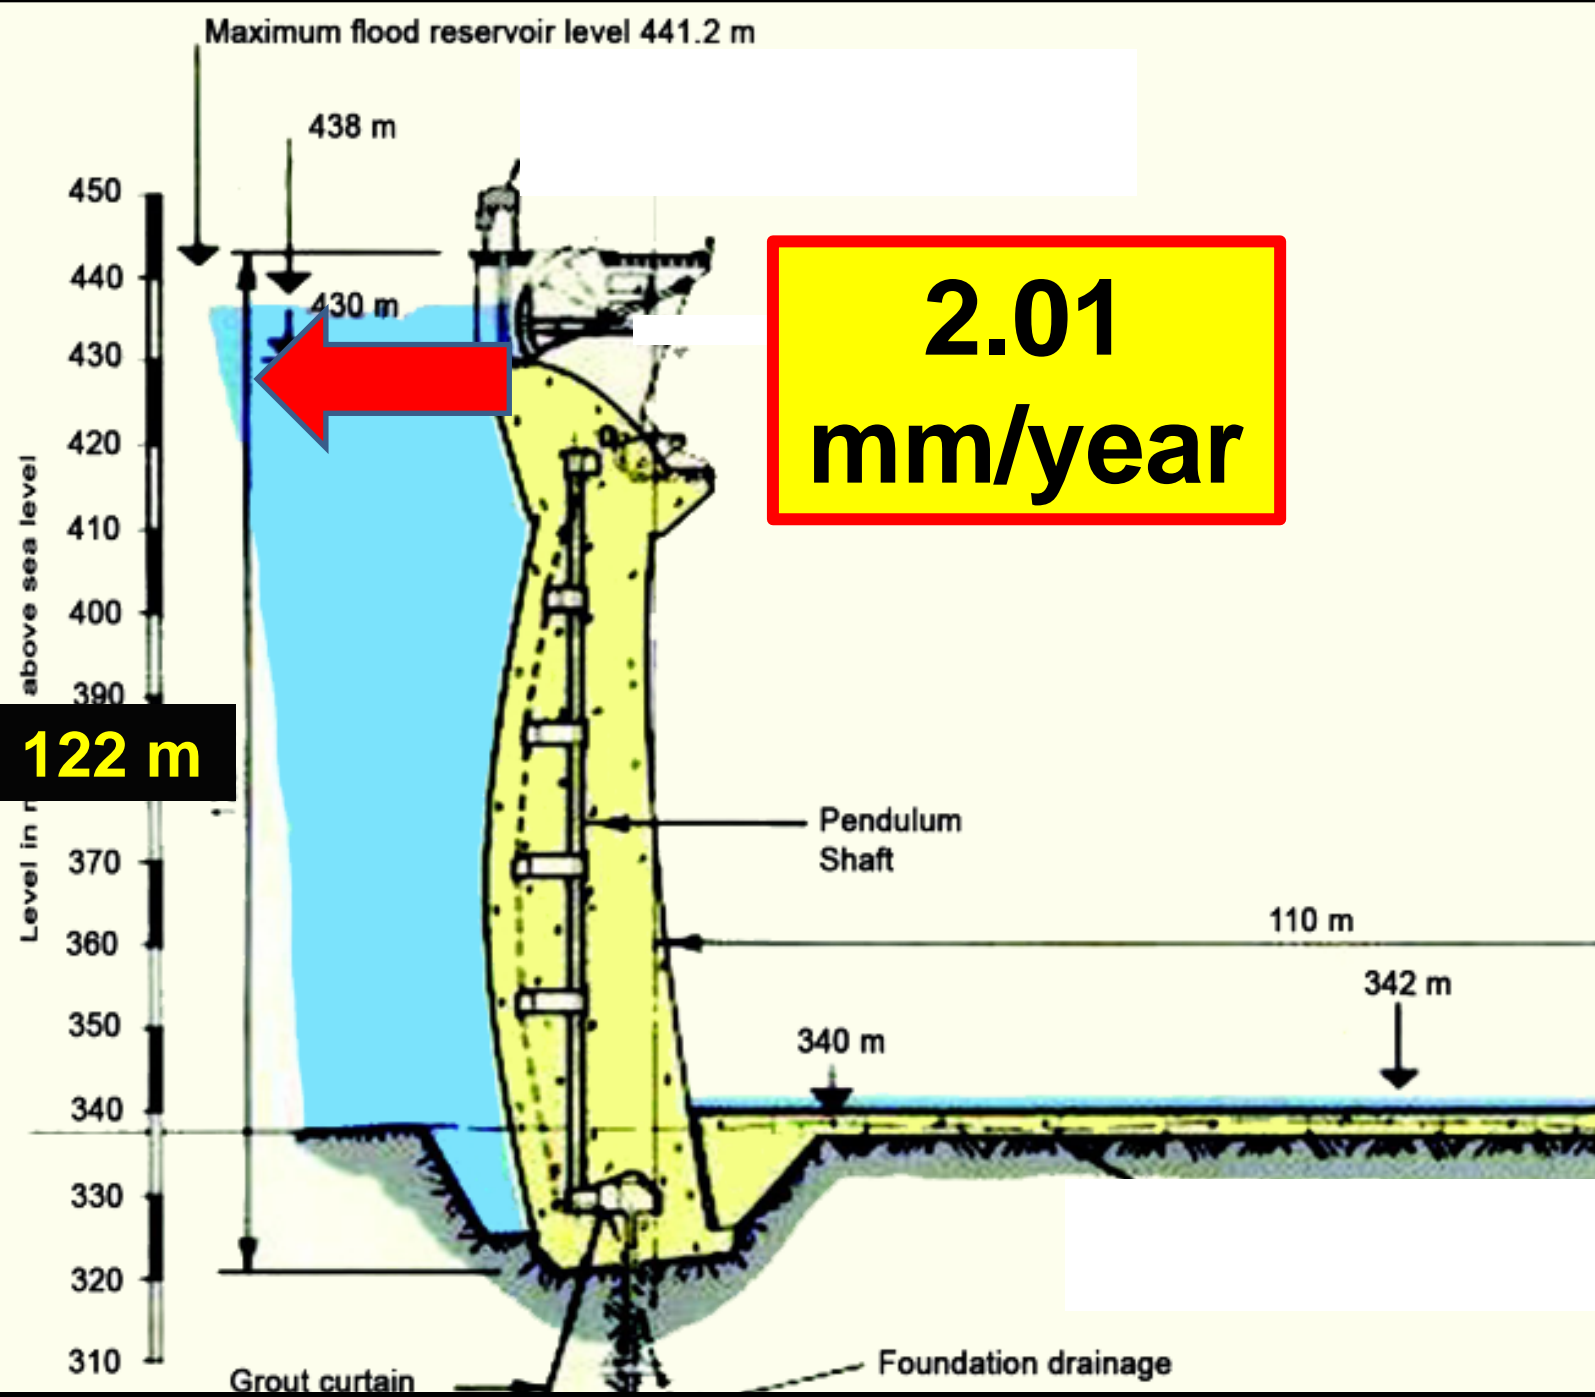
# Pendulum readings at Block 2

**2.01  
mm/year**

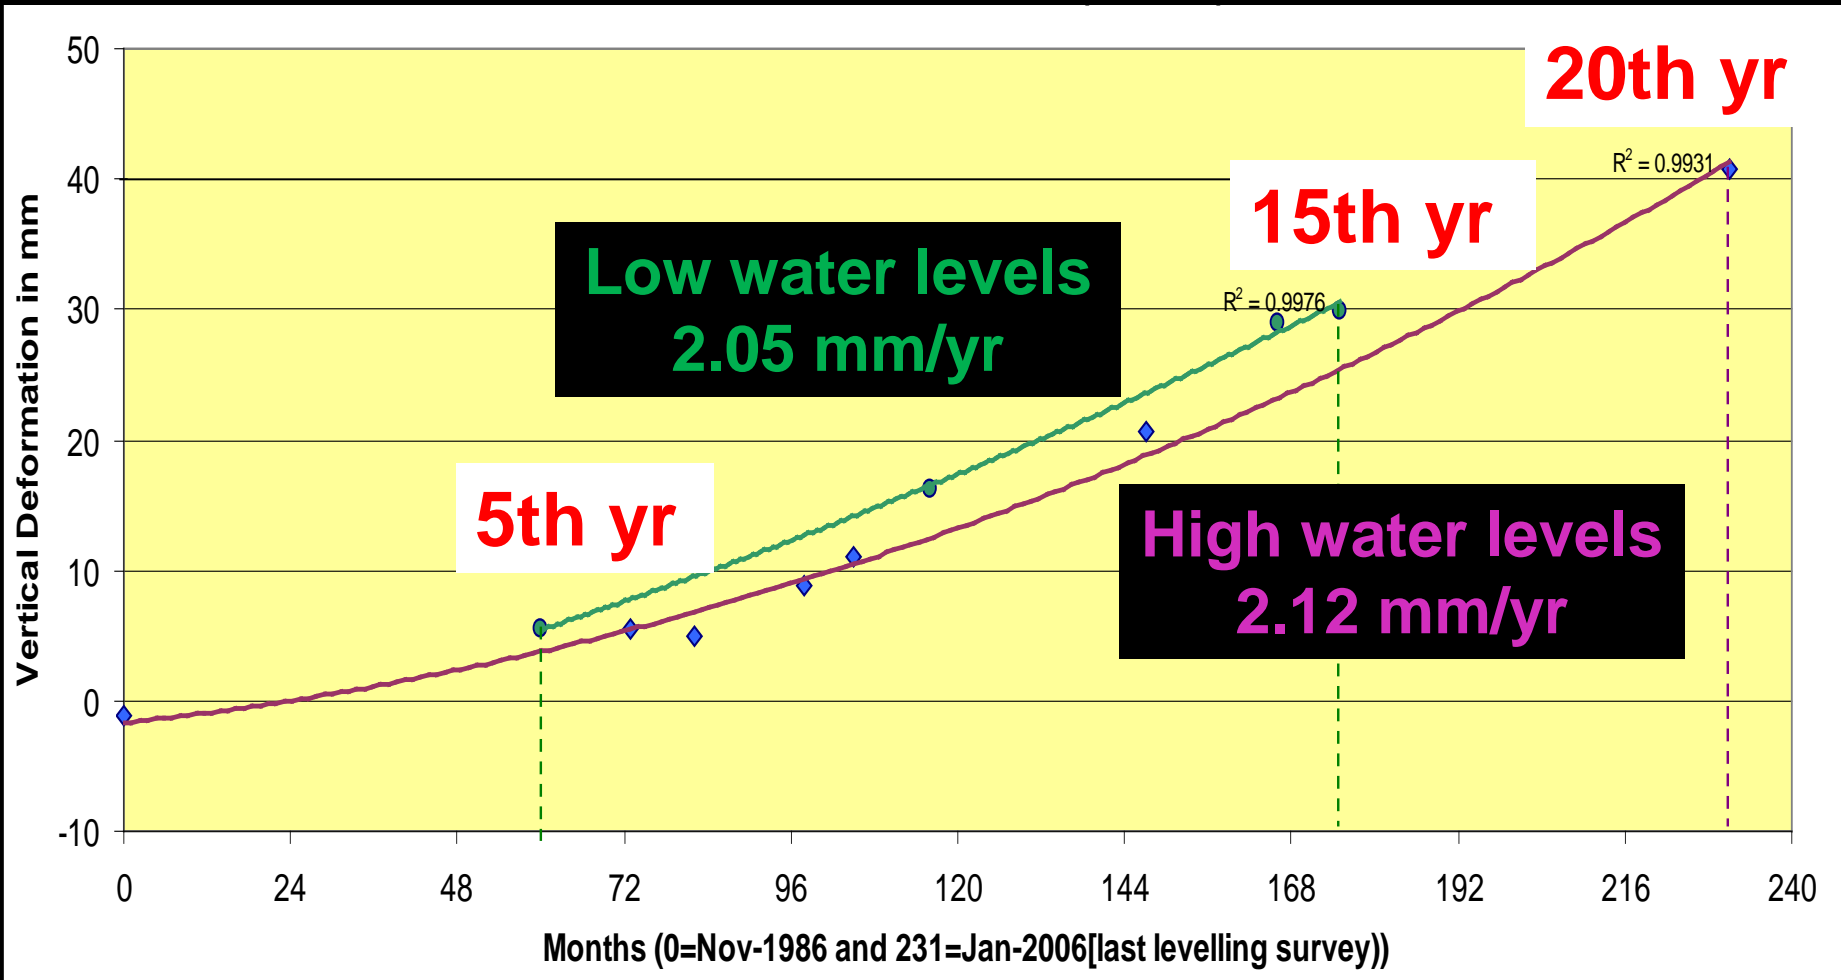
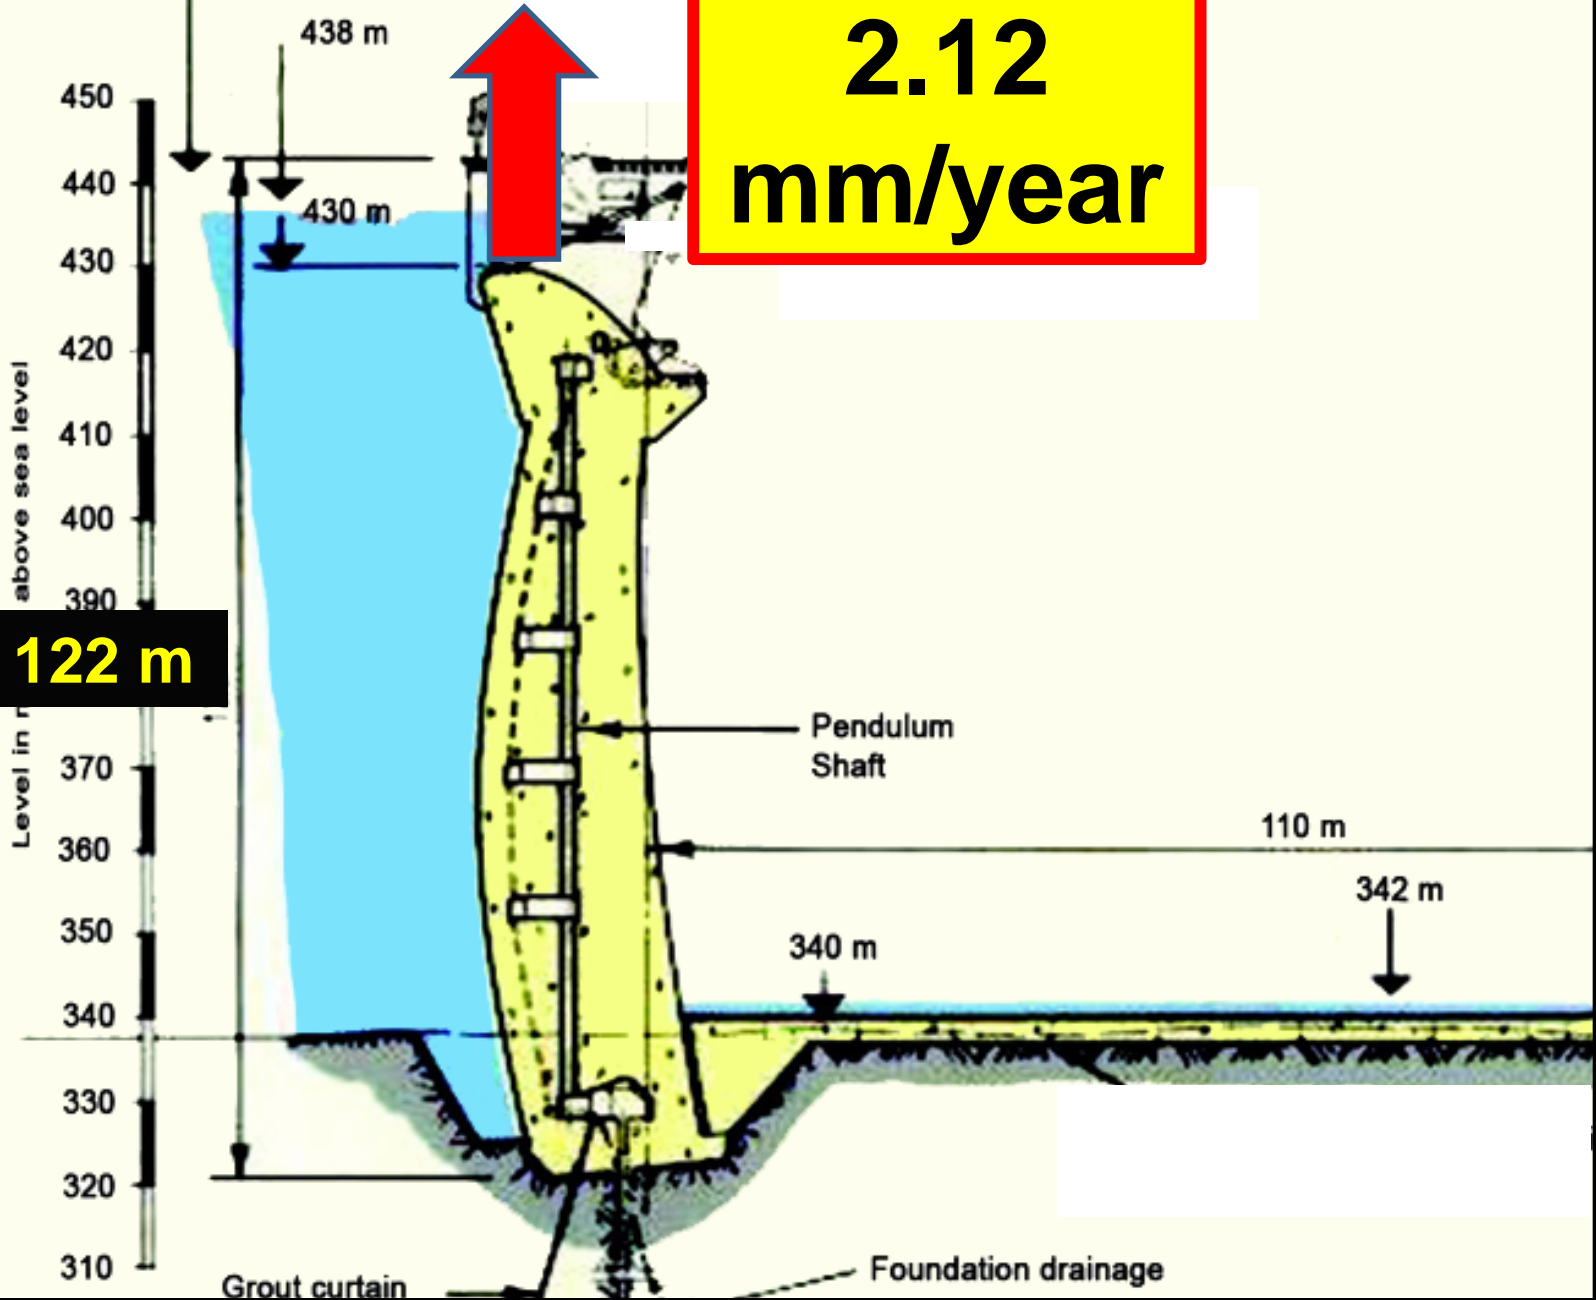
# Precise level readings

**2.12  
mm/year**
