# Headworks Division of Mahaweli Authority

## Victoria Dam Sri Lanka

Eng.S.R.K.Aruppola

November 2014

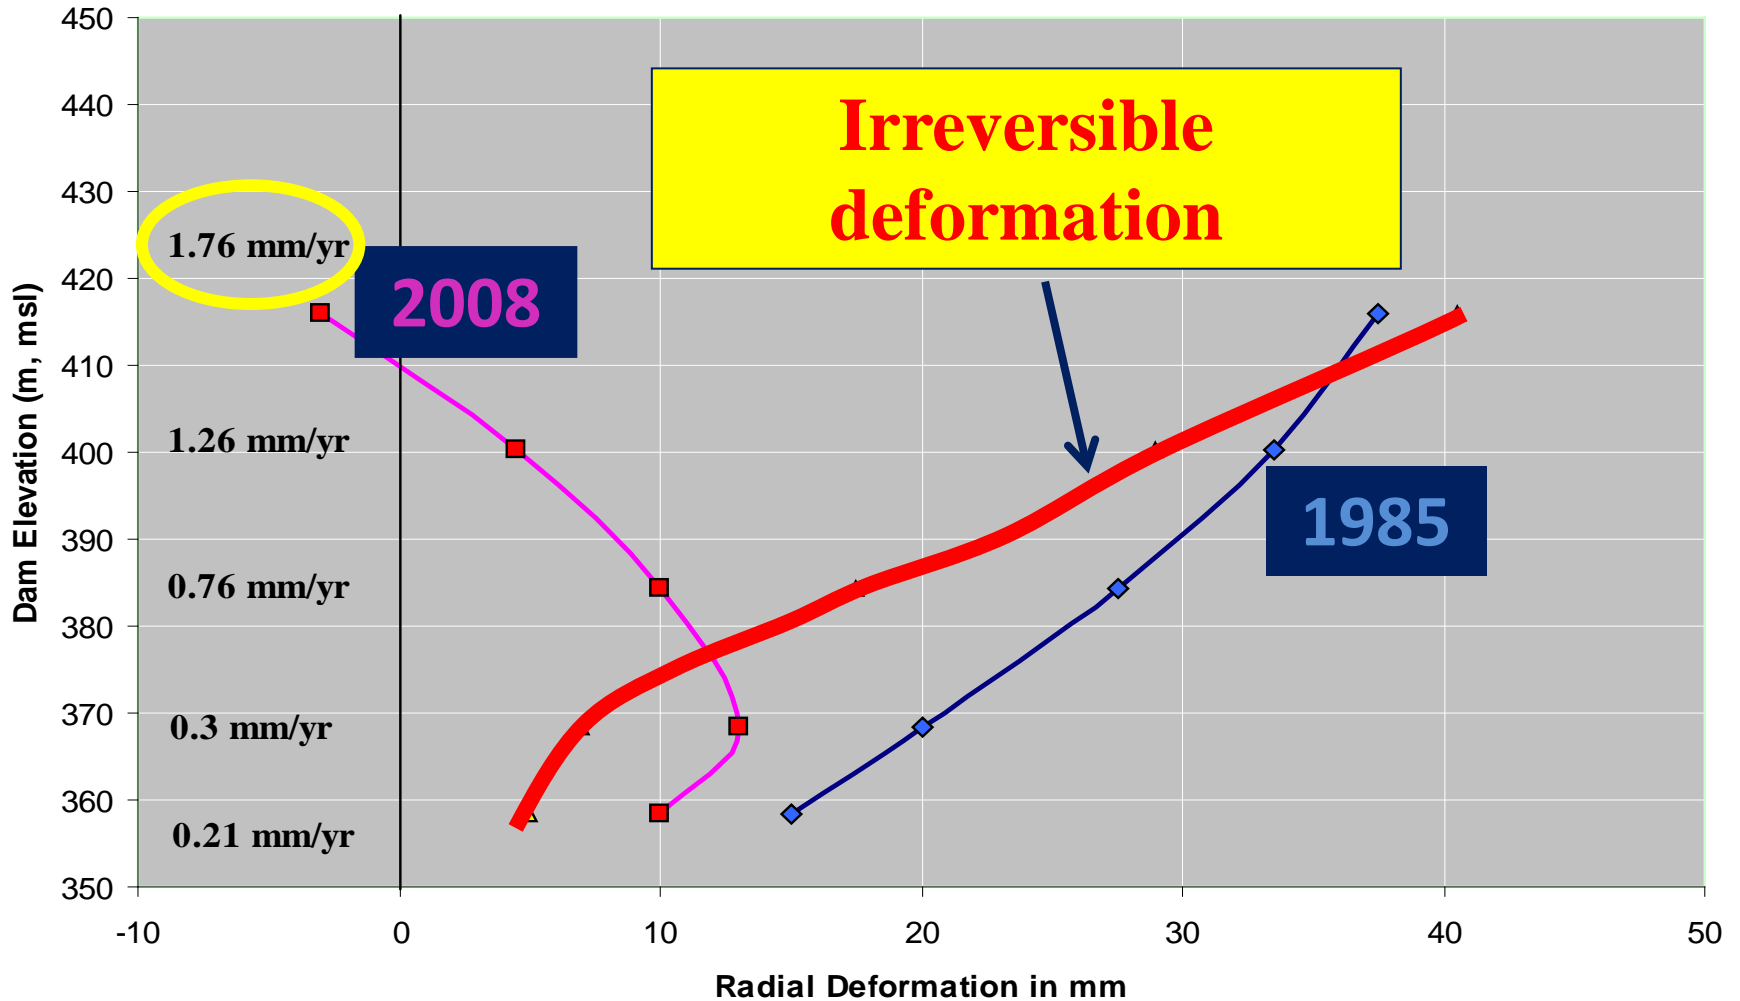
# Irreversible deformations (high water levels)

Trend of upstream movement

Trend of vertical rising

Back analysis

Possibility of AAR (ASR)

Lab test /core samples
