**2 nd Thematic Workshop
on Water Related Disaster and Its
Management
Oct.7-10, Manila Philippines 2008**

Assignment on Water-Related
Disaster and its Management
in Bangladesh

Shamsul Huda Khan

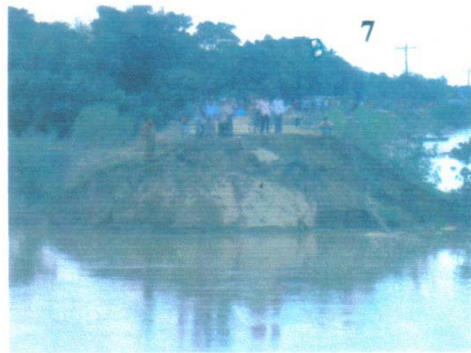
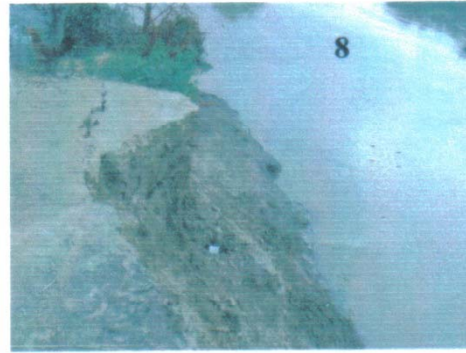
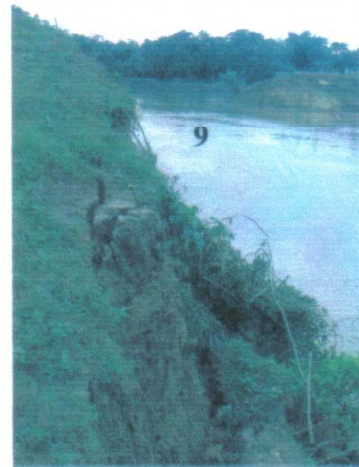
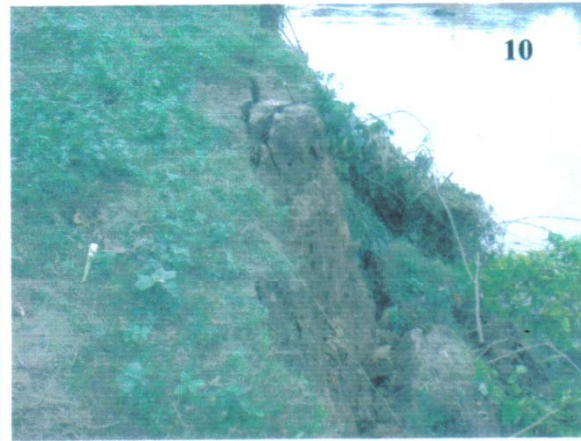
Photoes (7 to 10) showing earth slide and soil condition of breach portion of embankment

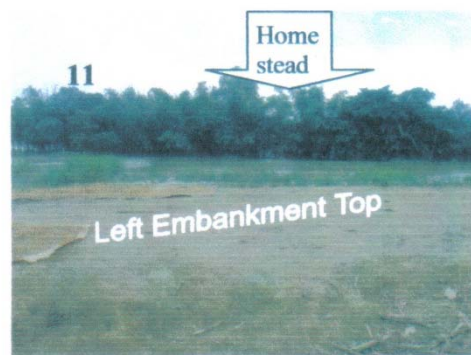
Photo (11) showing homestead 70m far from LE and Main River is 130m behind the homestead not seen

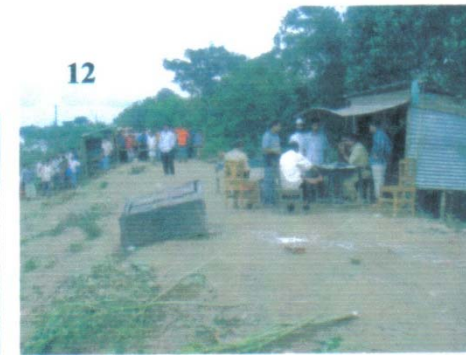
Photo(12) showing BWDB and security personals at the breach location

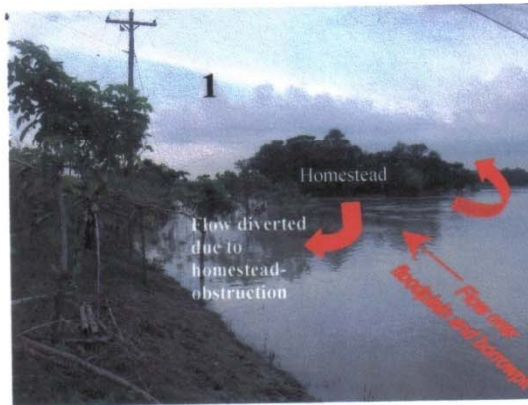
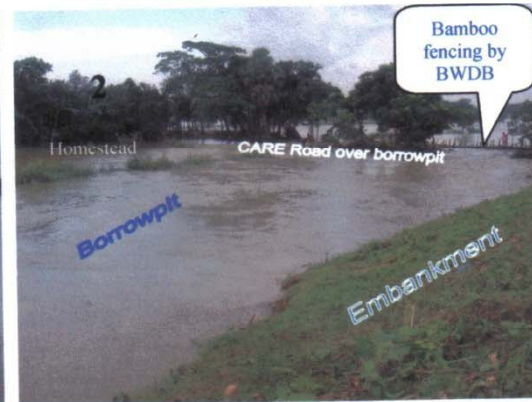
Photoes (1 to 2) showing existing situations near the breach

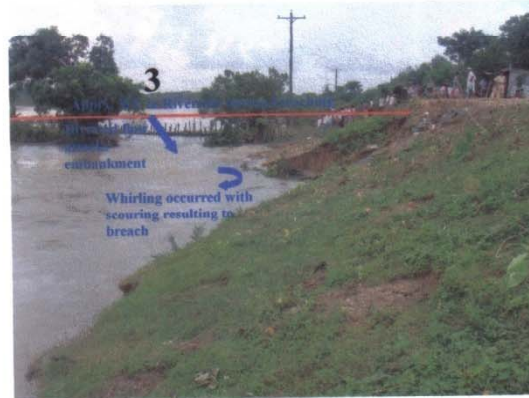
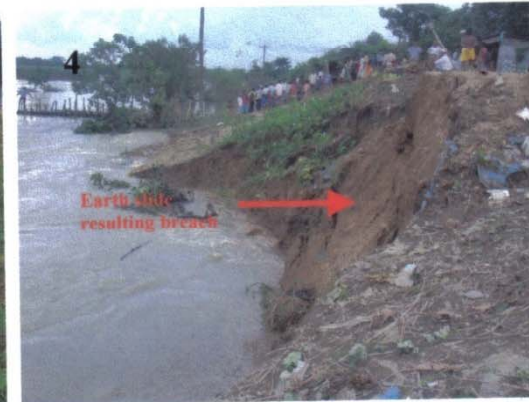
Photoes (3 to 4) describing a reason for breach at Bara Alampur, Devidwar, Comilla

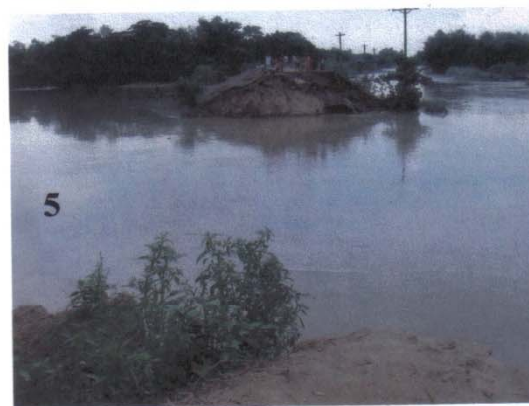
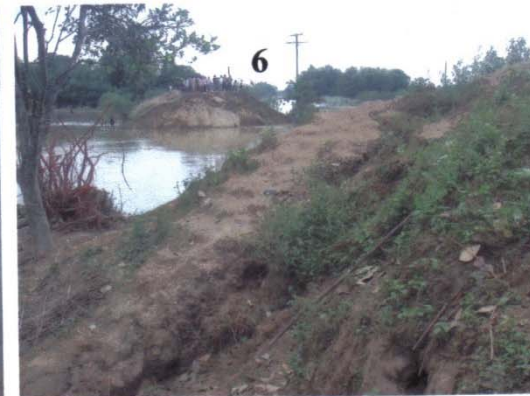
Photoes (5-6) showing breach occurred at Bara Alampur, Devidwar, Comilla
