RAPID FLOOD MANAGEMENT ASSESSMENT

**Lesson Learn and Future Direction for Water Policy:
Structure and non-structure flood prevention**

River and Canal Dredging

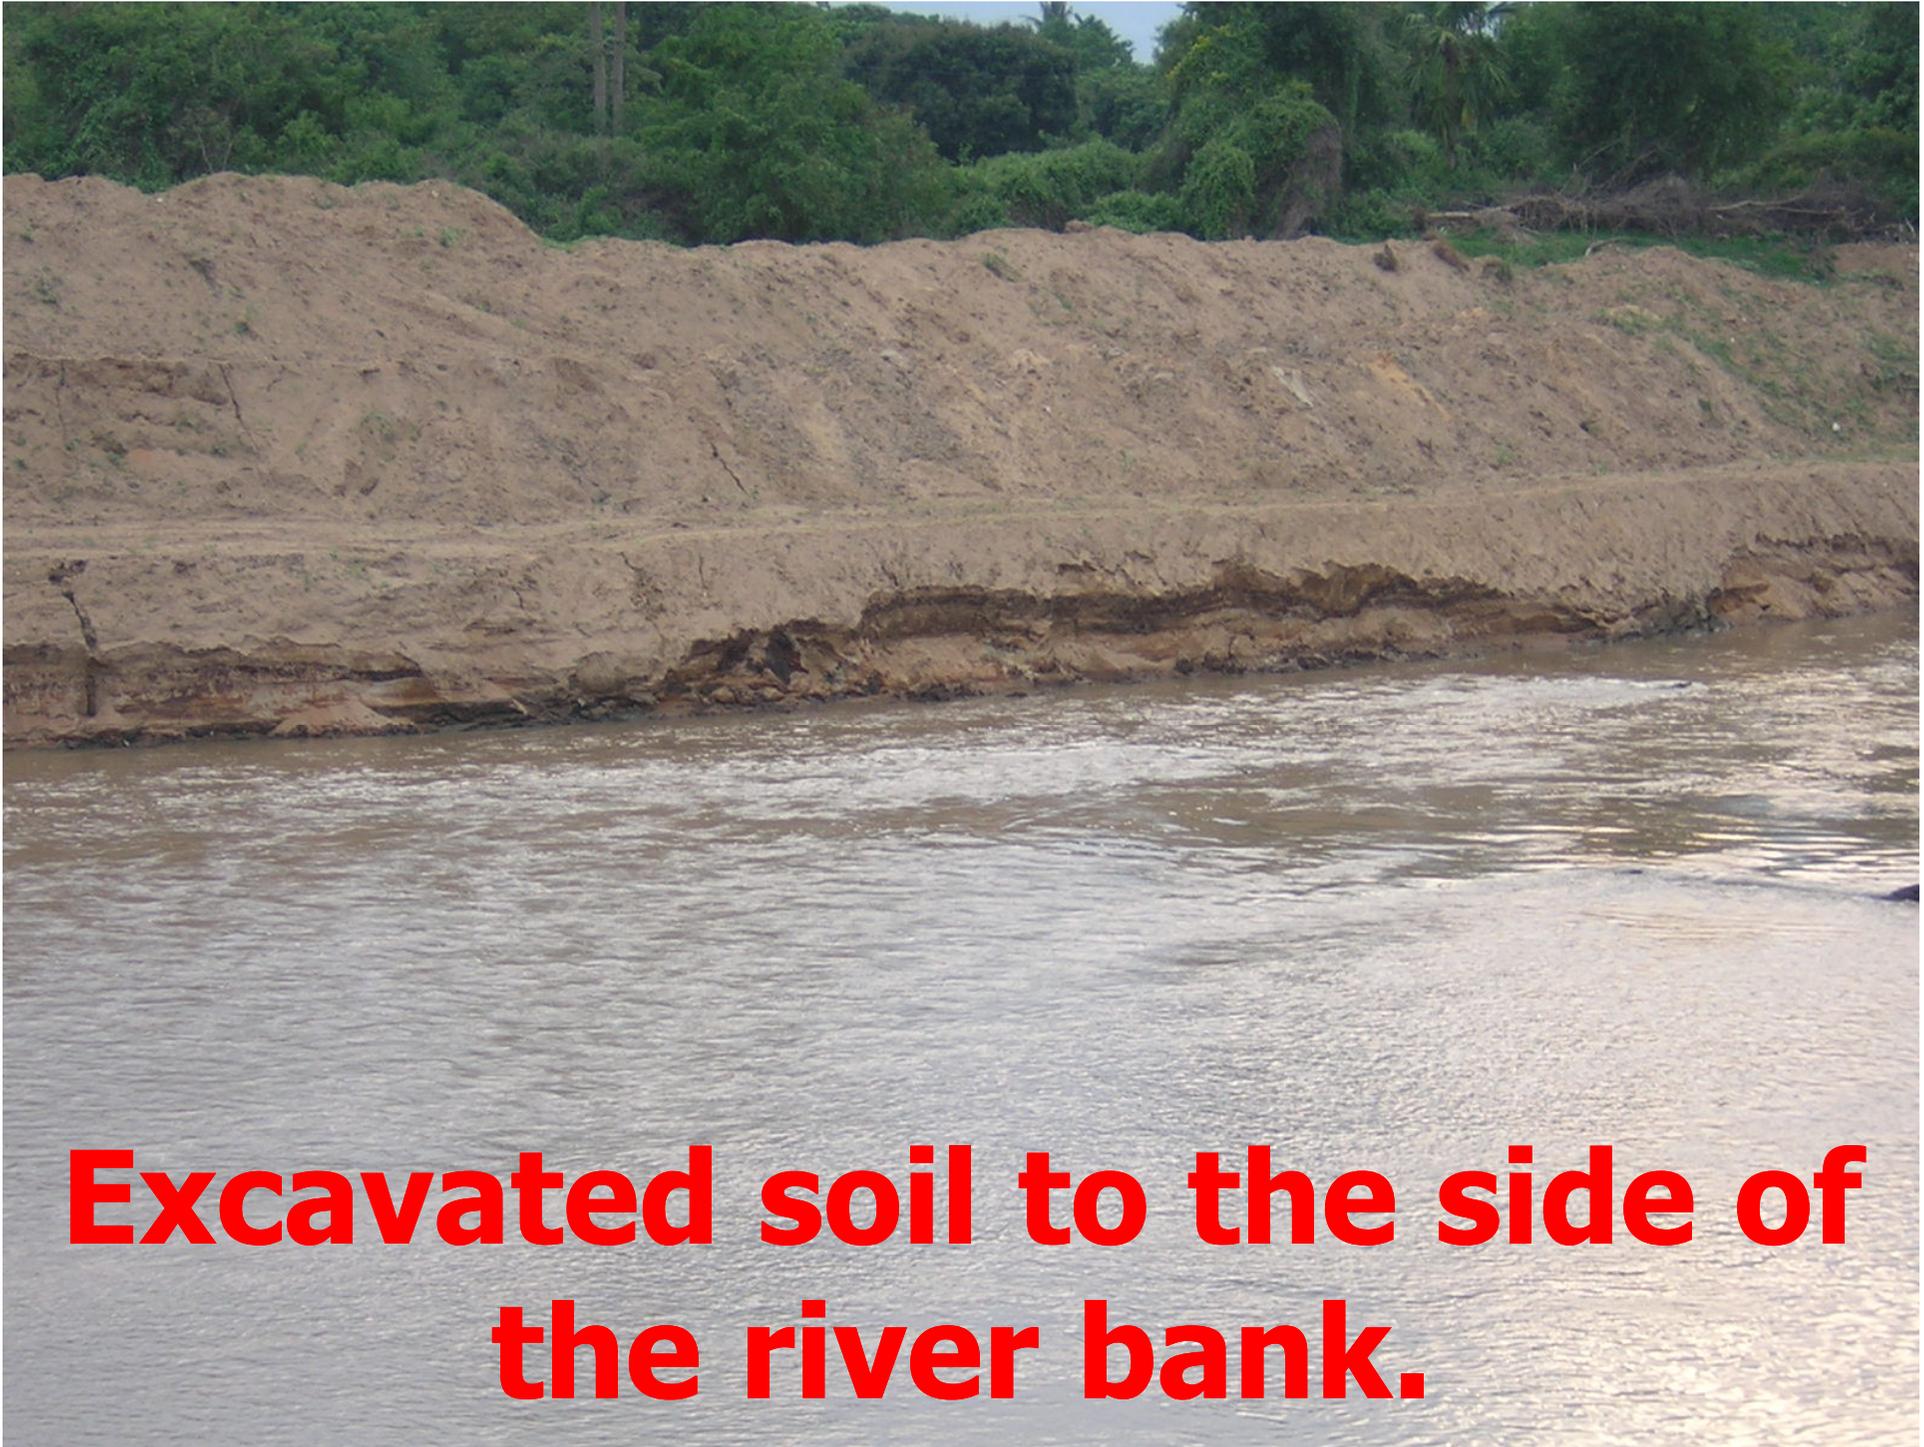
**Excavated soil to the side of
the river bank.**

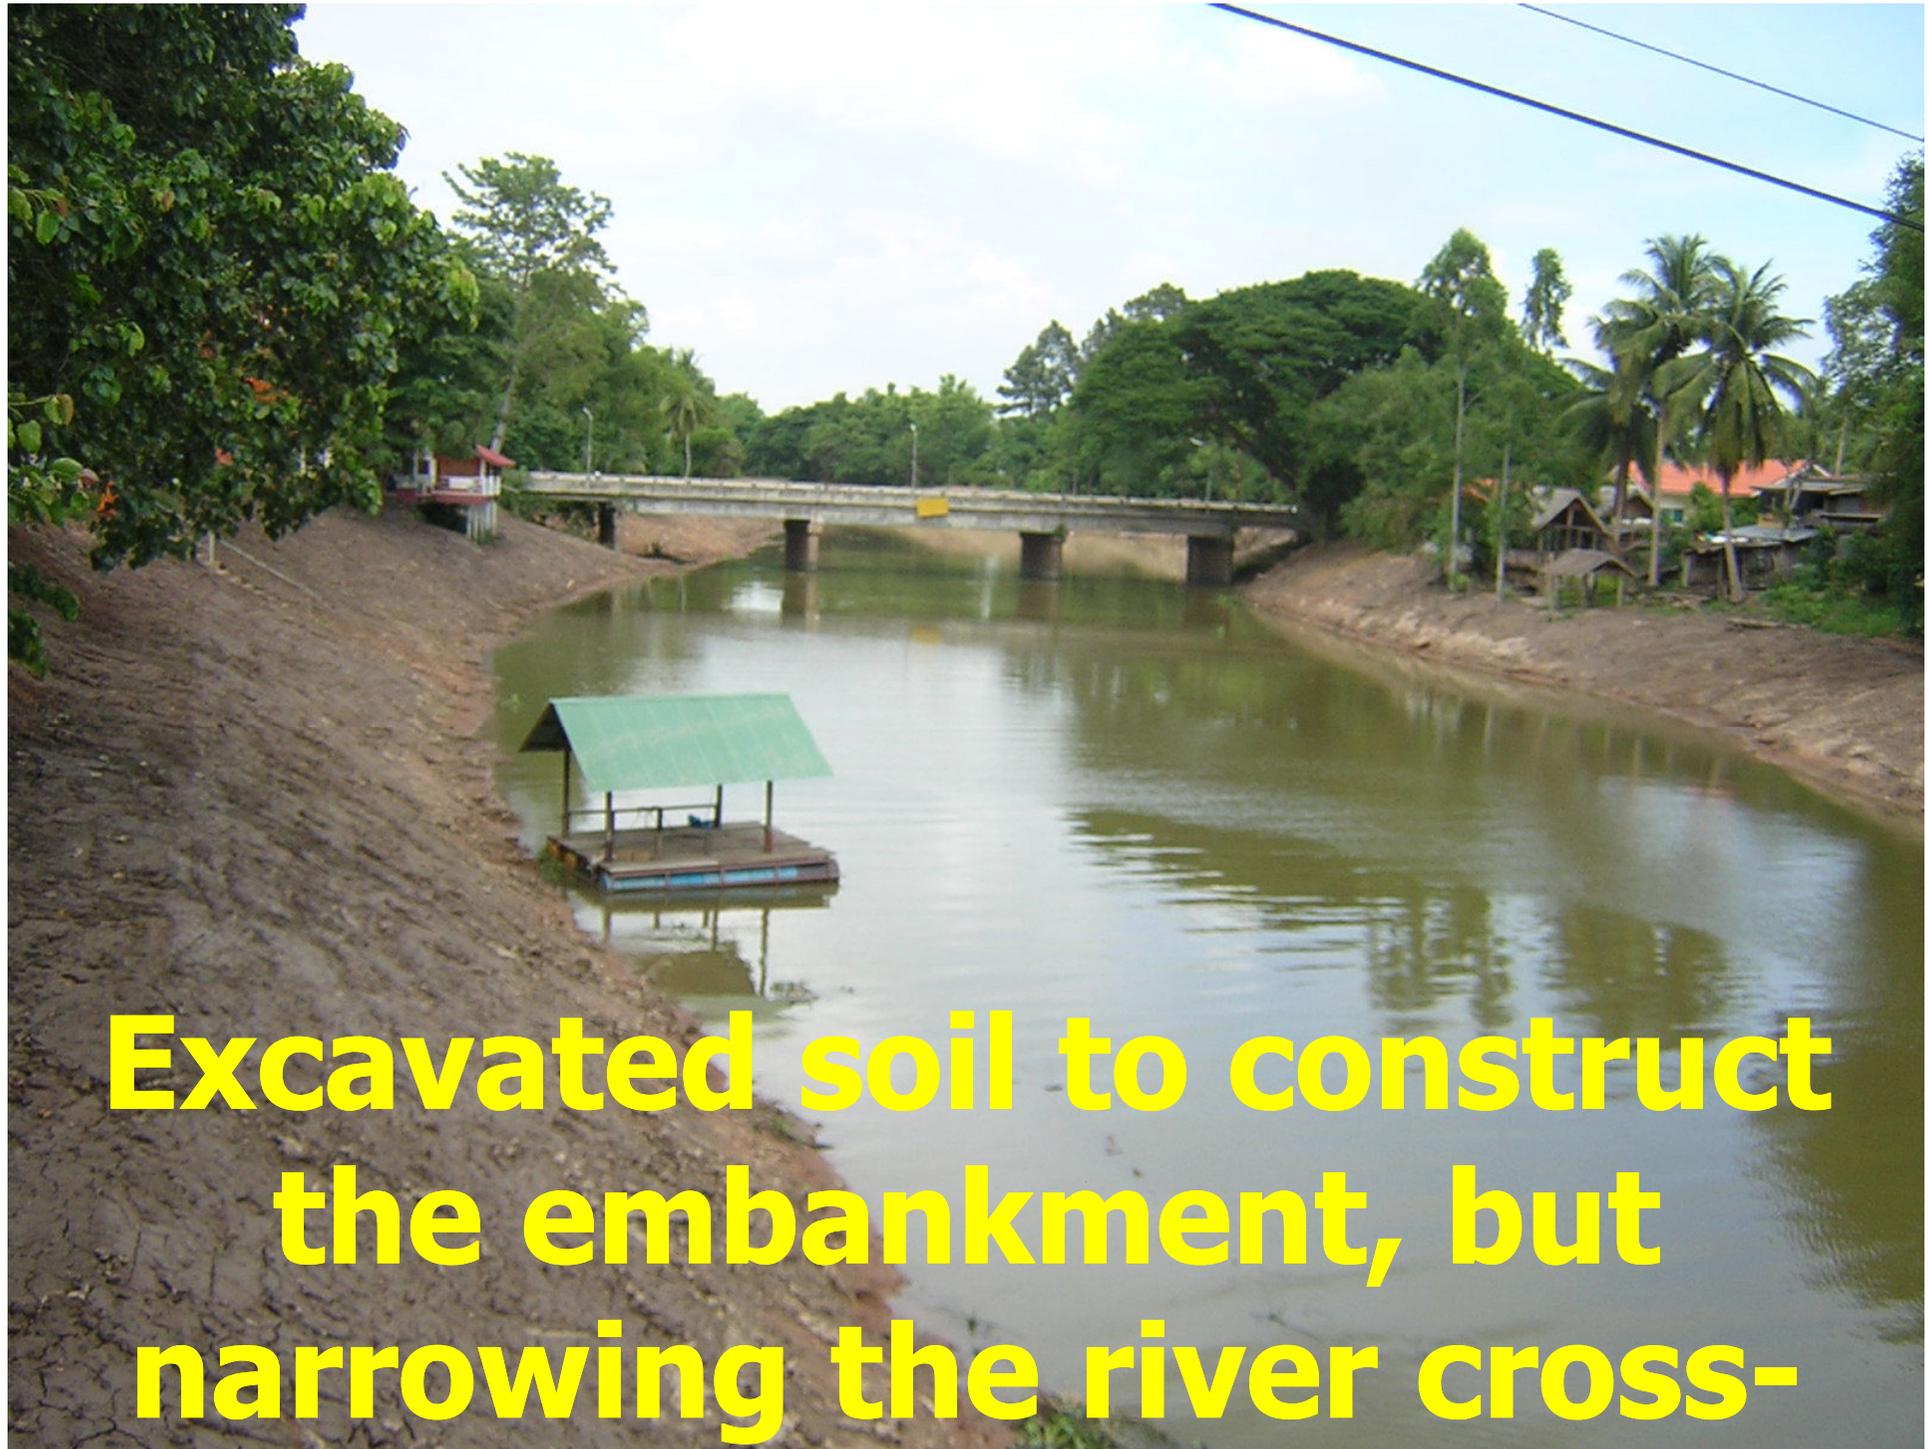
**Excavated soil to construct
the embankment, but
narrowing the river cross-**

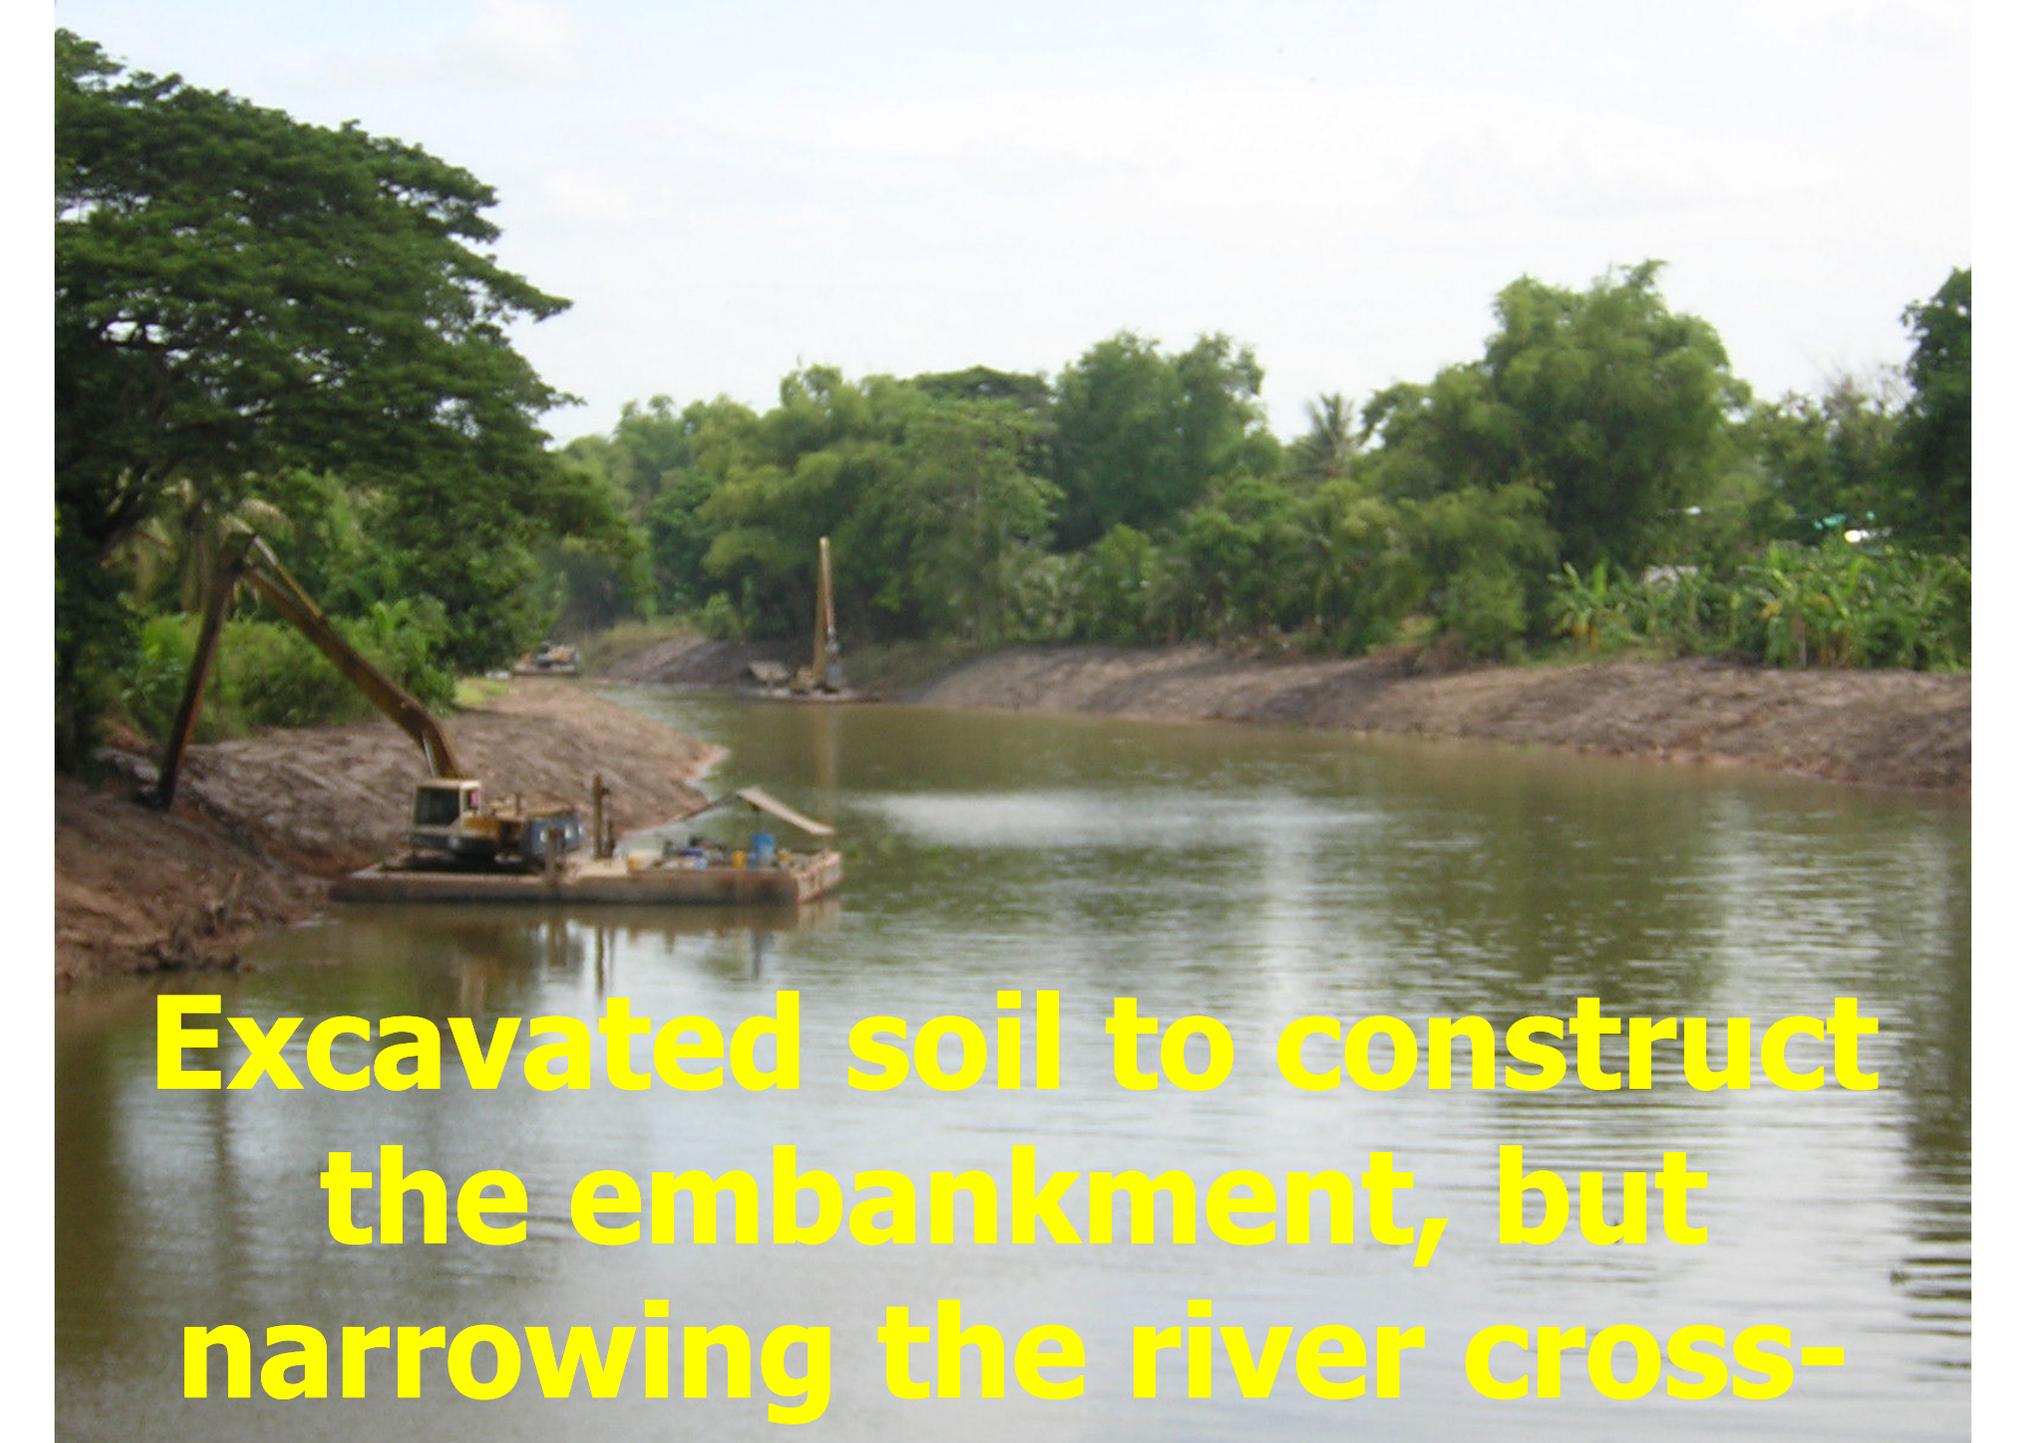
Excavated soil to construct the embankment, but narrowing the river cross-

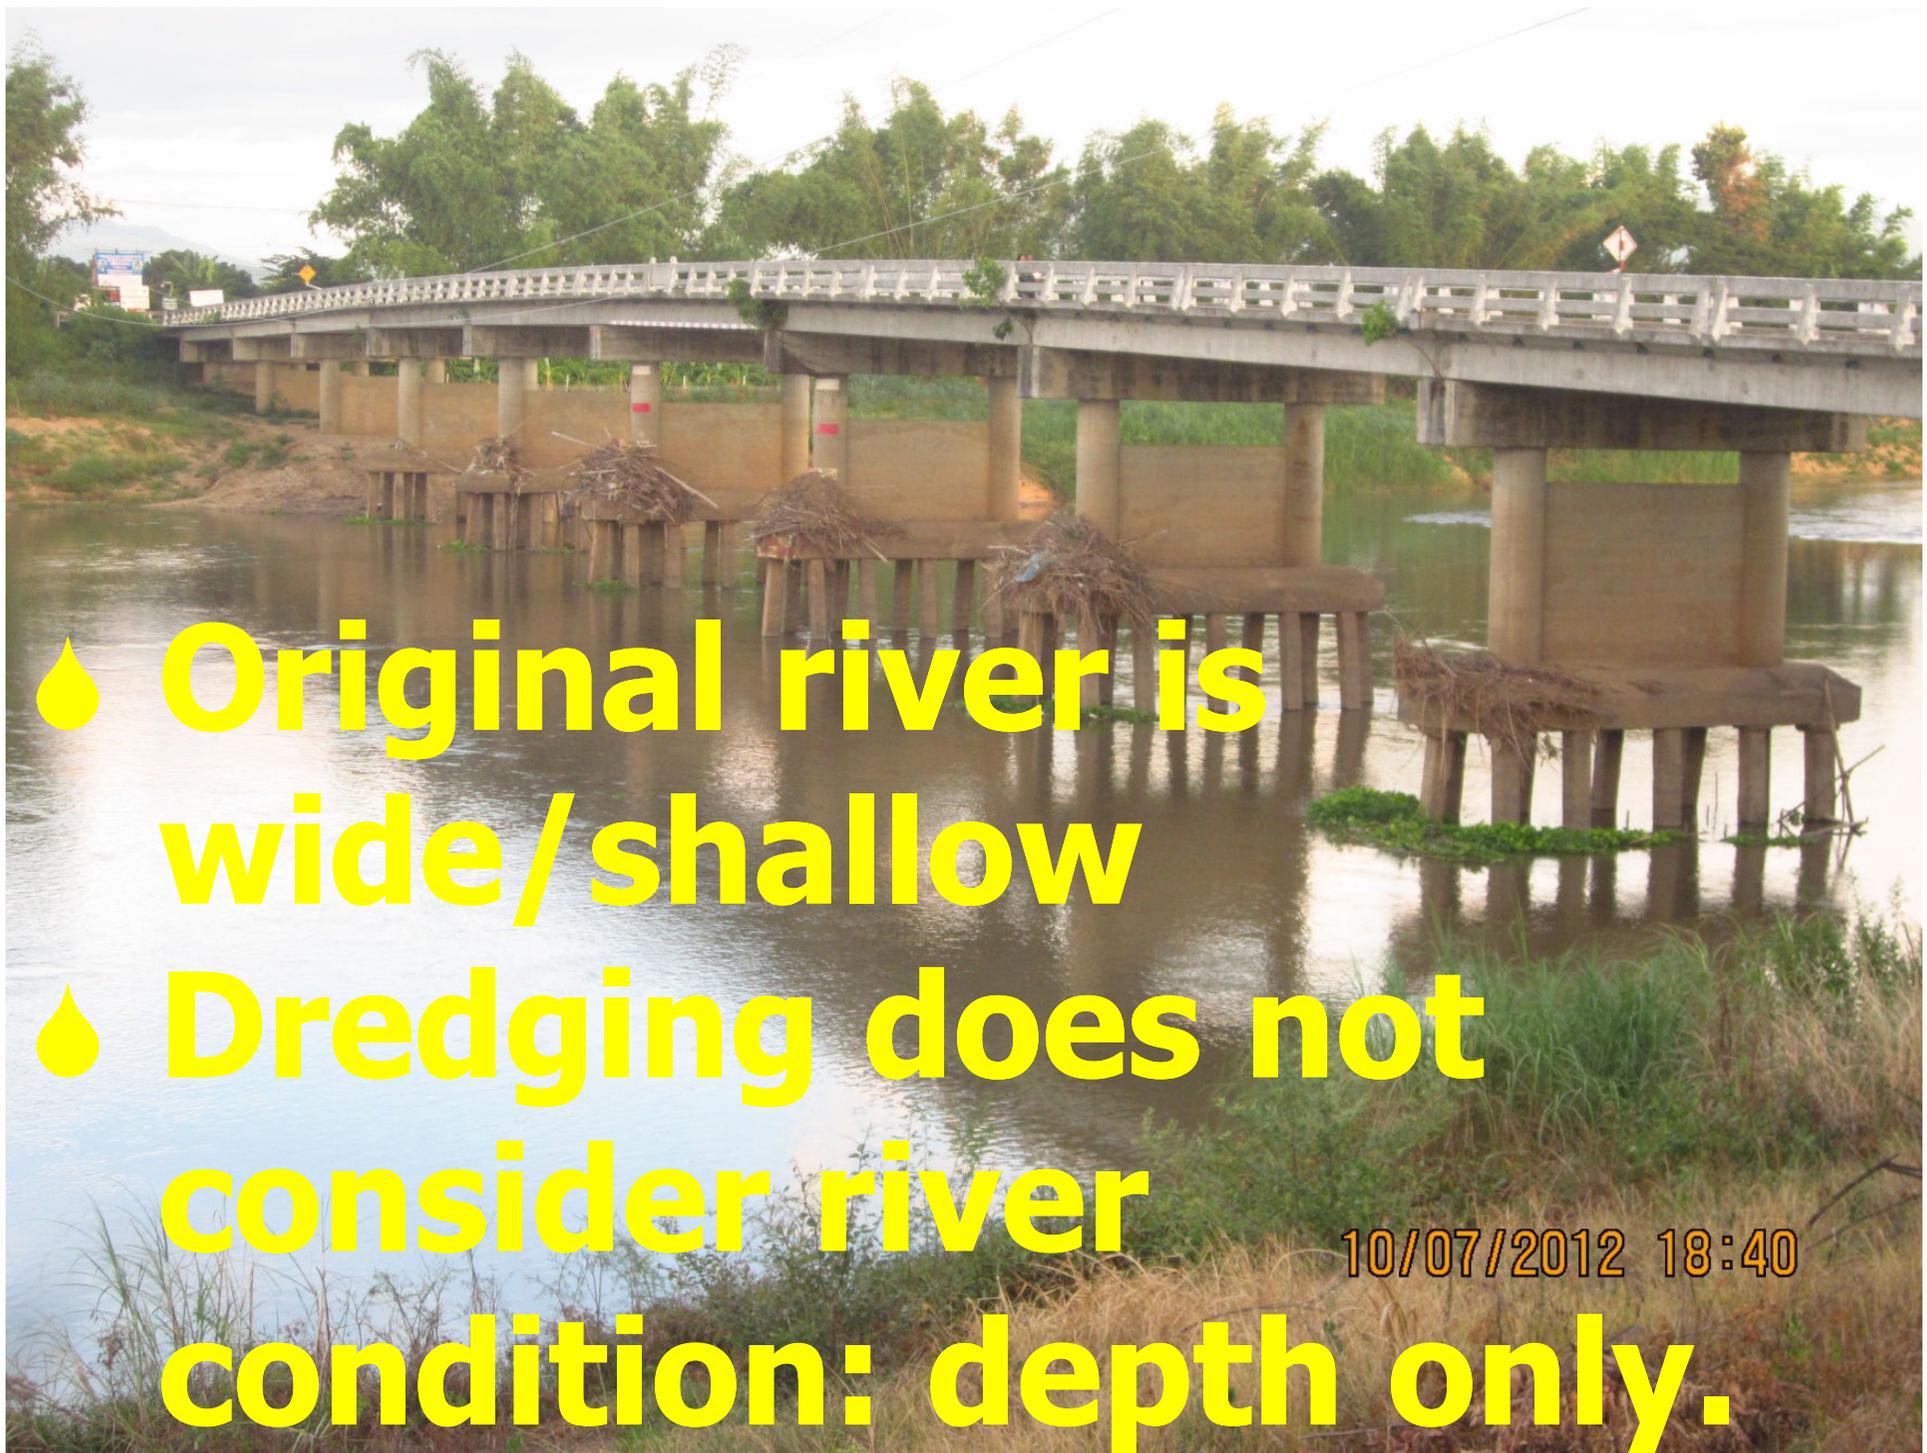
- 💧 **Original river is wide/shallow**
- 💧 **Dredging does not consider river condition: depth only.**

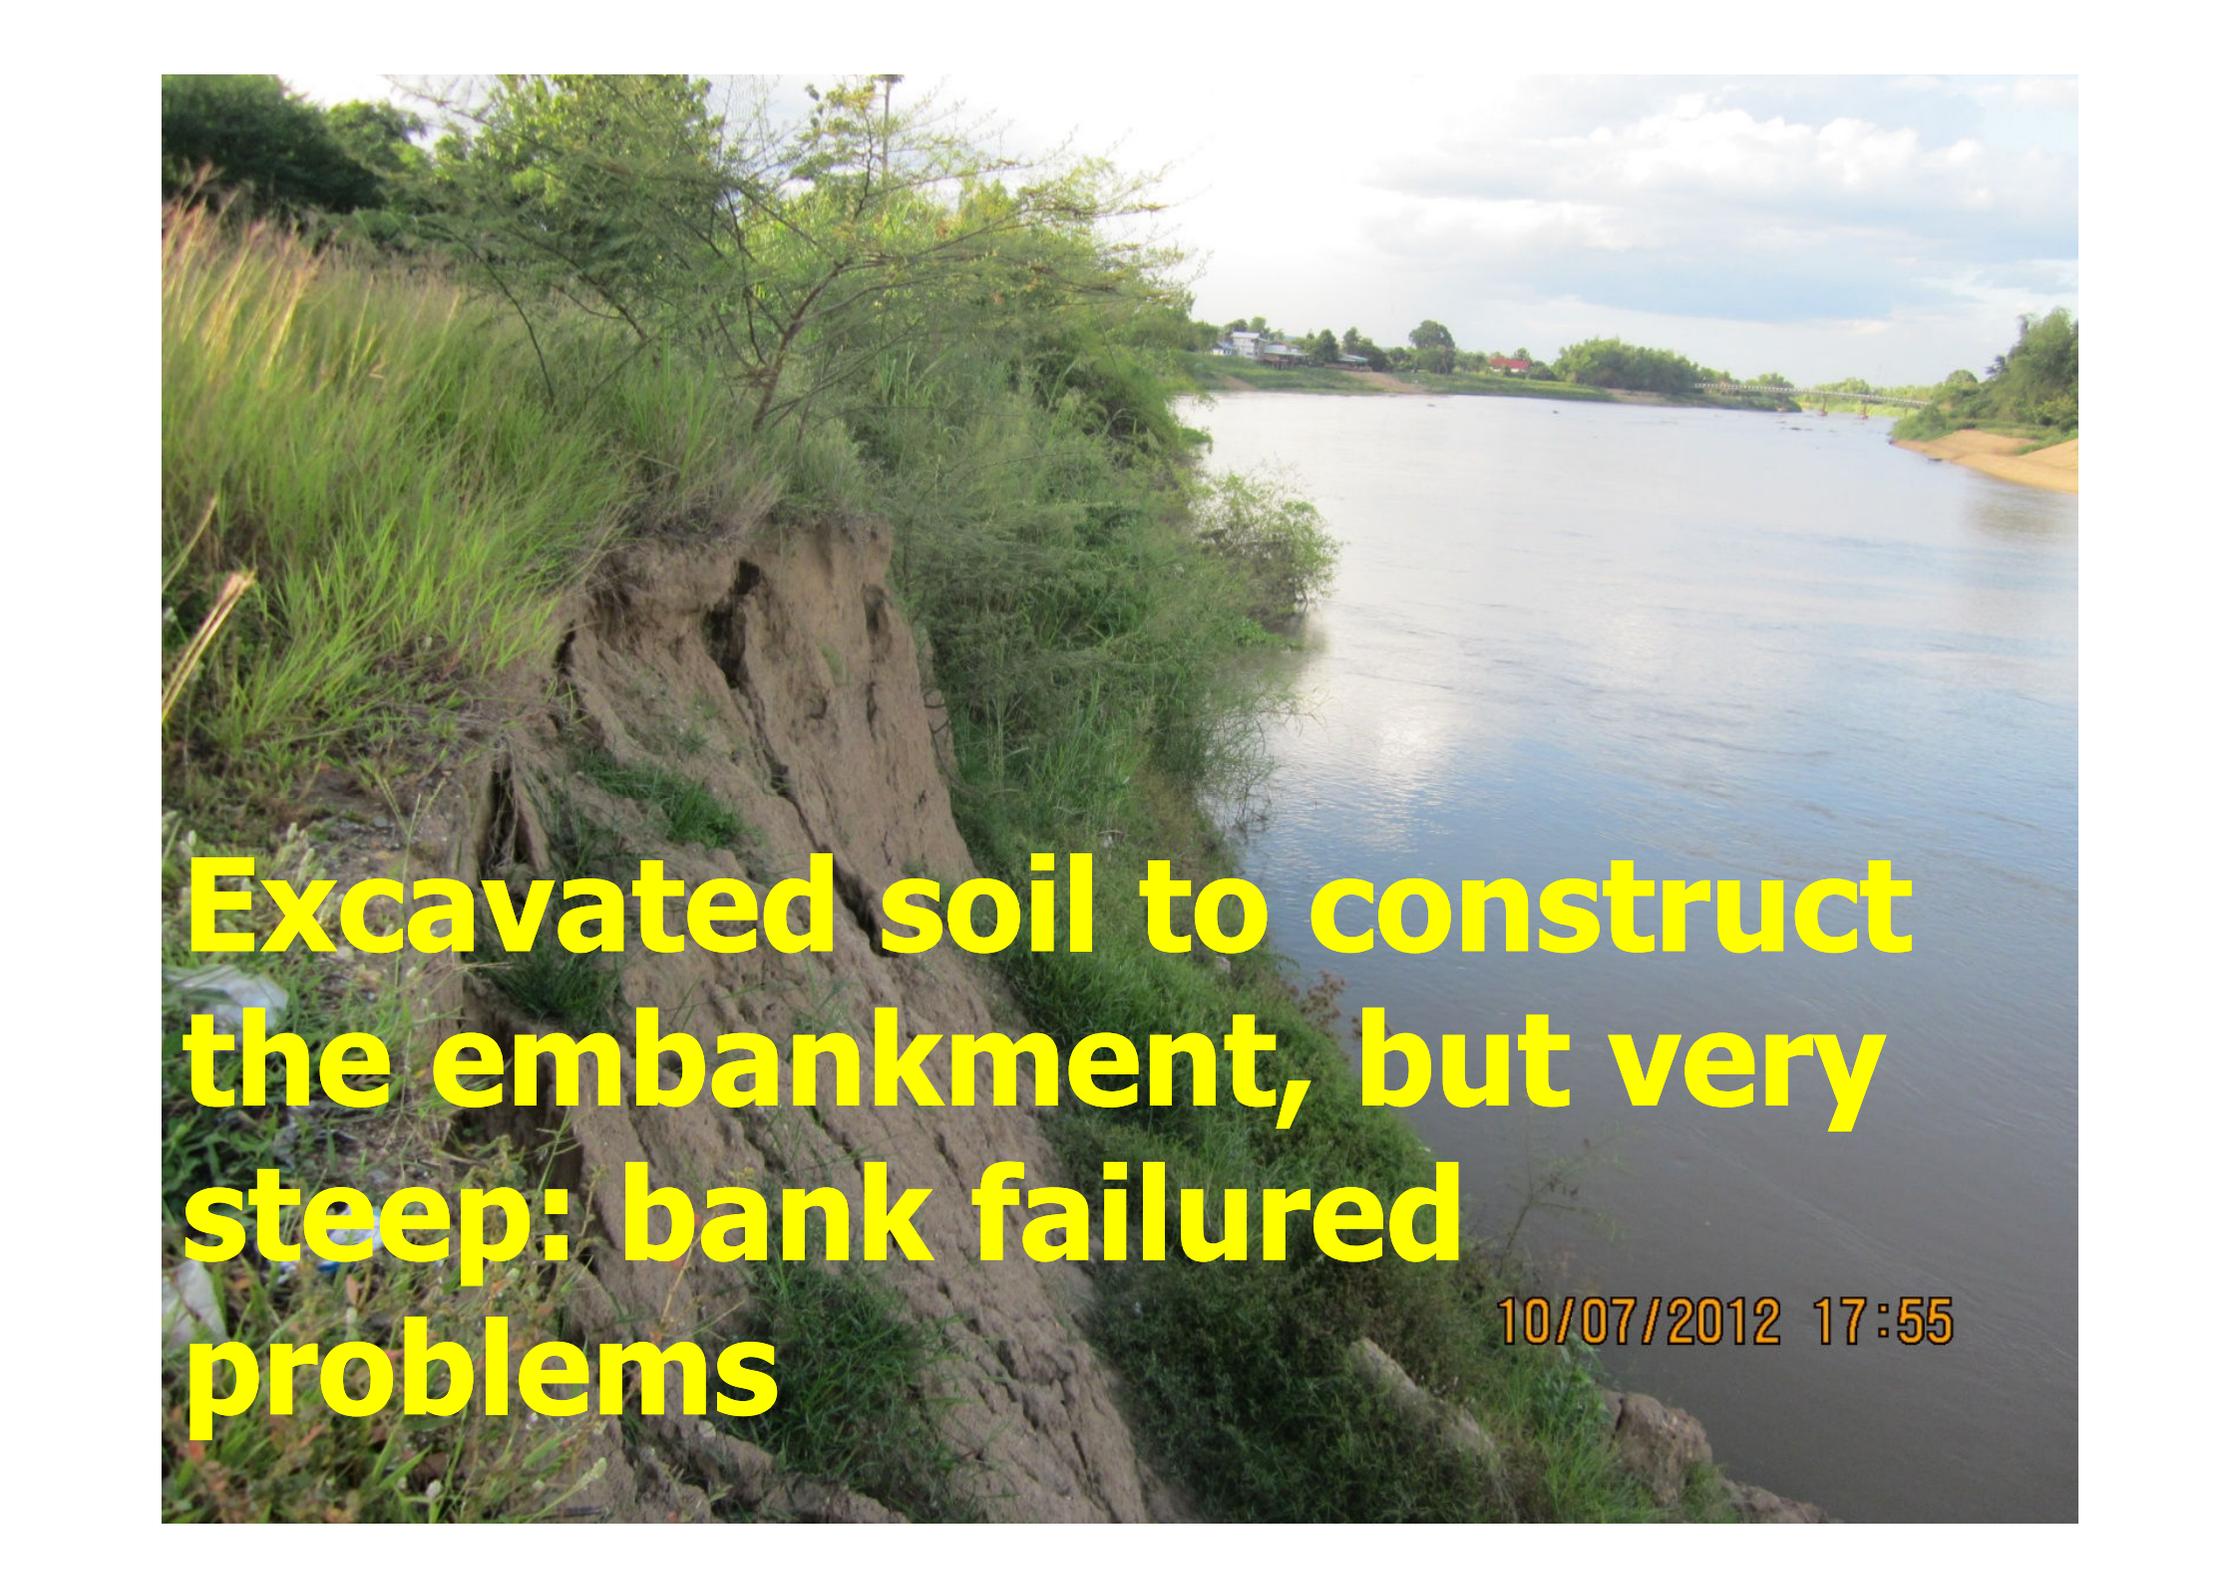
**Excavated soil to construct
the embankment, but very
steep: bank failed
problems**

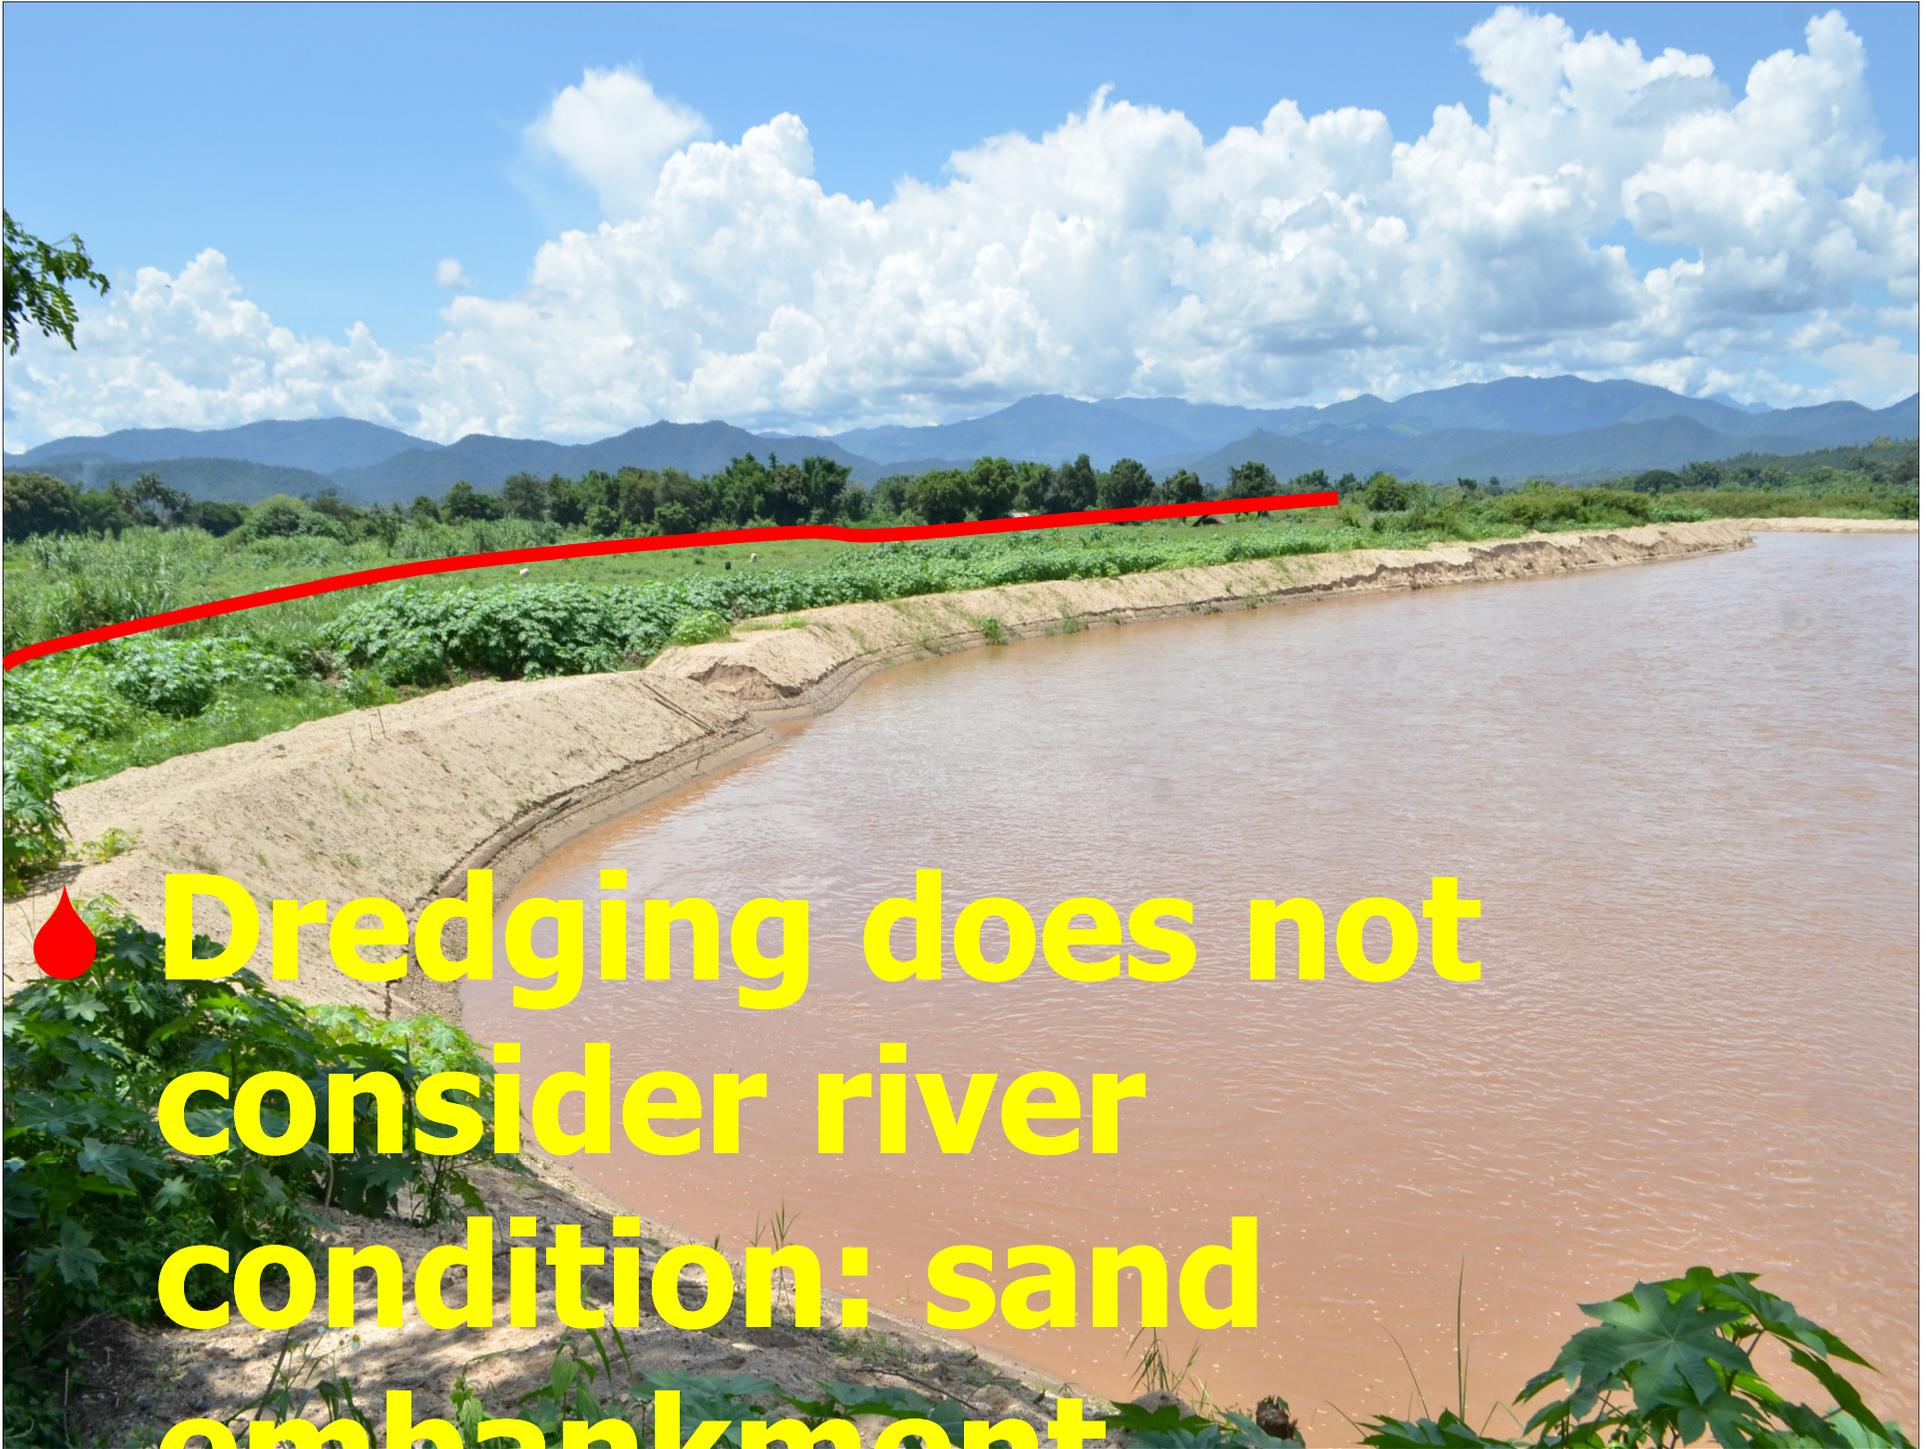
**Dredging does not consider river condition: sand embankment**

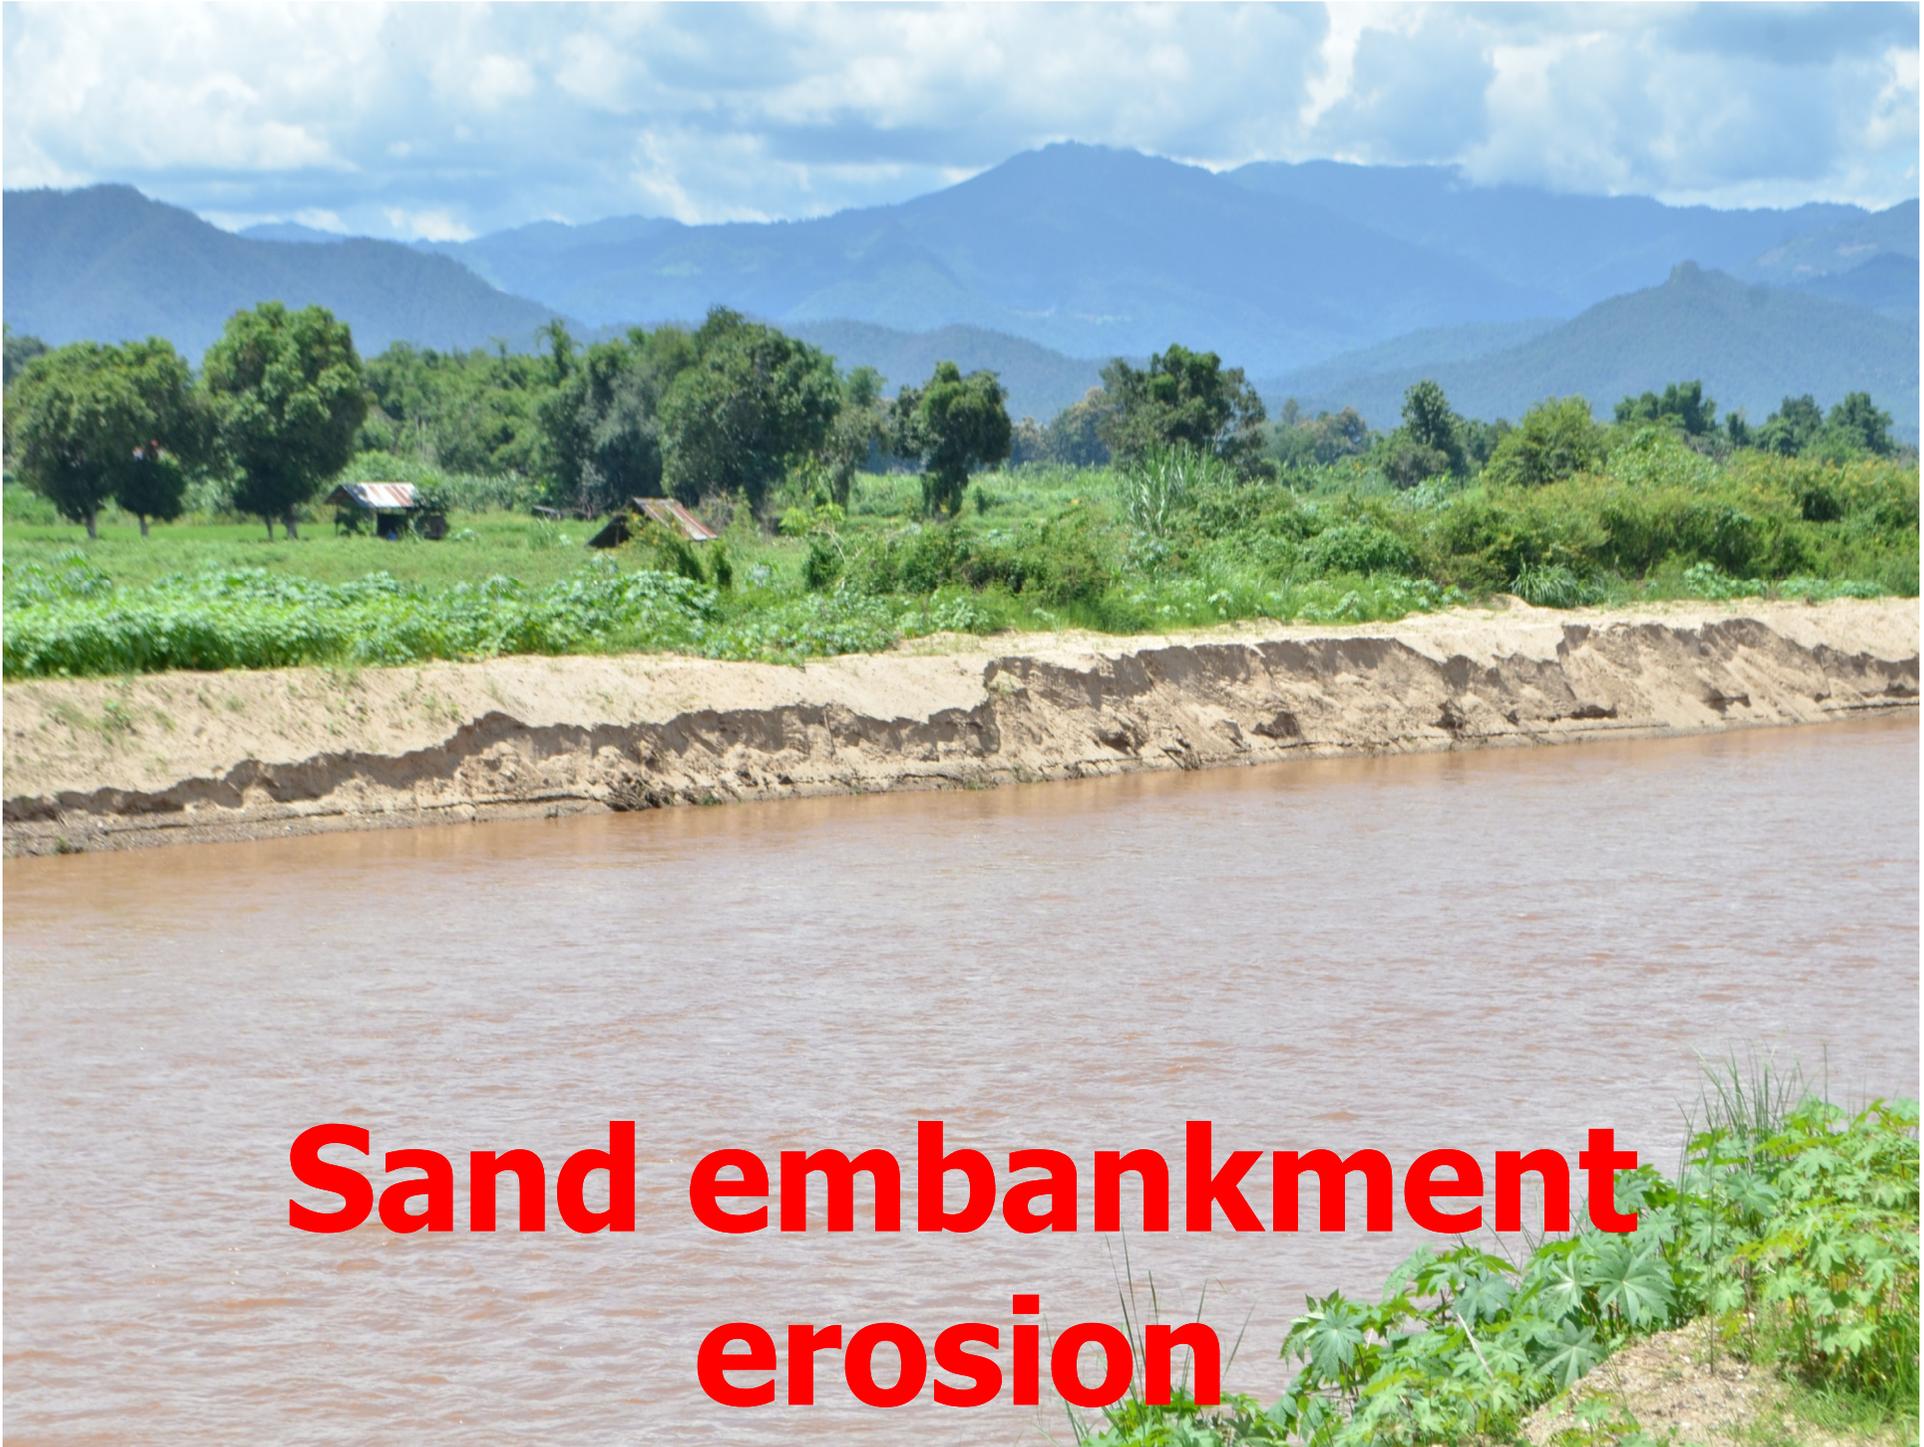
**Sand embankment
erosion**

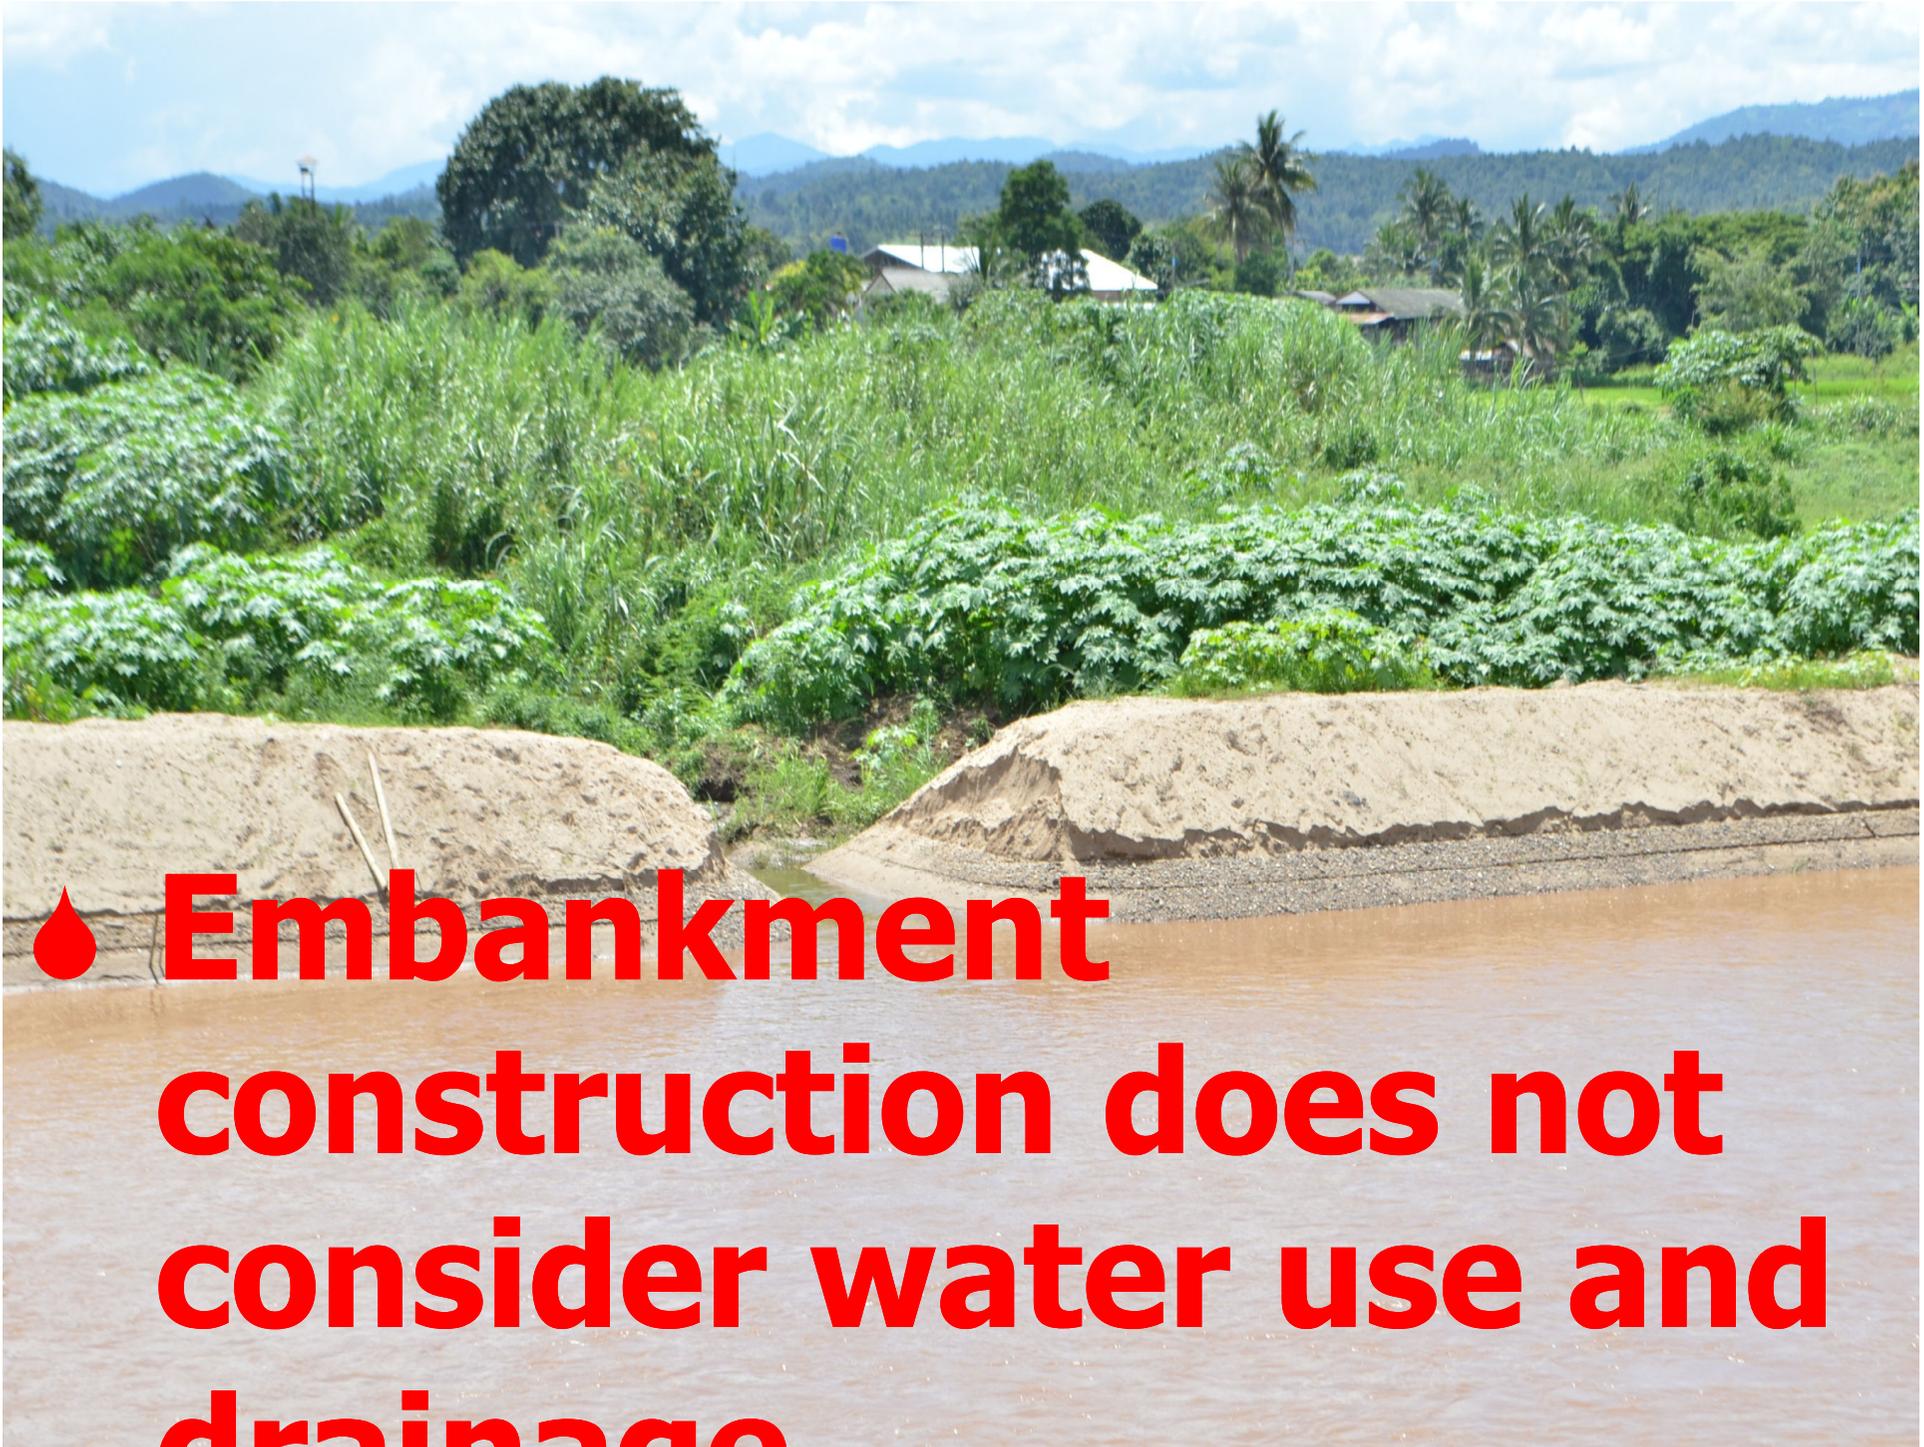
**construction does not
consider water use and
drainage**
