RAPID FLOOD MANAGEMENT ASSESSMENT

**Lesson Learn and Future Direction for Water Policy:
Structure and non-structure flood prevention**

River and Canal Dredging

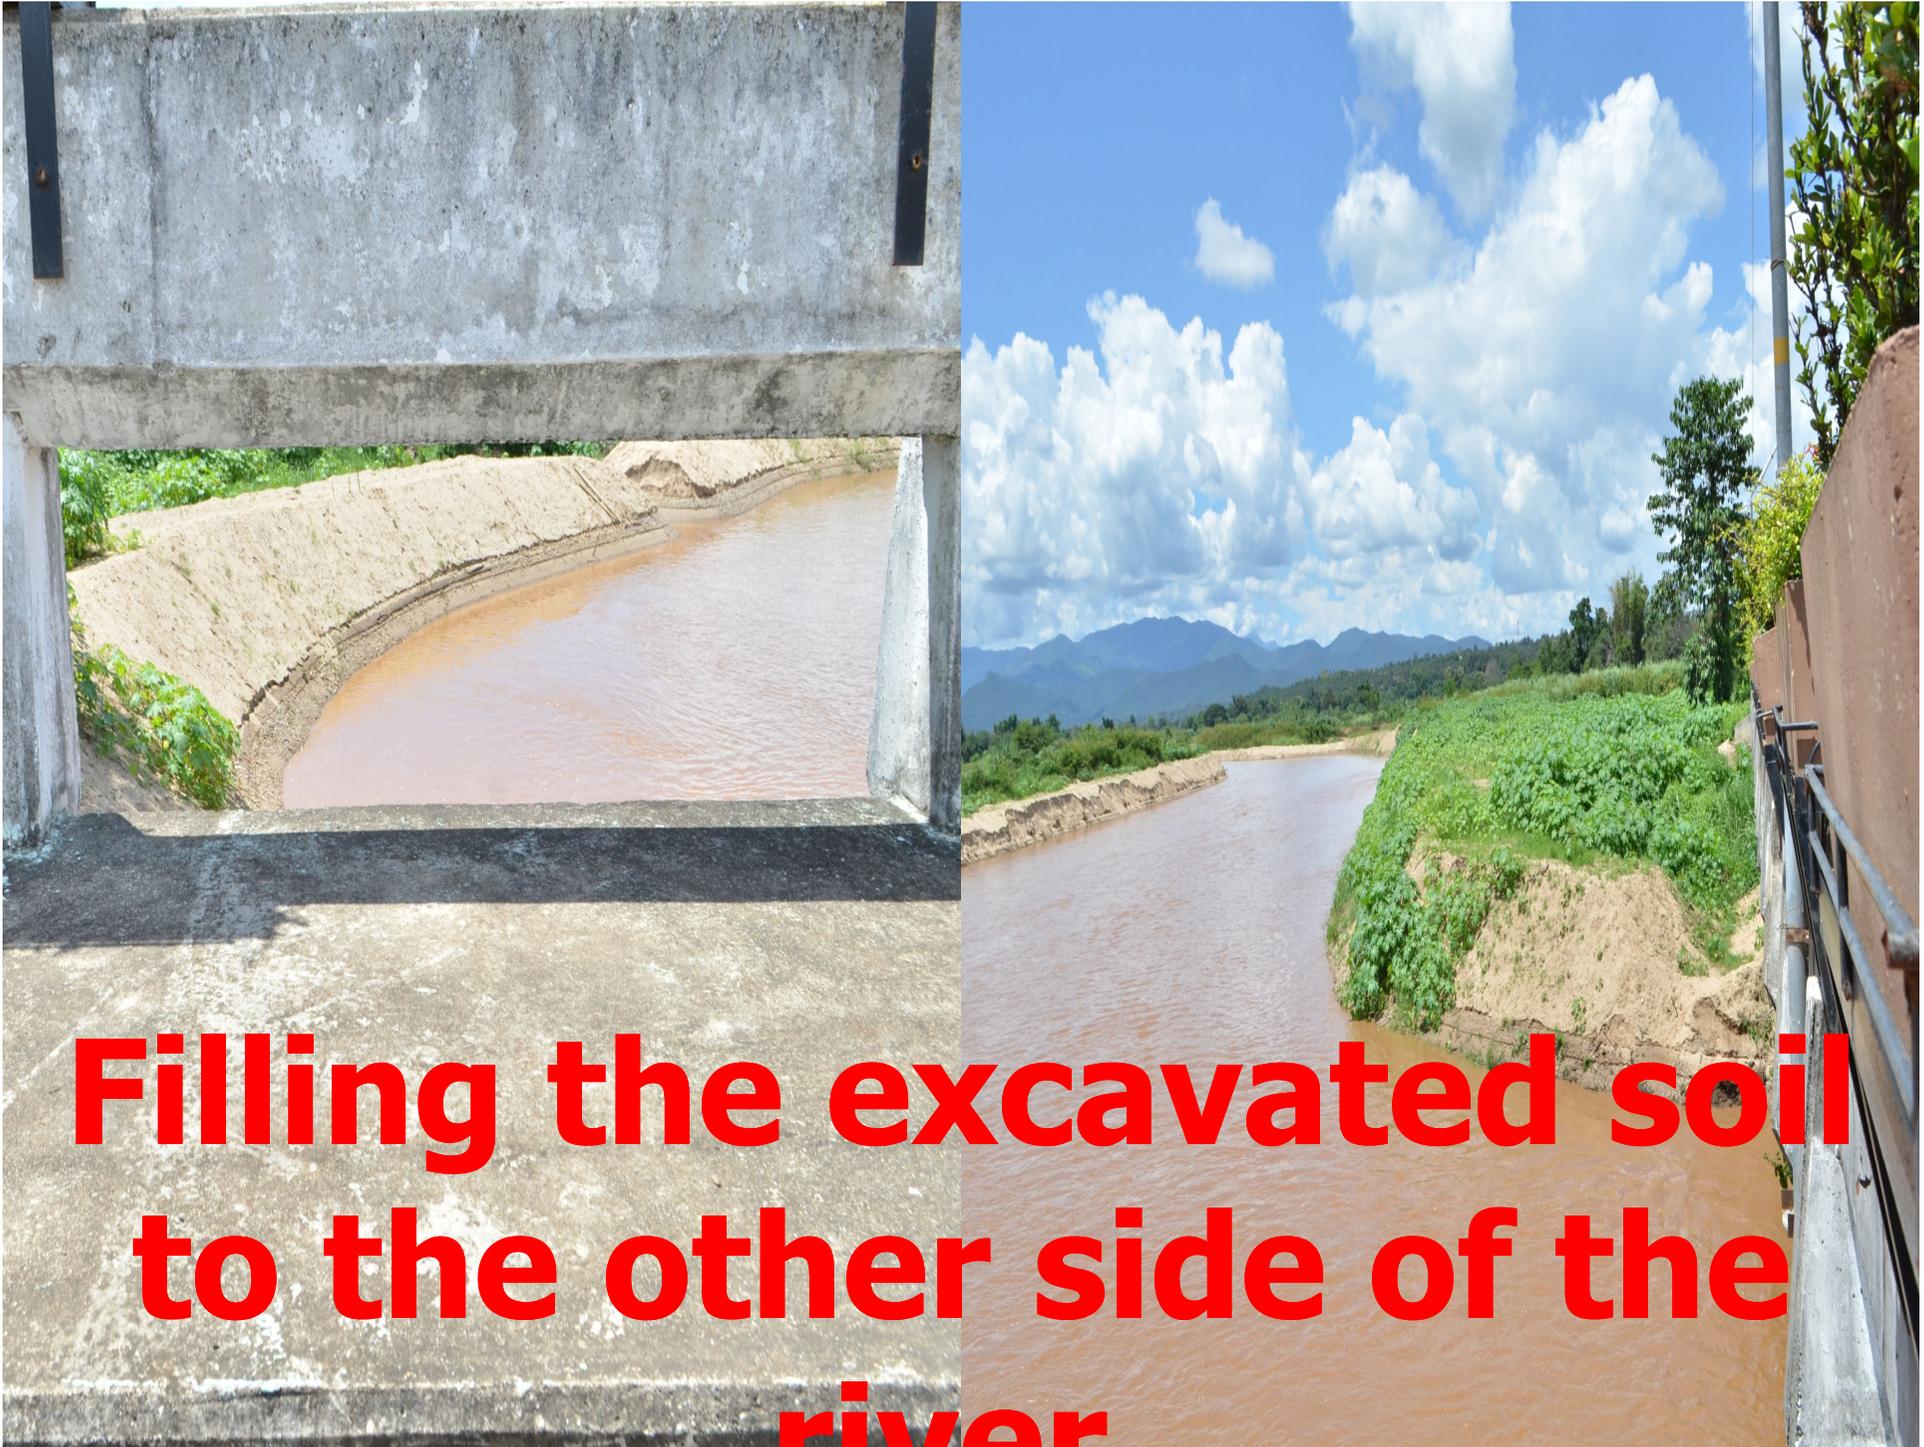
**Filling the excavated soil
to the other side of the
river**

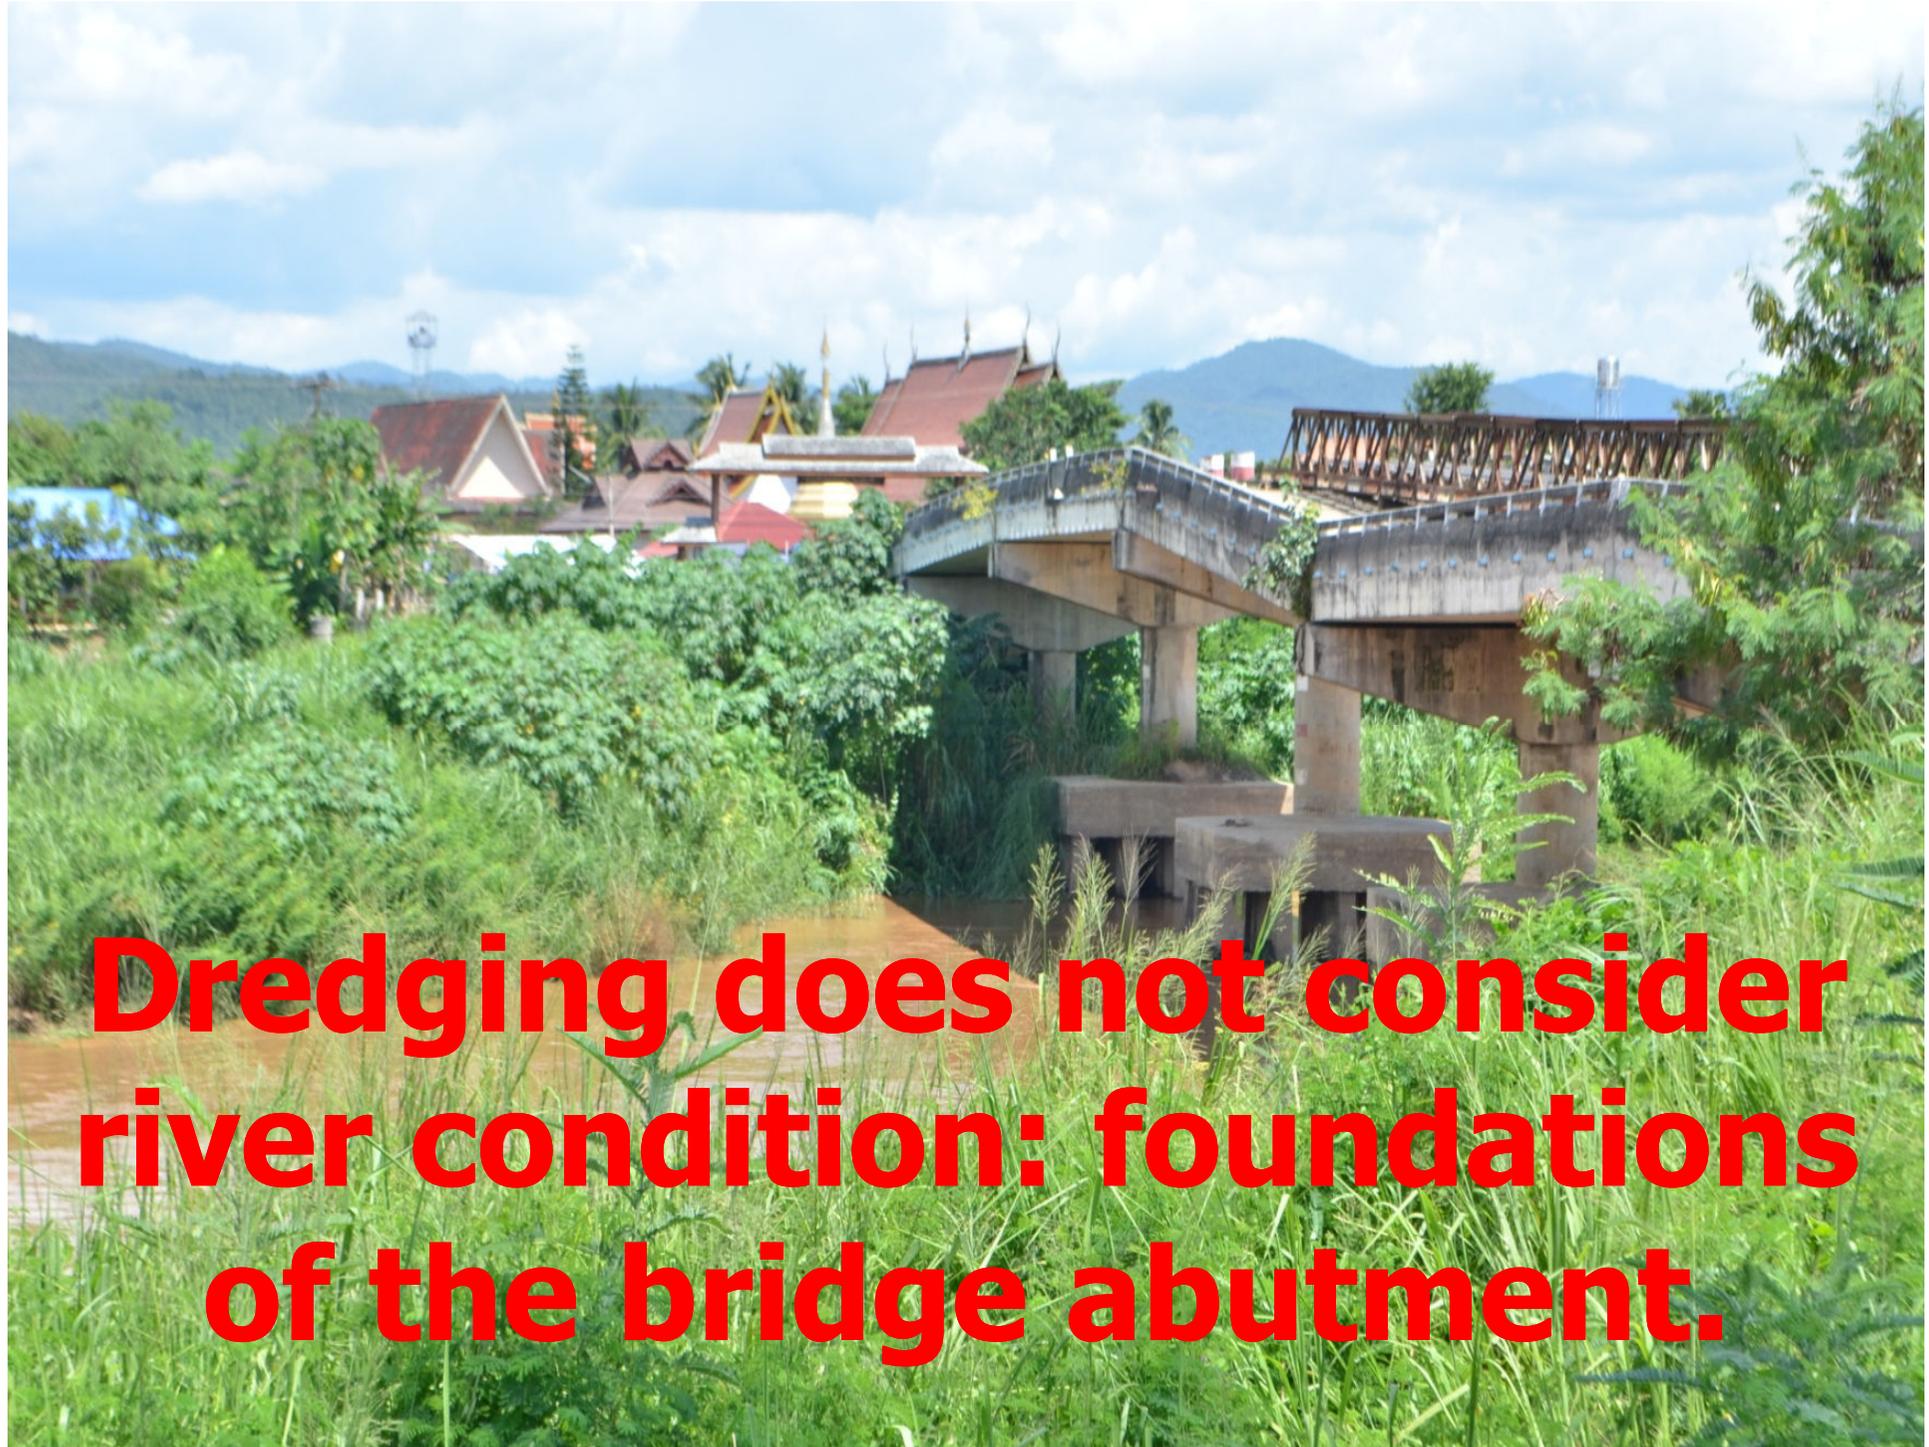
Dredging does not consider river condition: foundations of the bridge abutment.

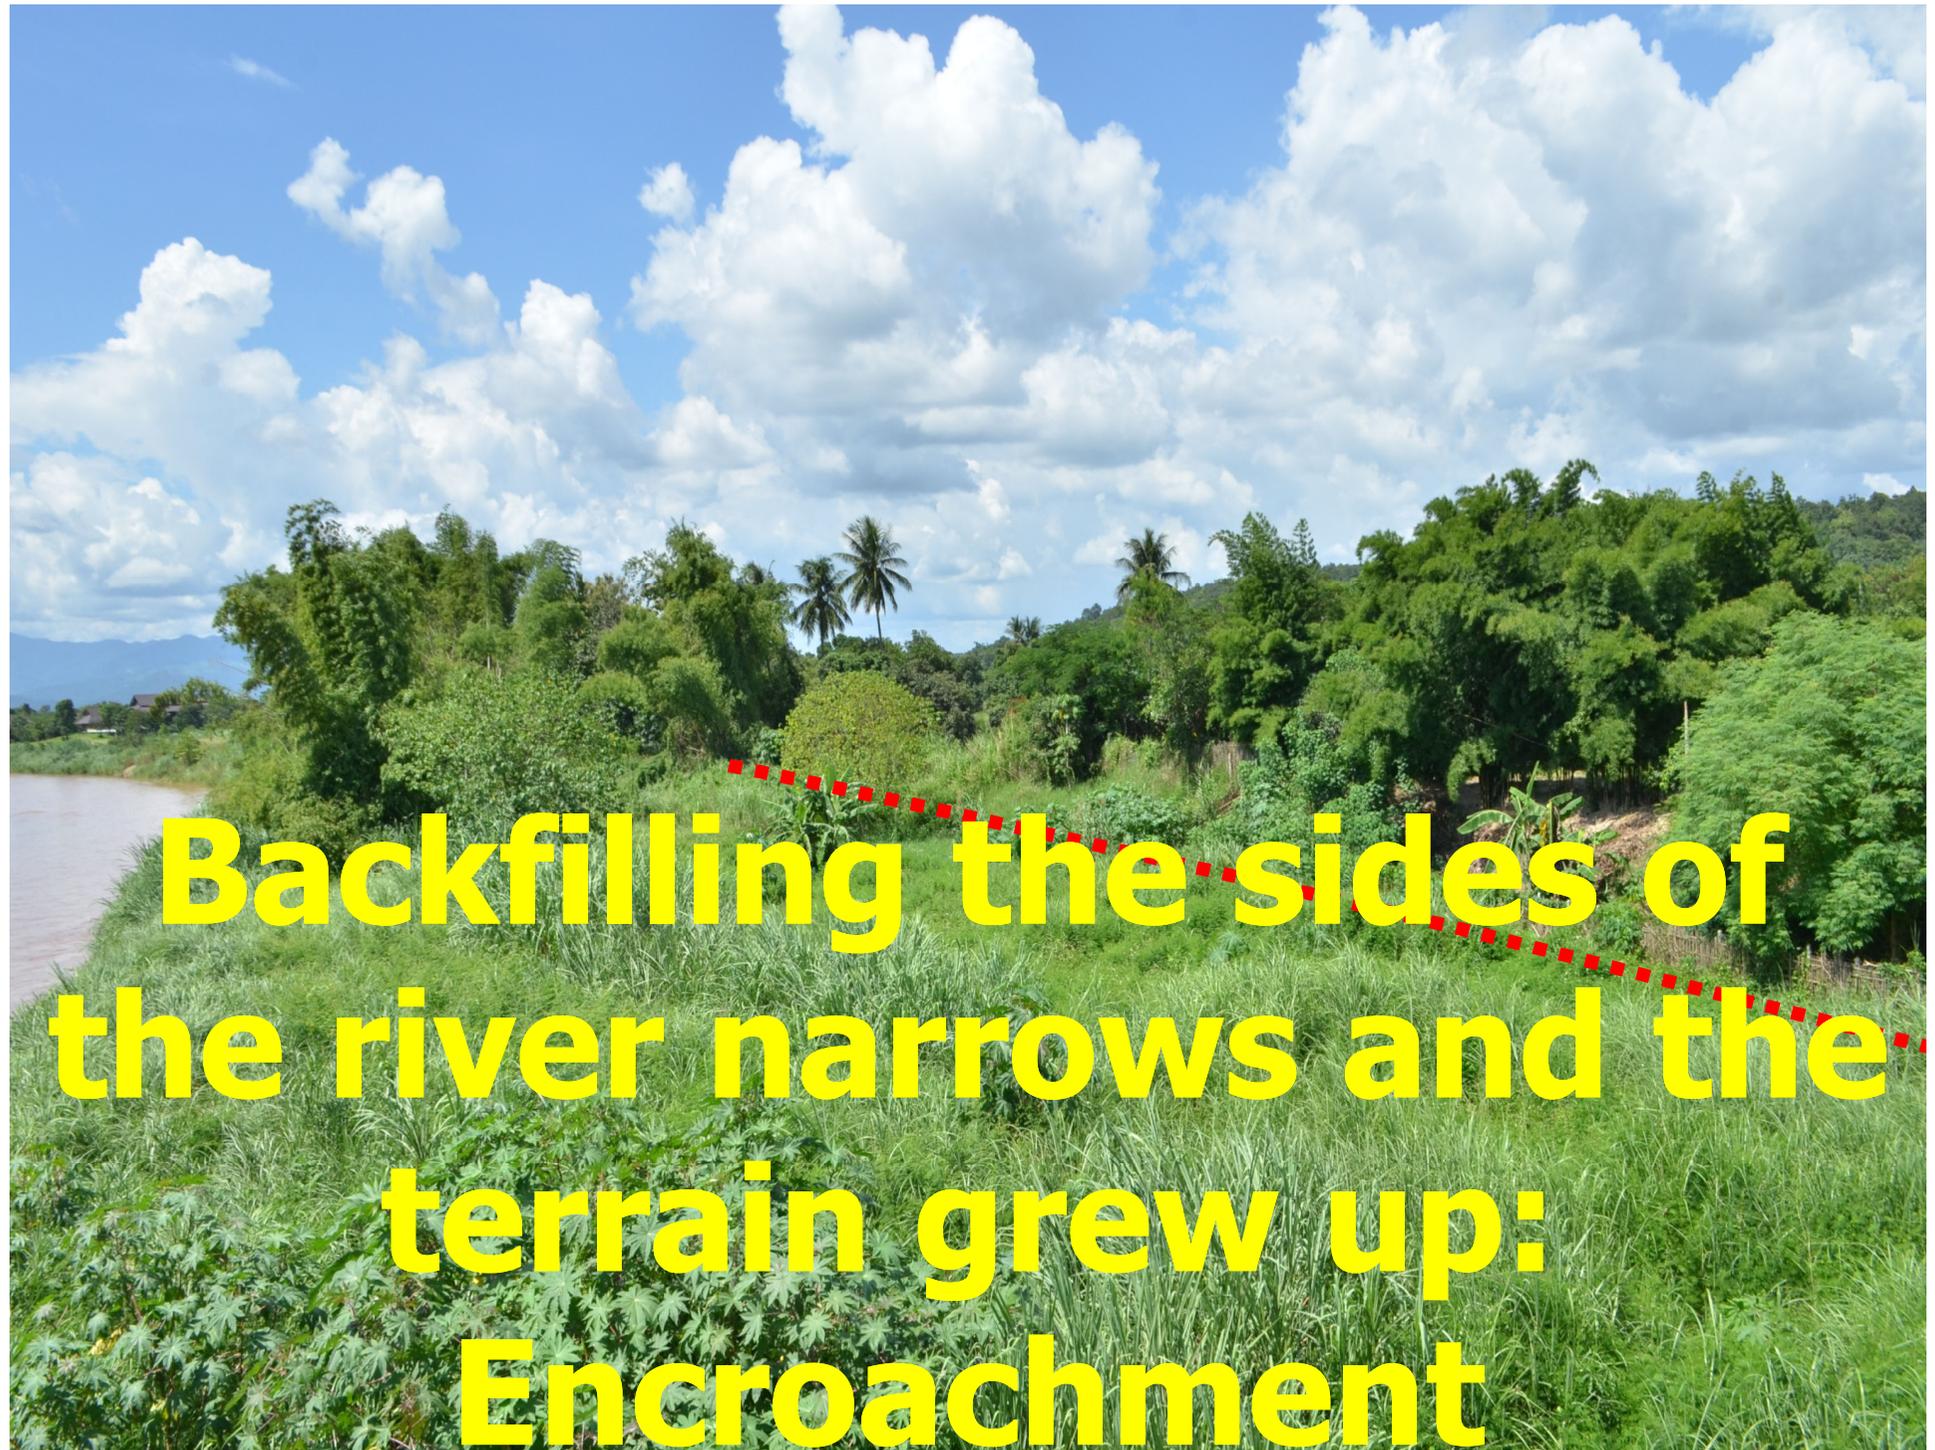
**Backfilling the sides of
the river narrows and the
terrain grew up:
Encroachment**

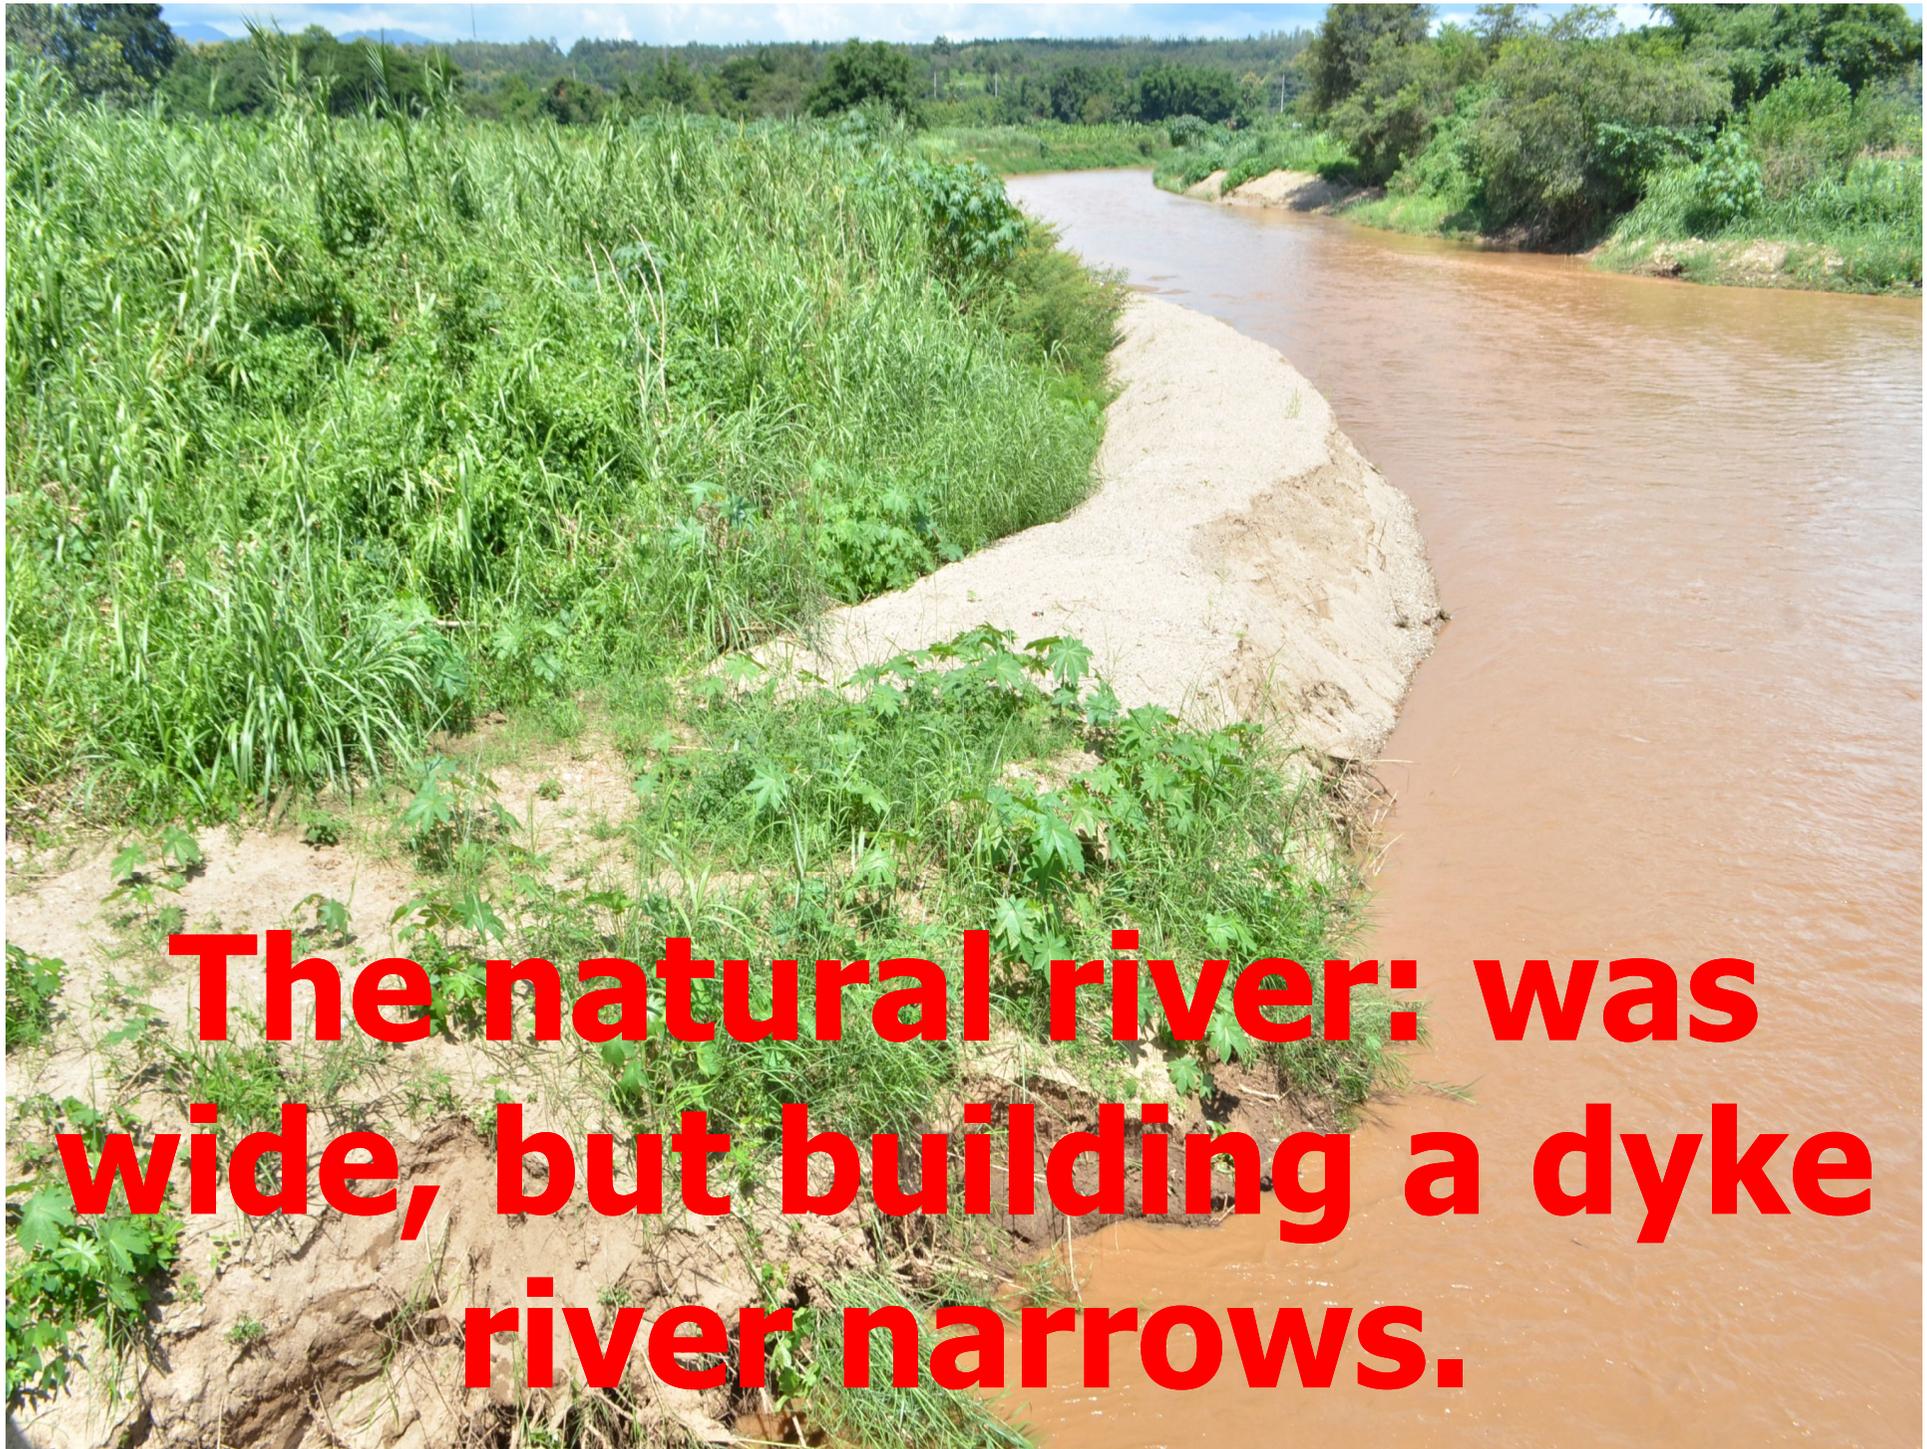
The natural river: was wide, but building a dyke river narrows.

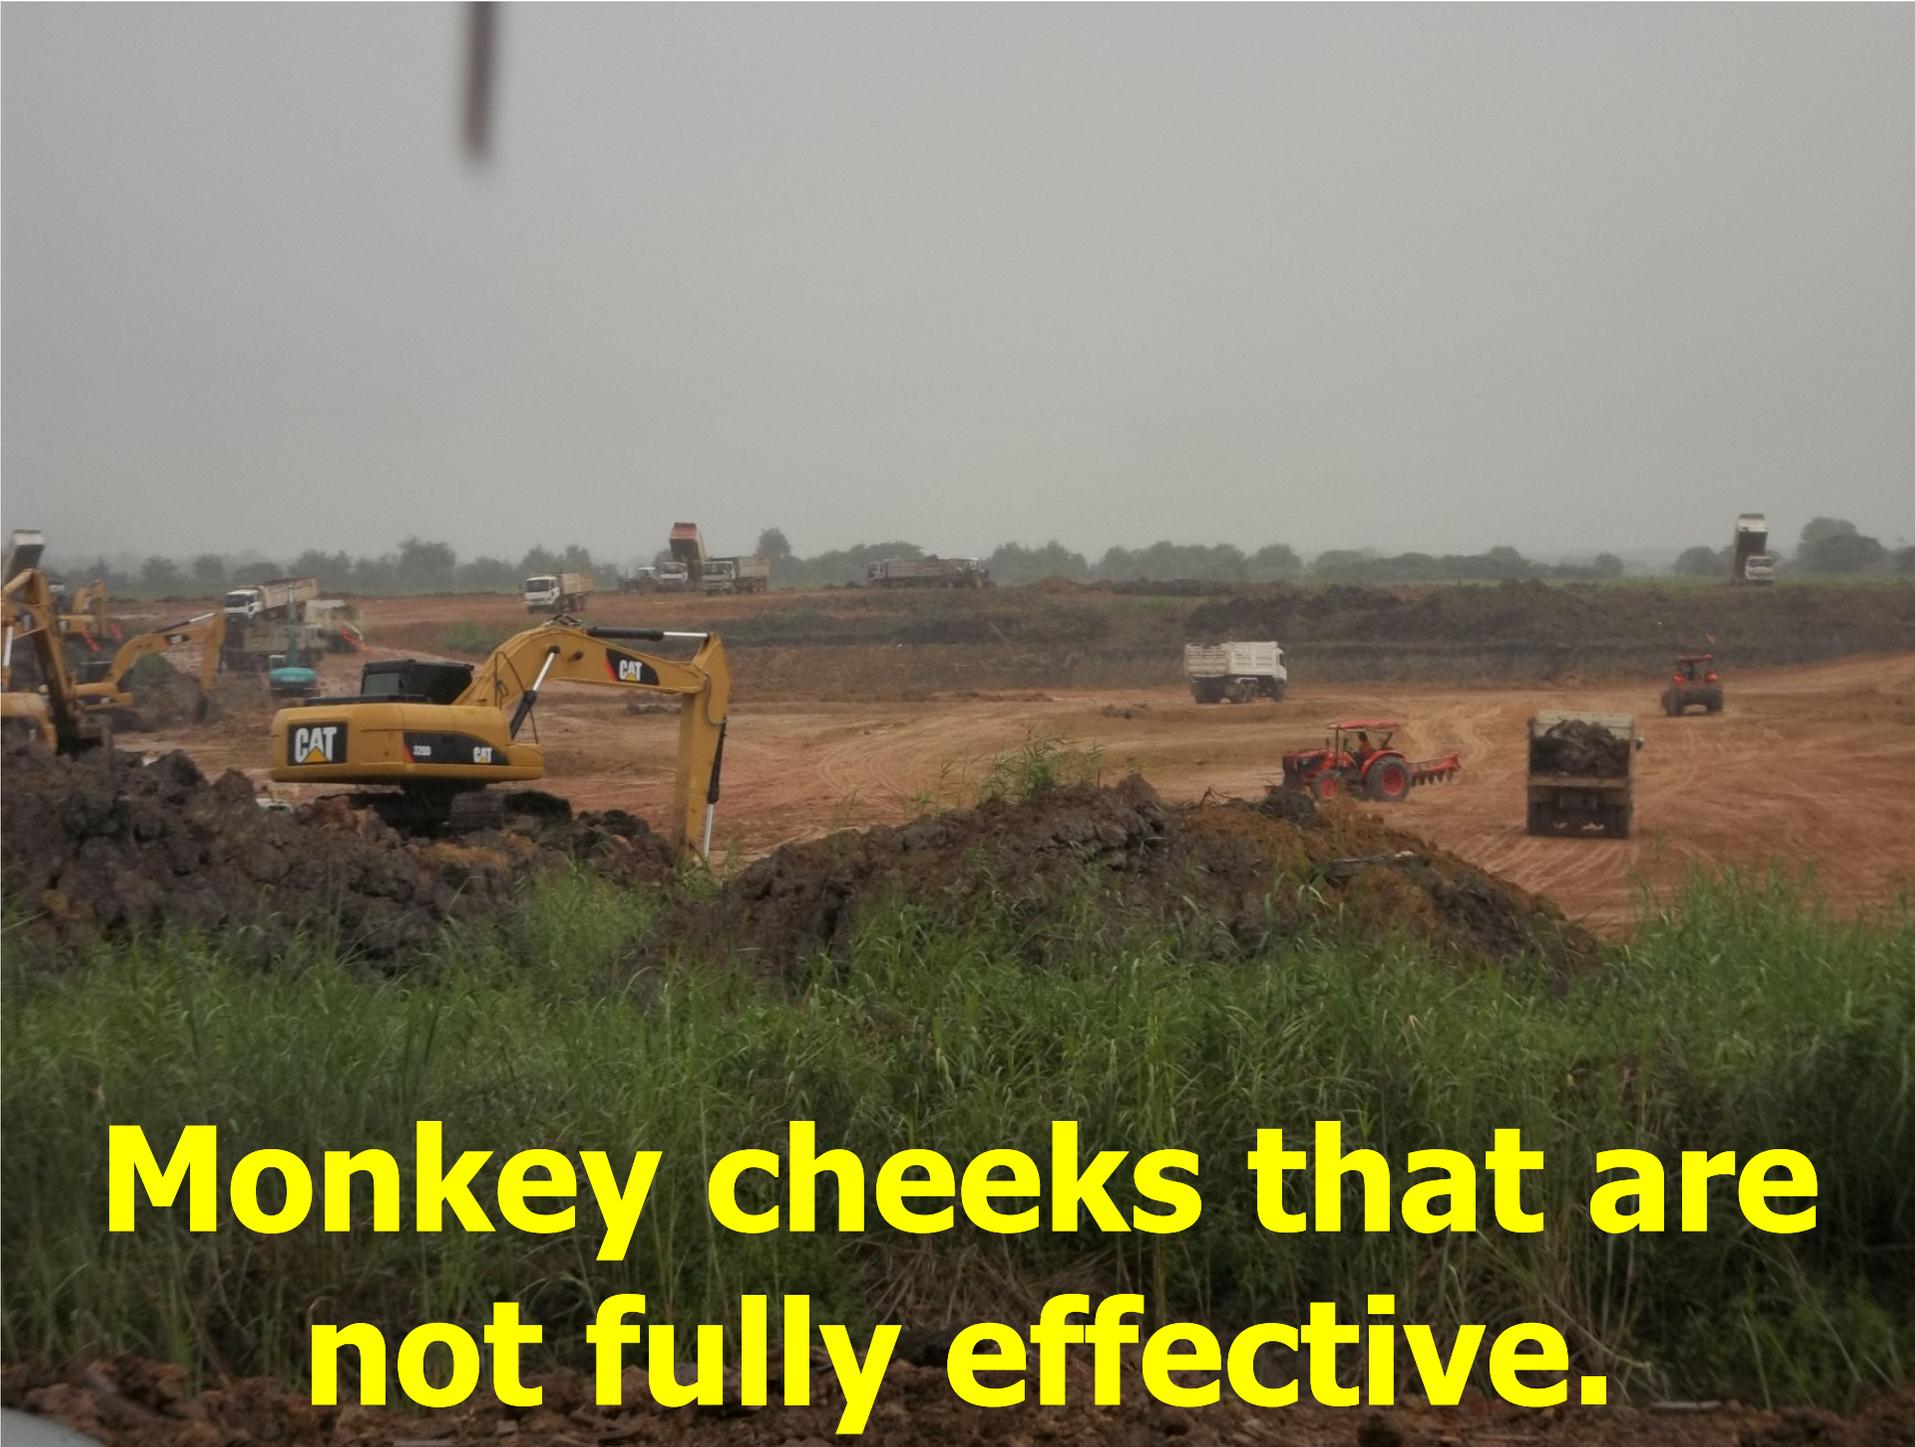
Monkey cheeks that are not fully effective.

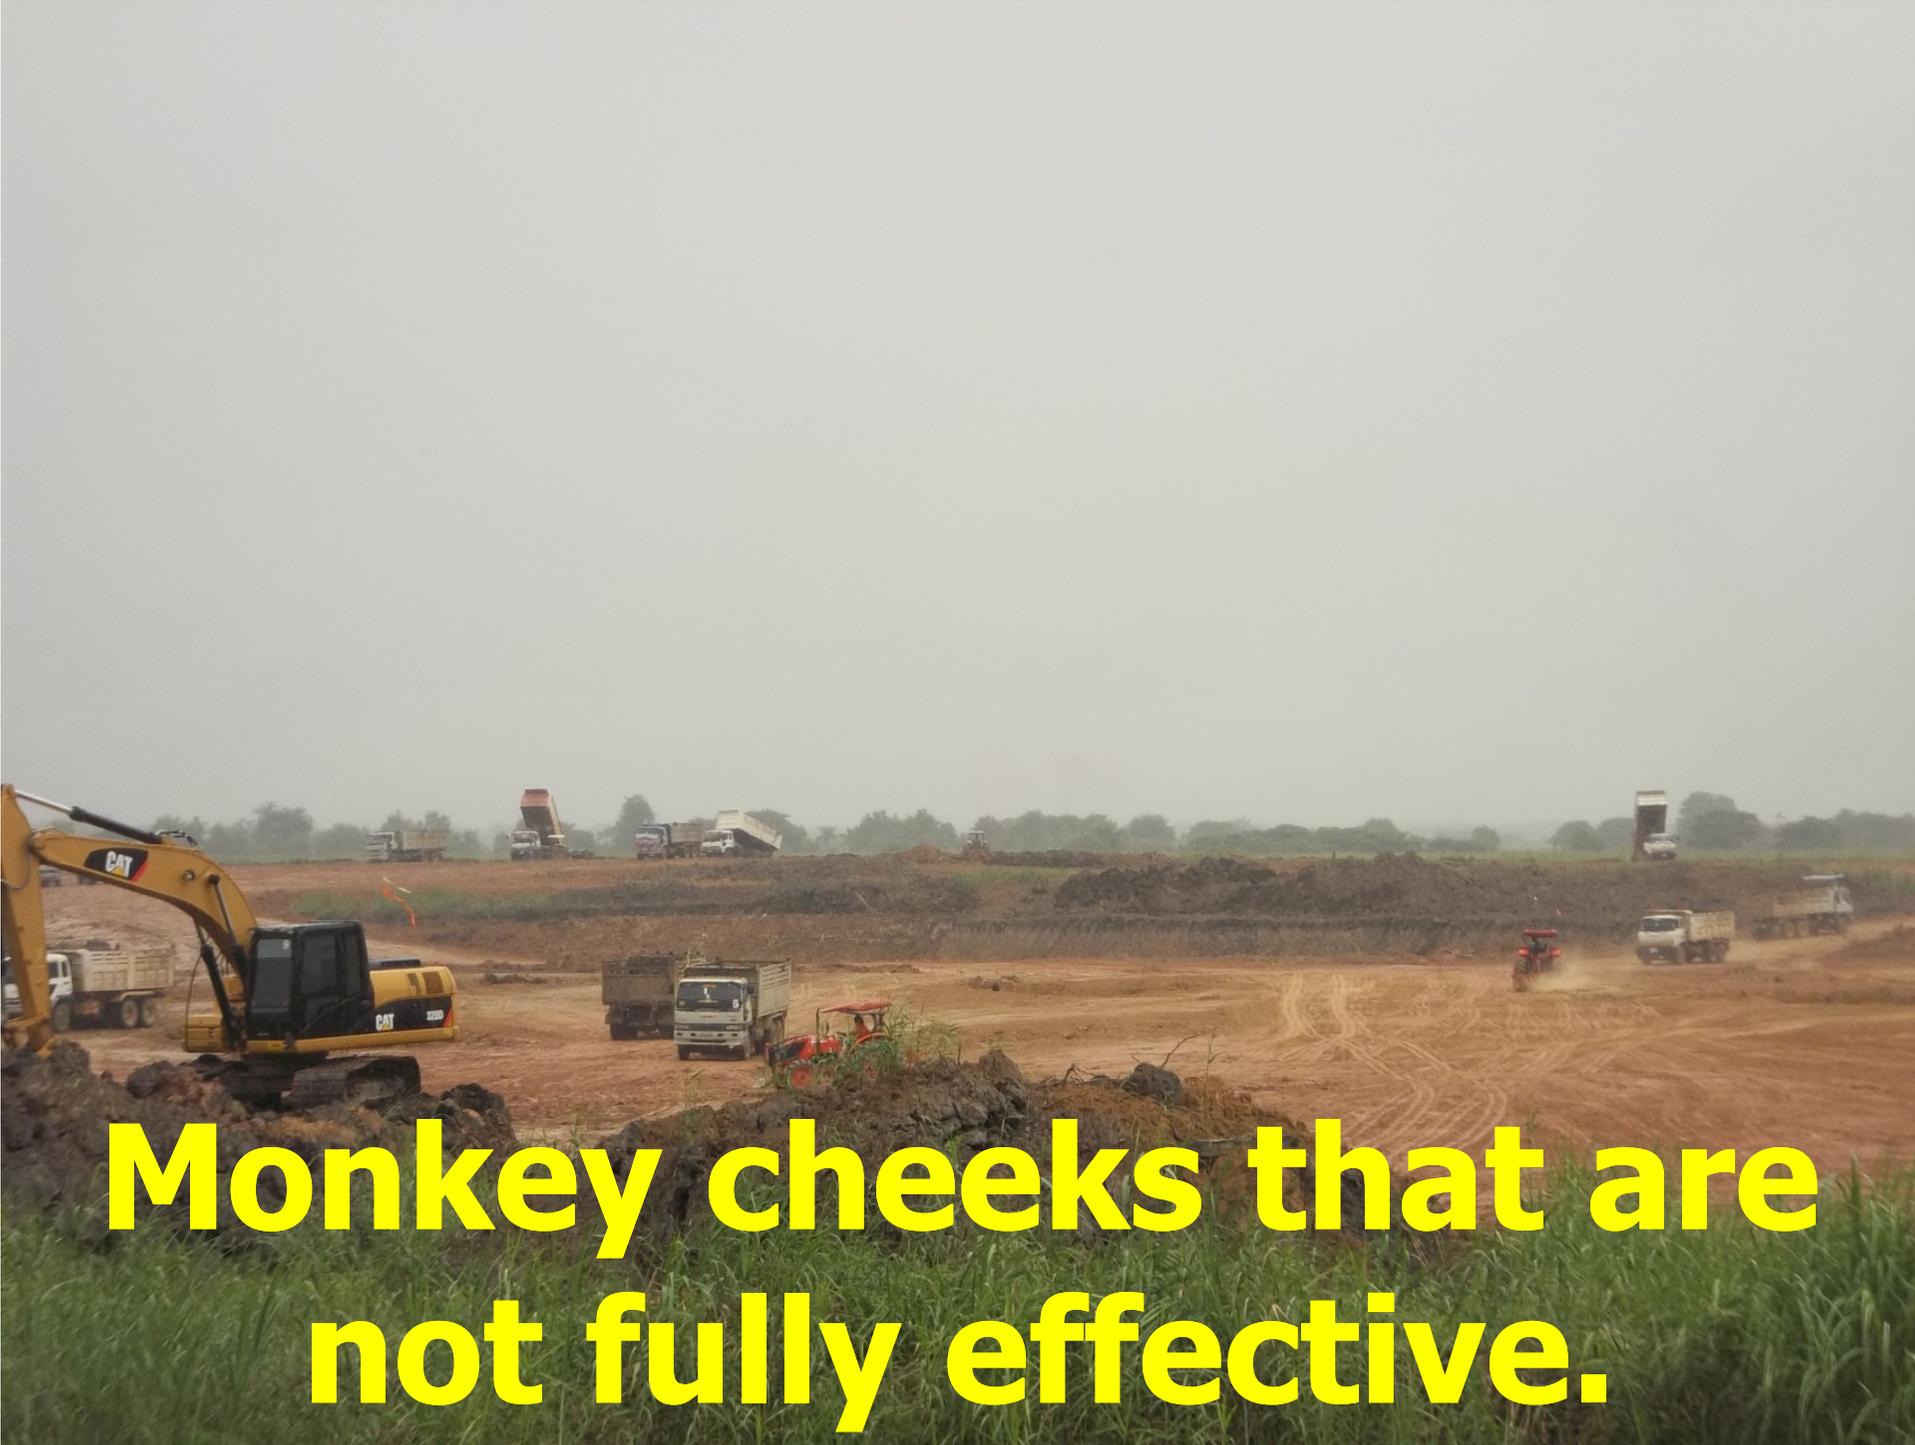
Monkey cheeks that are not fully effective.

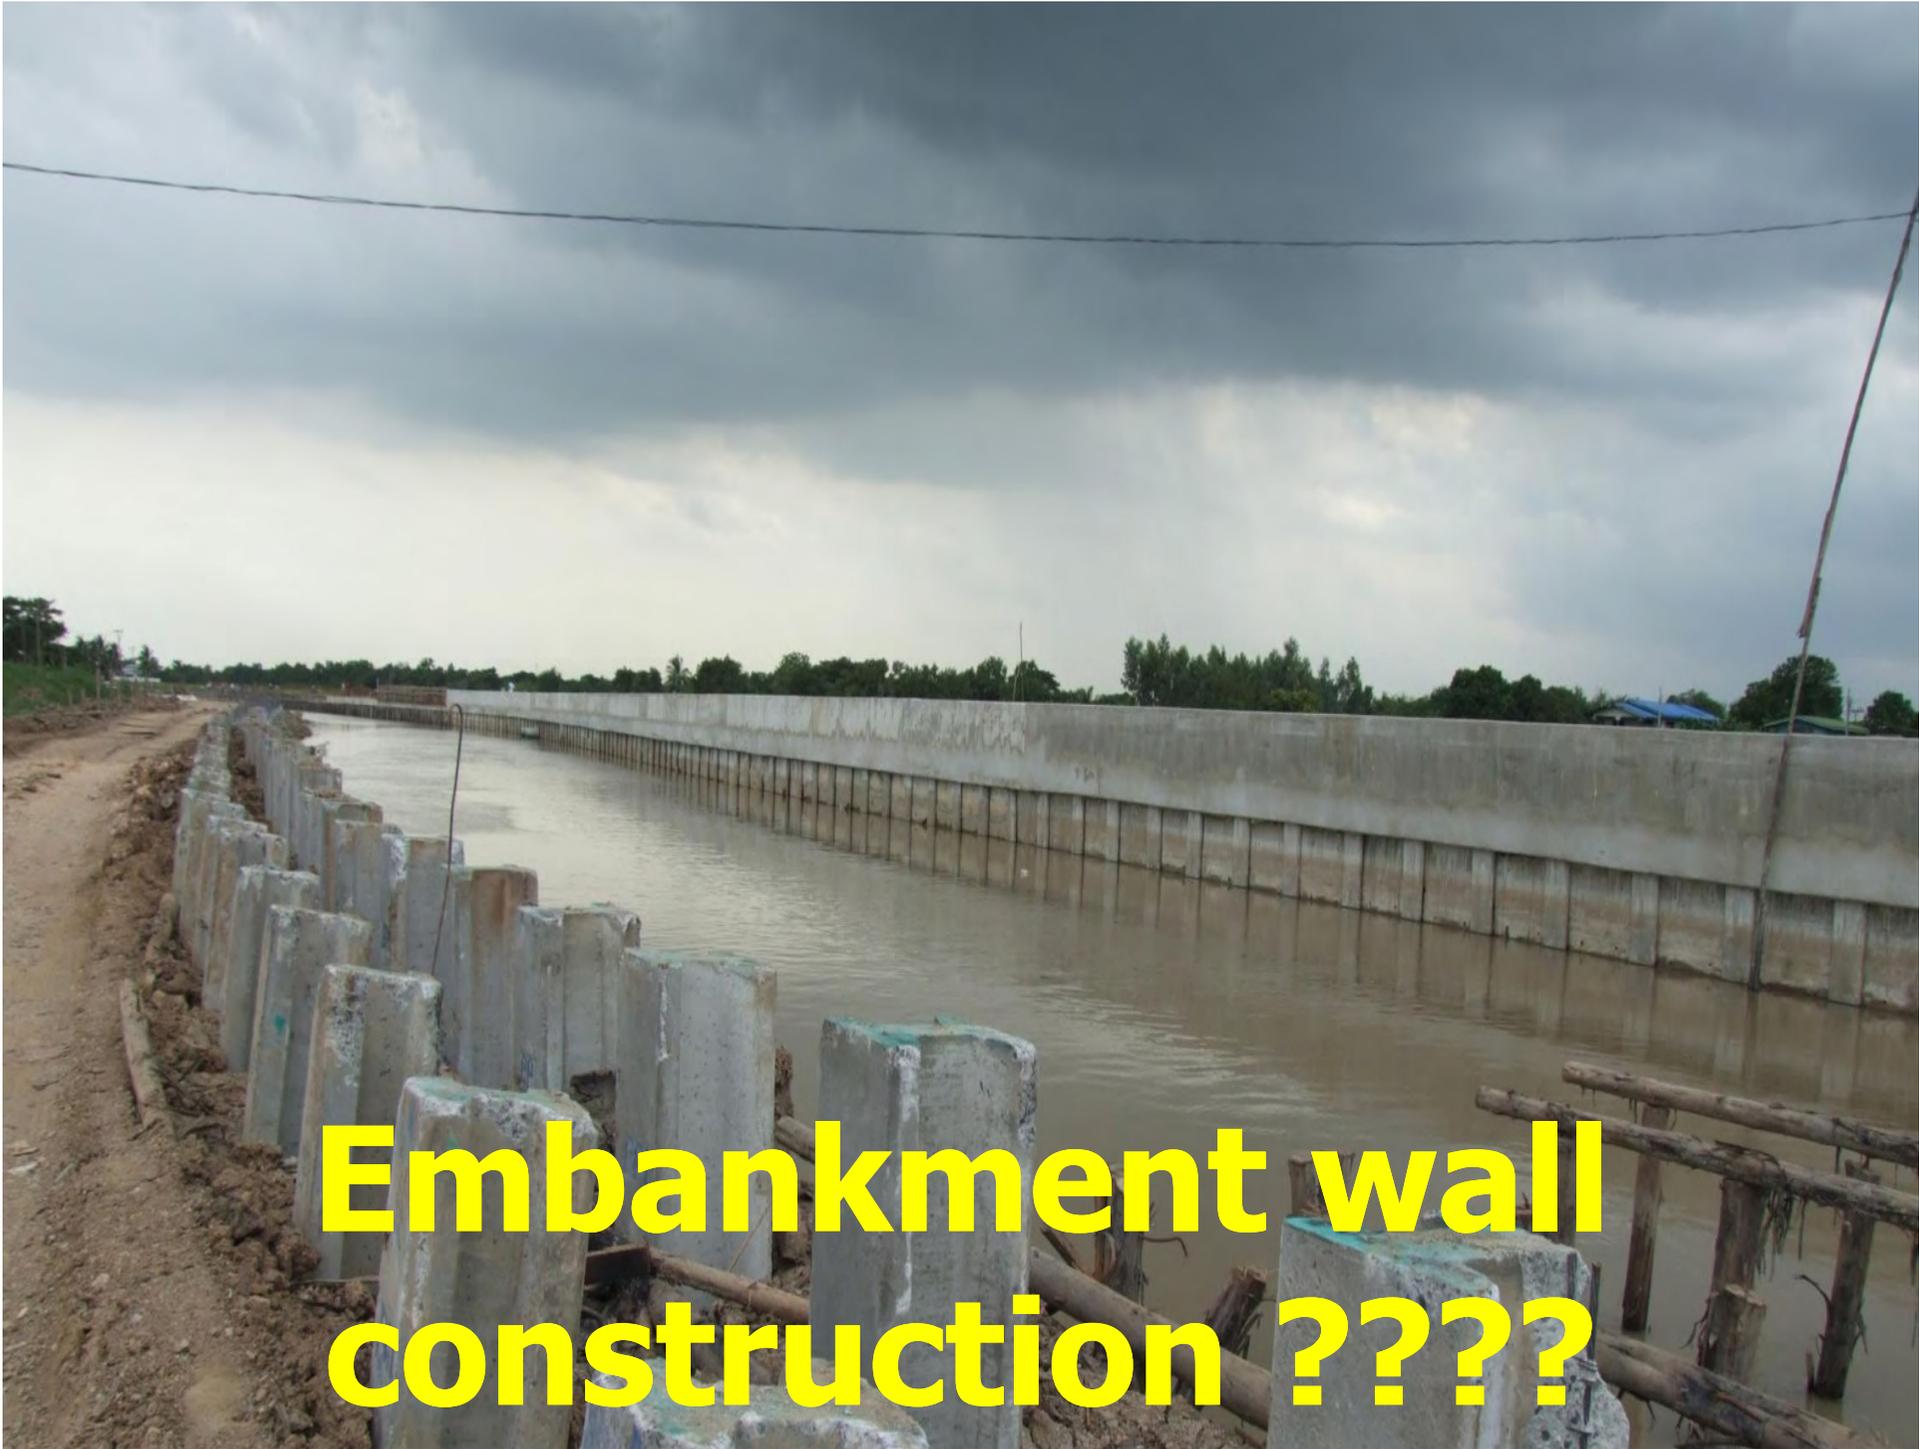
**Embankment wall
construction ?????**

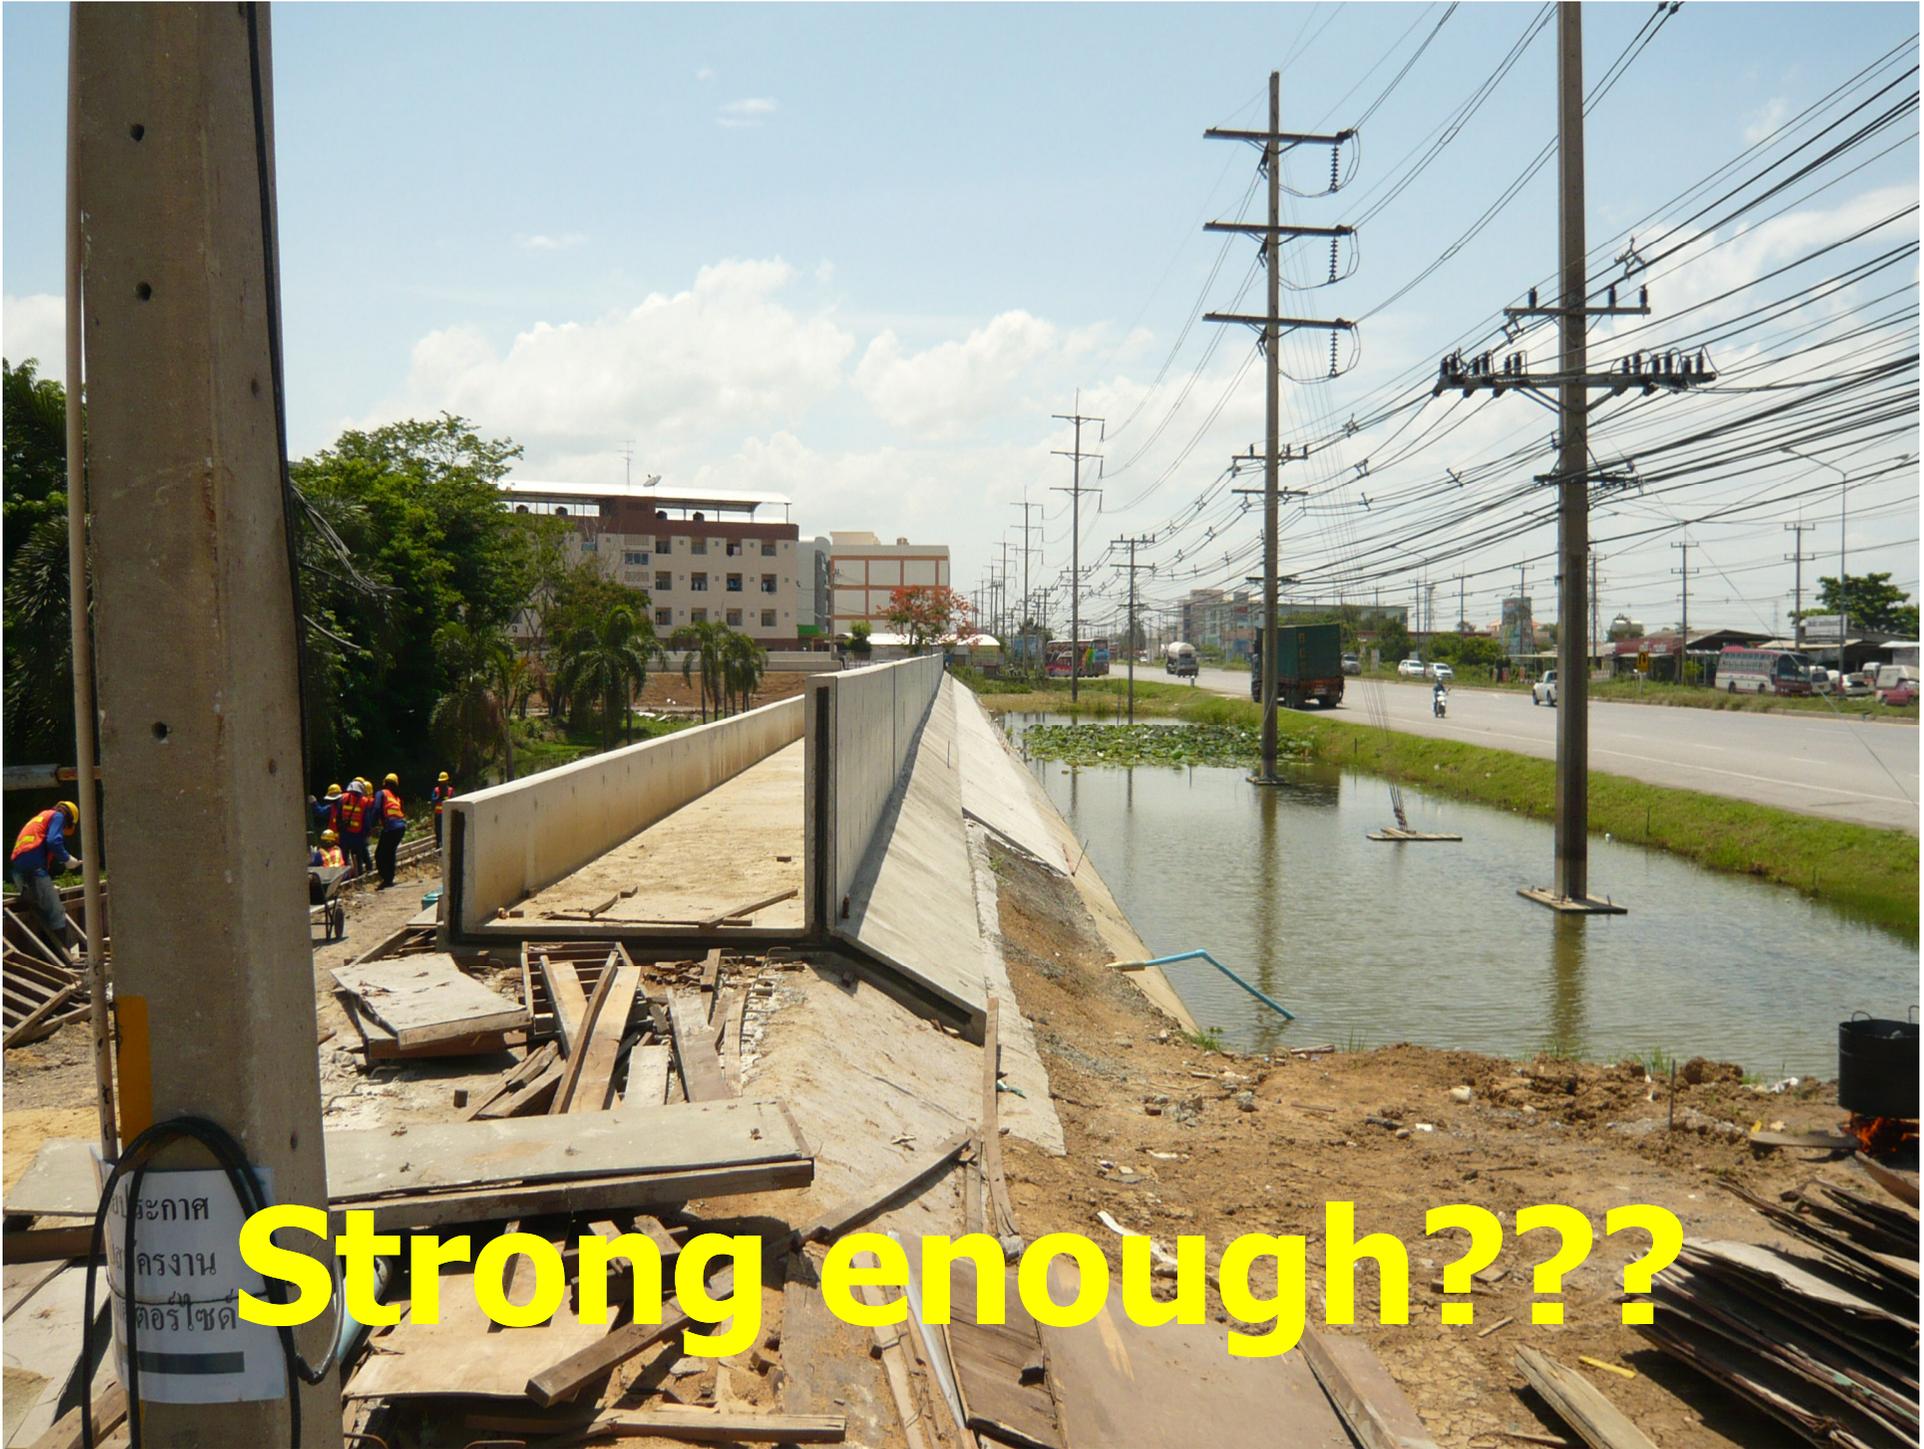
Strong enough???
