RAPID FLOOD MANAGEMENT ASSESSMENT

**Lesson Learn and Future Direction for Water Policy:
Structure and non-structure flood prevention**

River and Canal Dredging

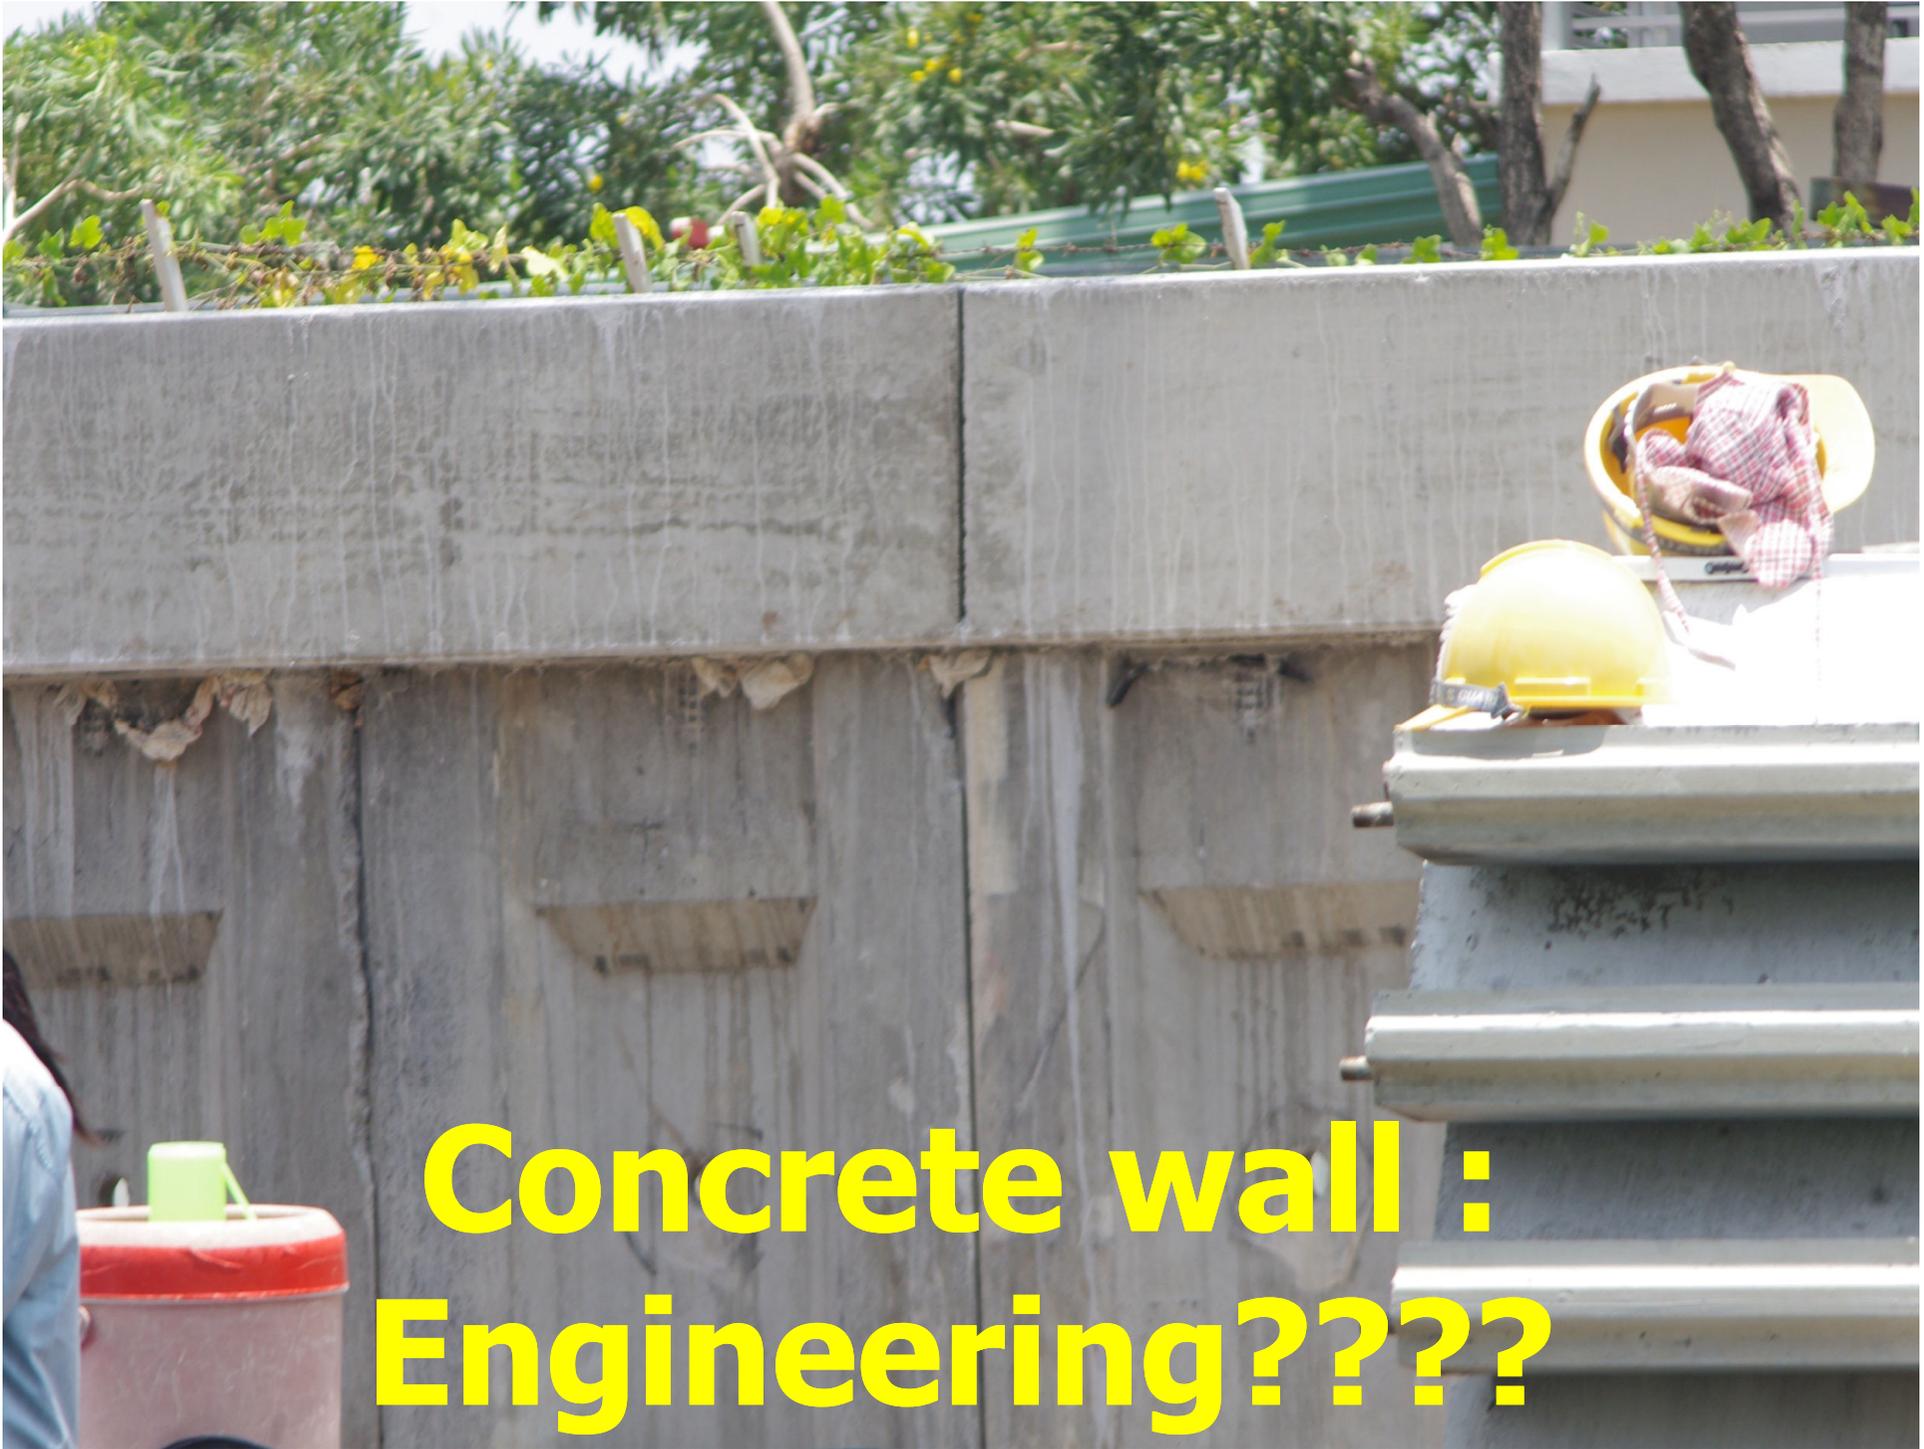
**Concrete wall :
Engineering????**

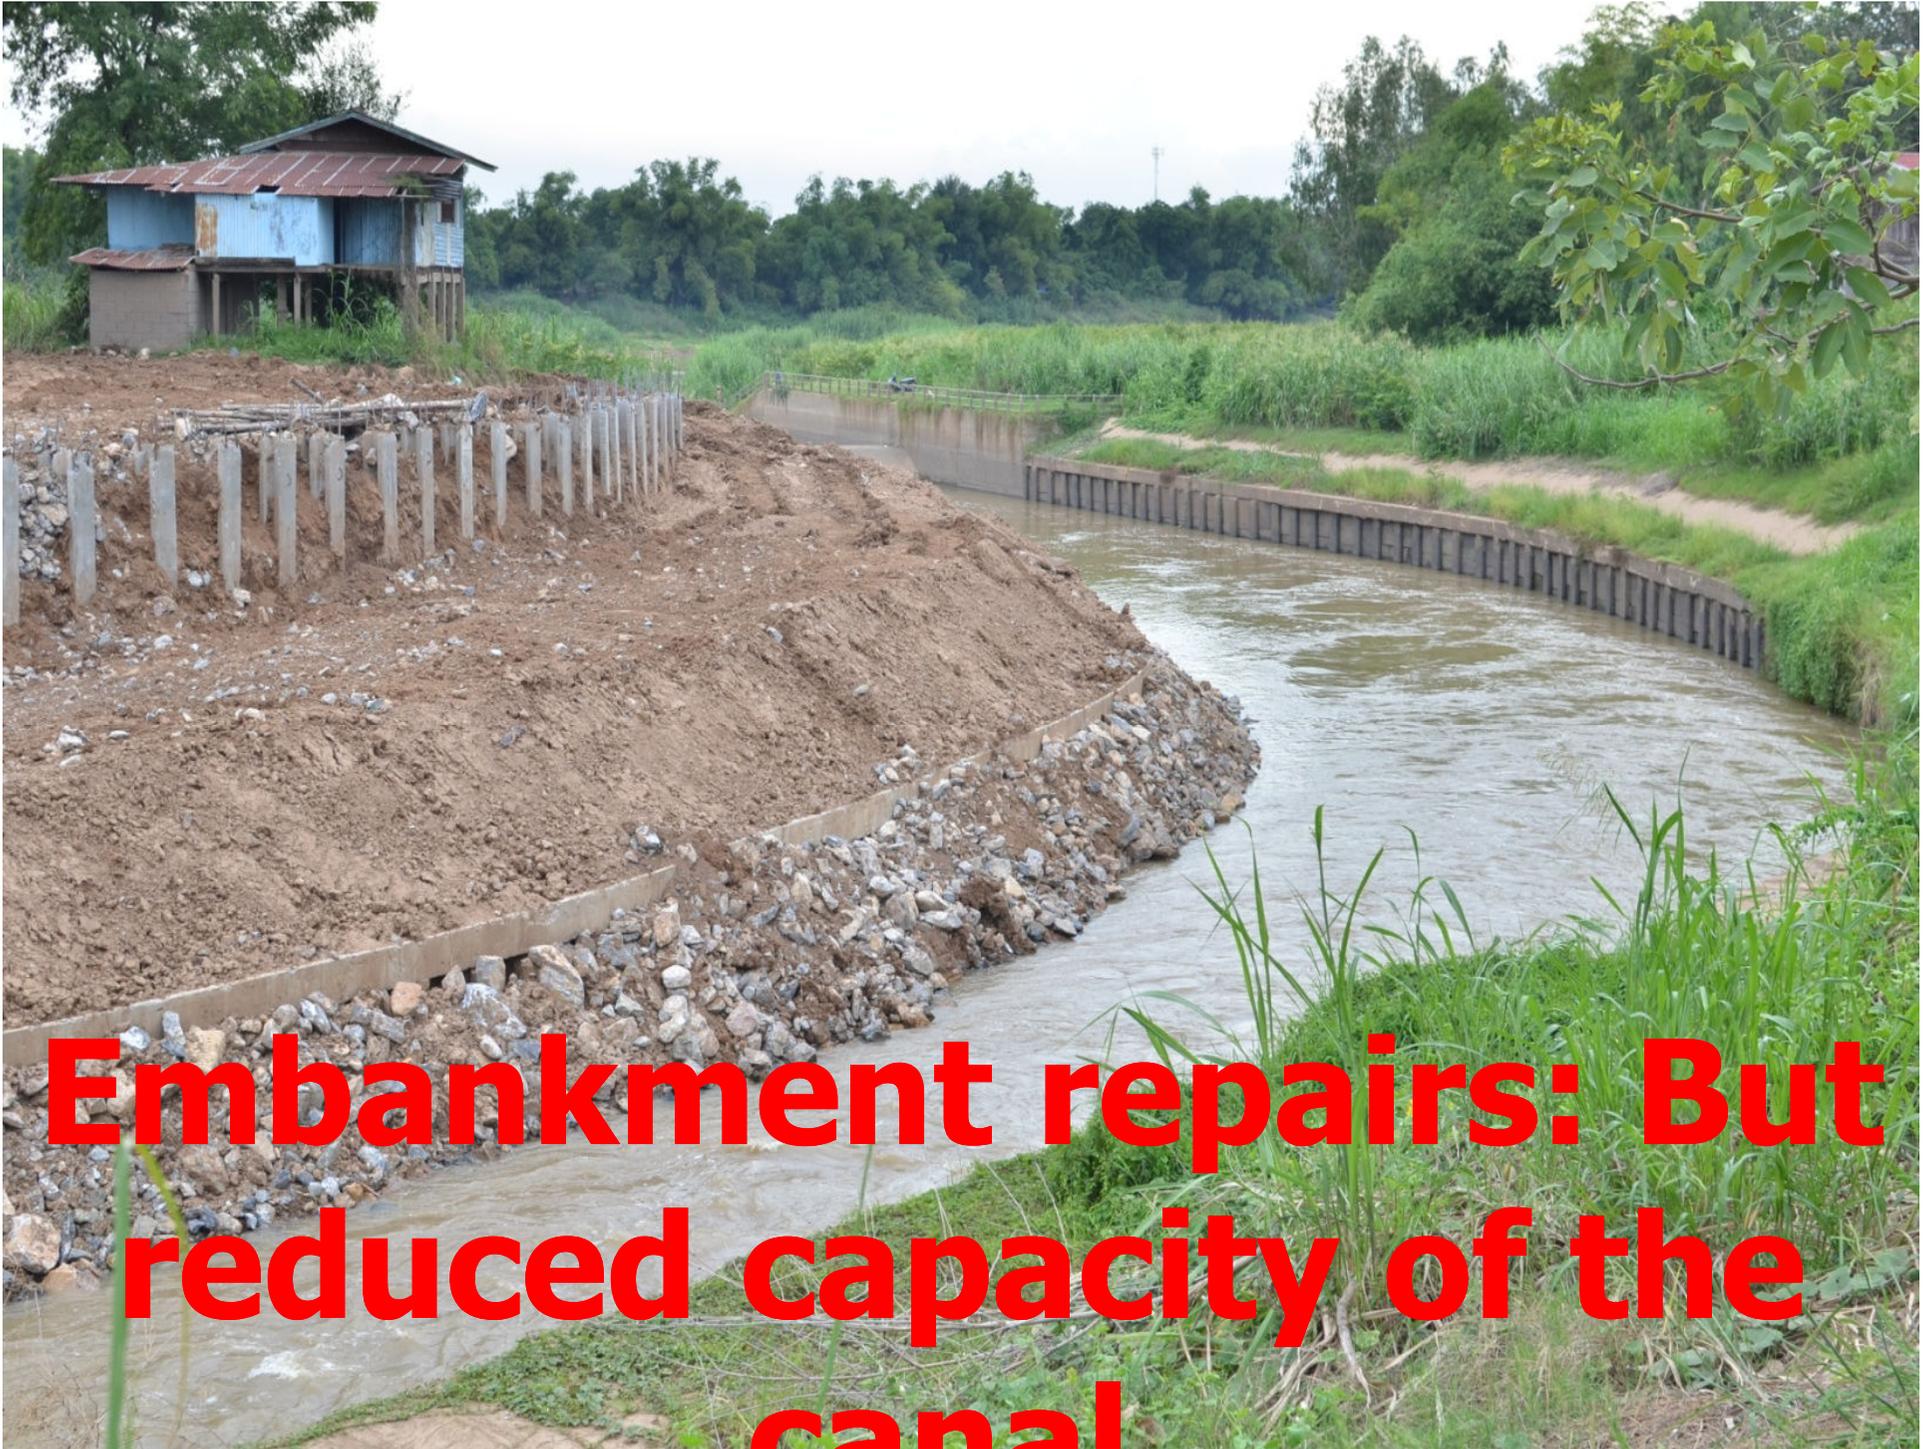
Embankment repairs: But reduced capacity of the canal

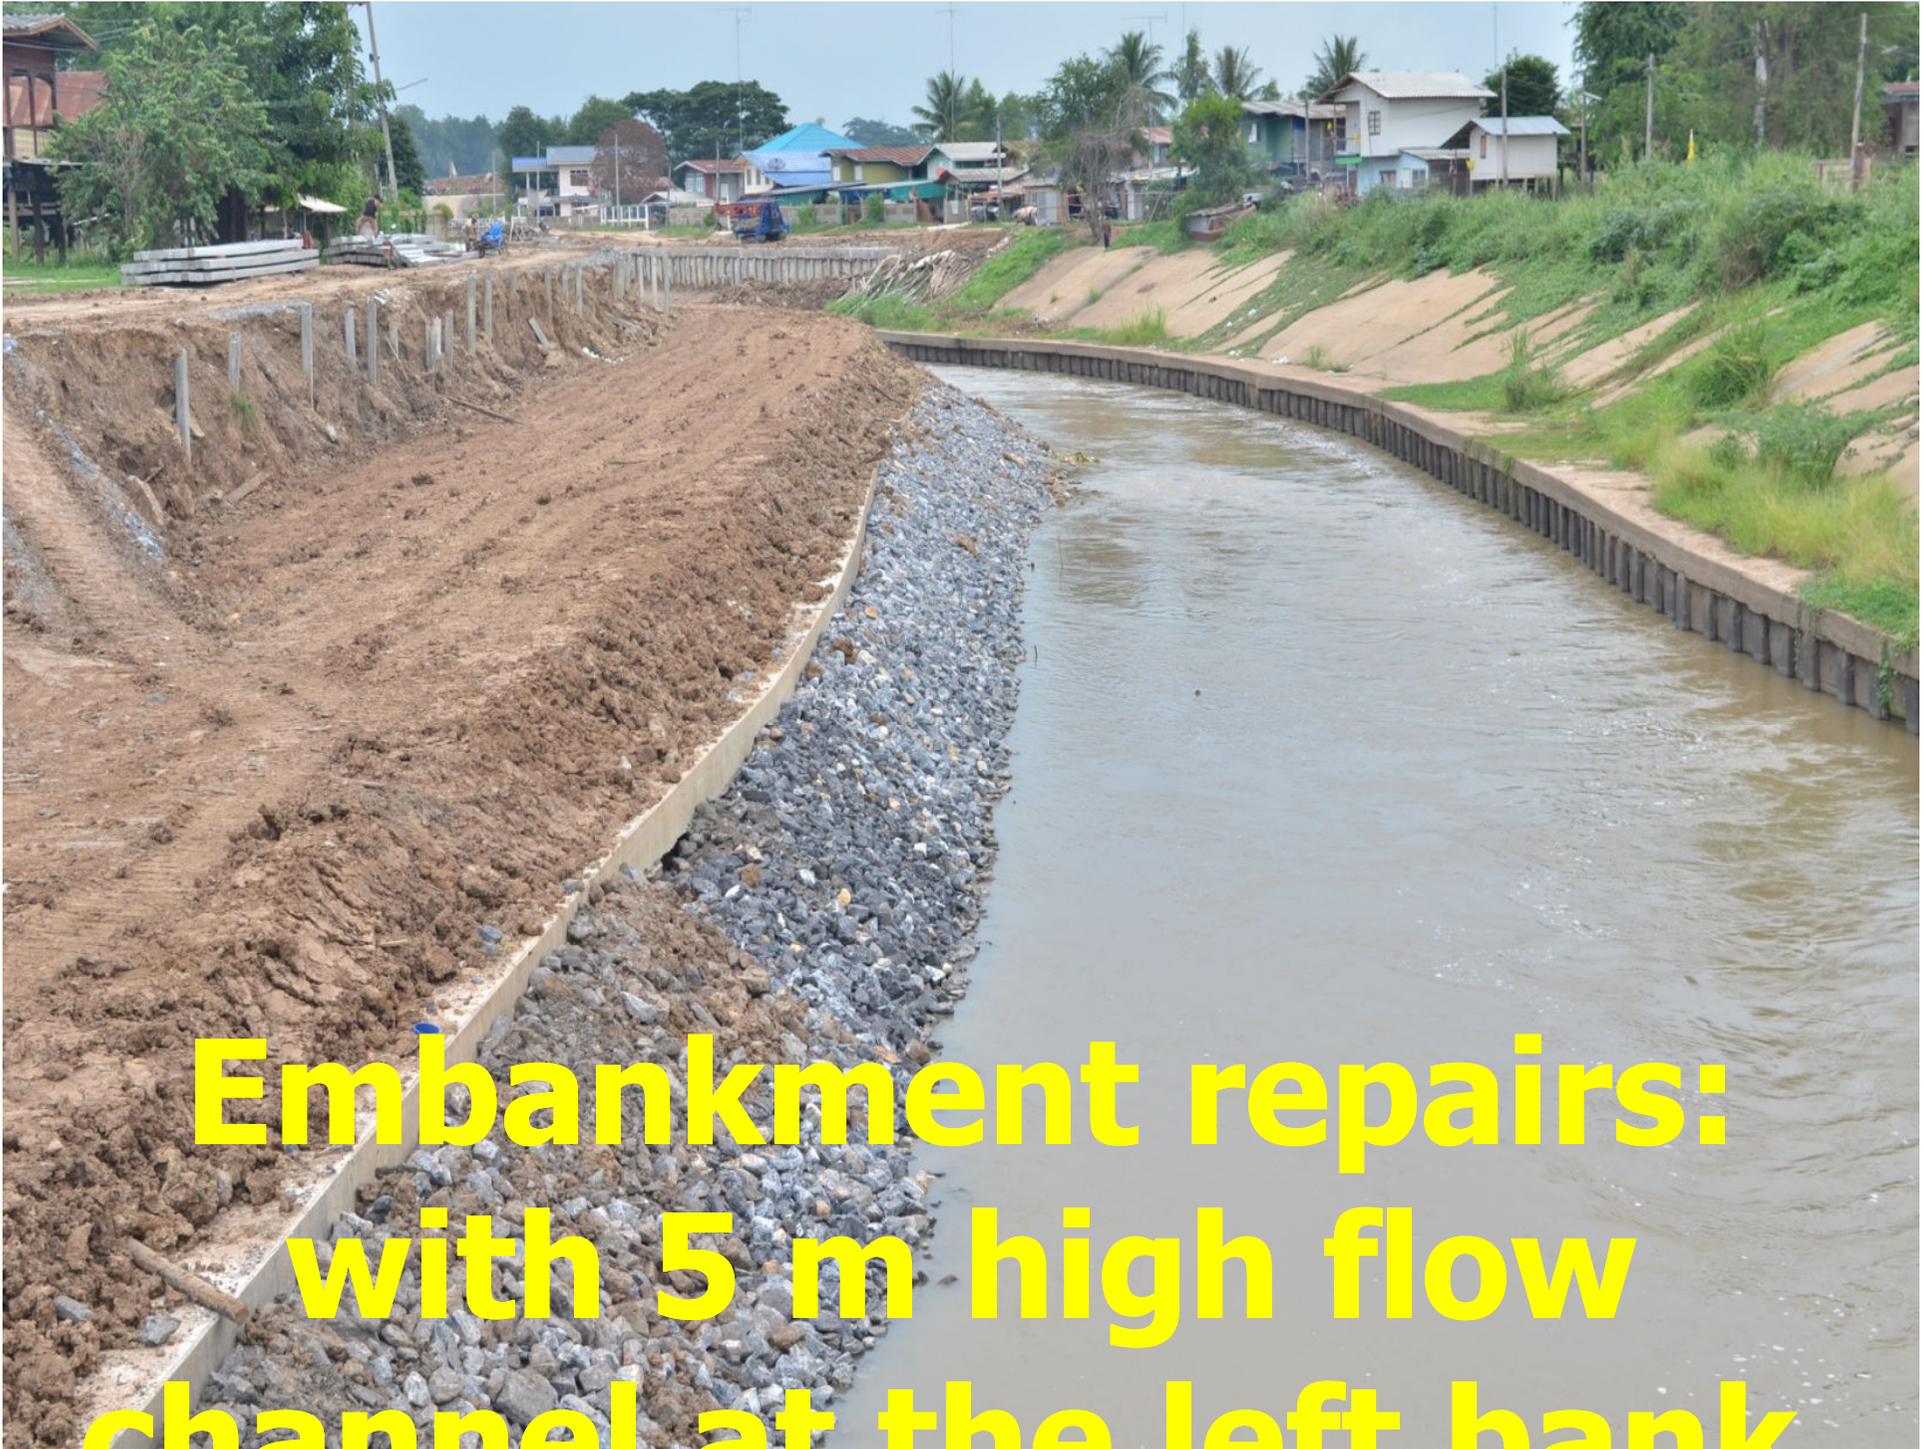
**Embankment repairs:
with 5 m high flow
channel at the left bank**

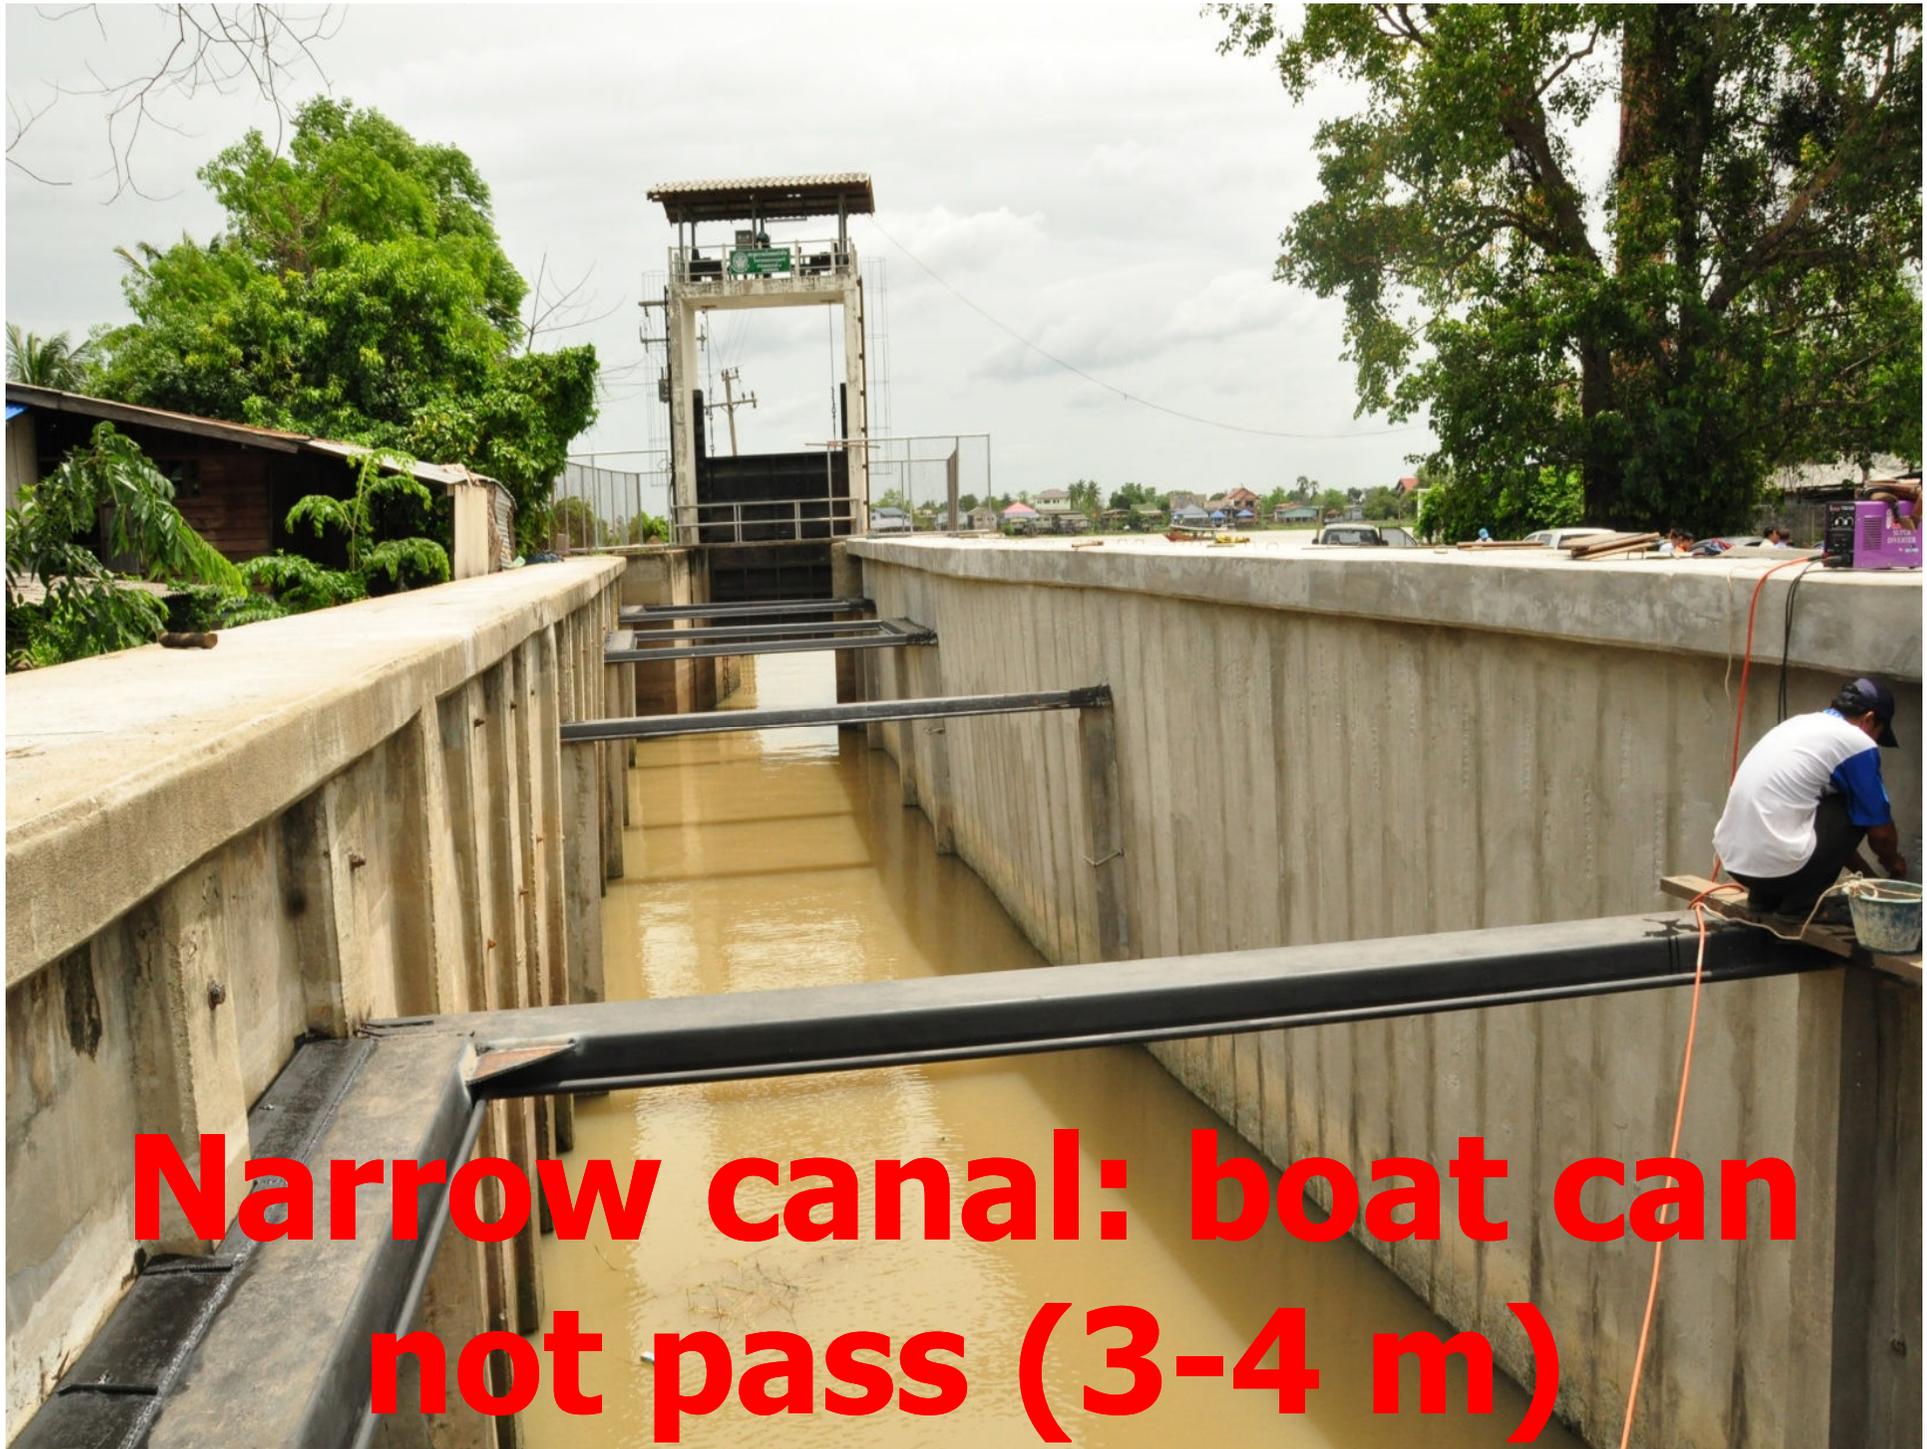
Narrow canal: boat can not pass (3-4 m)

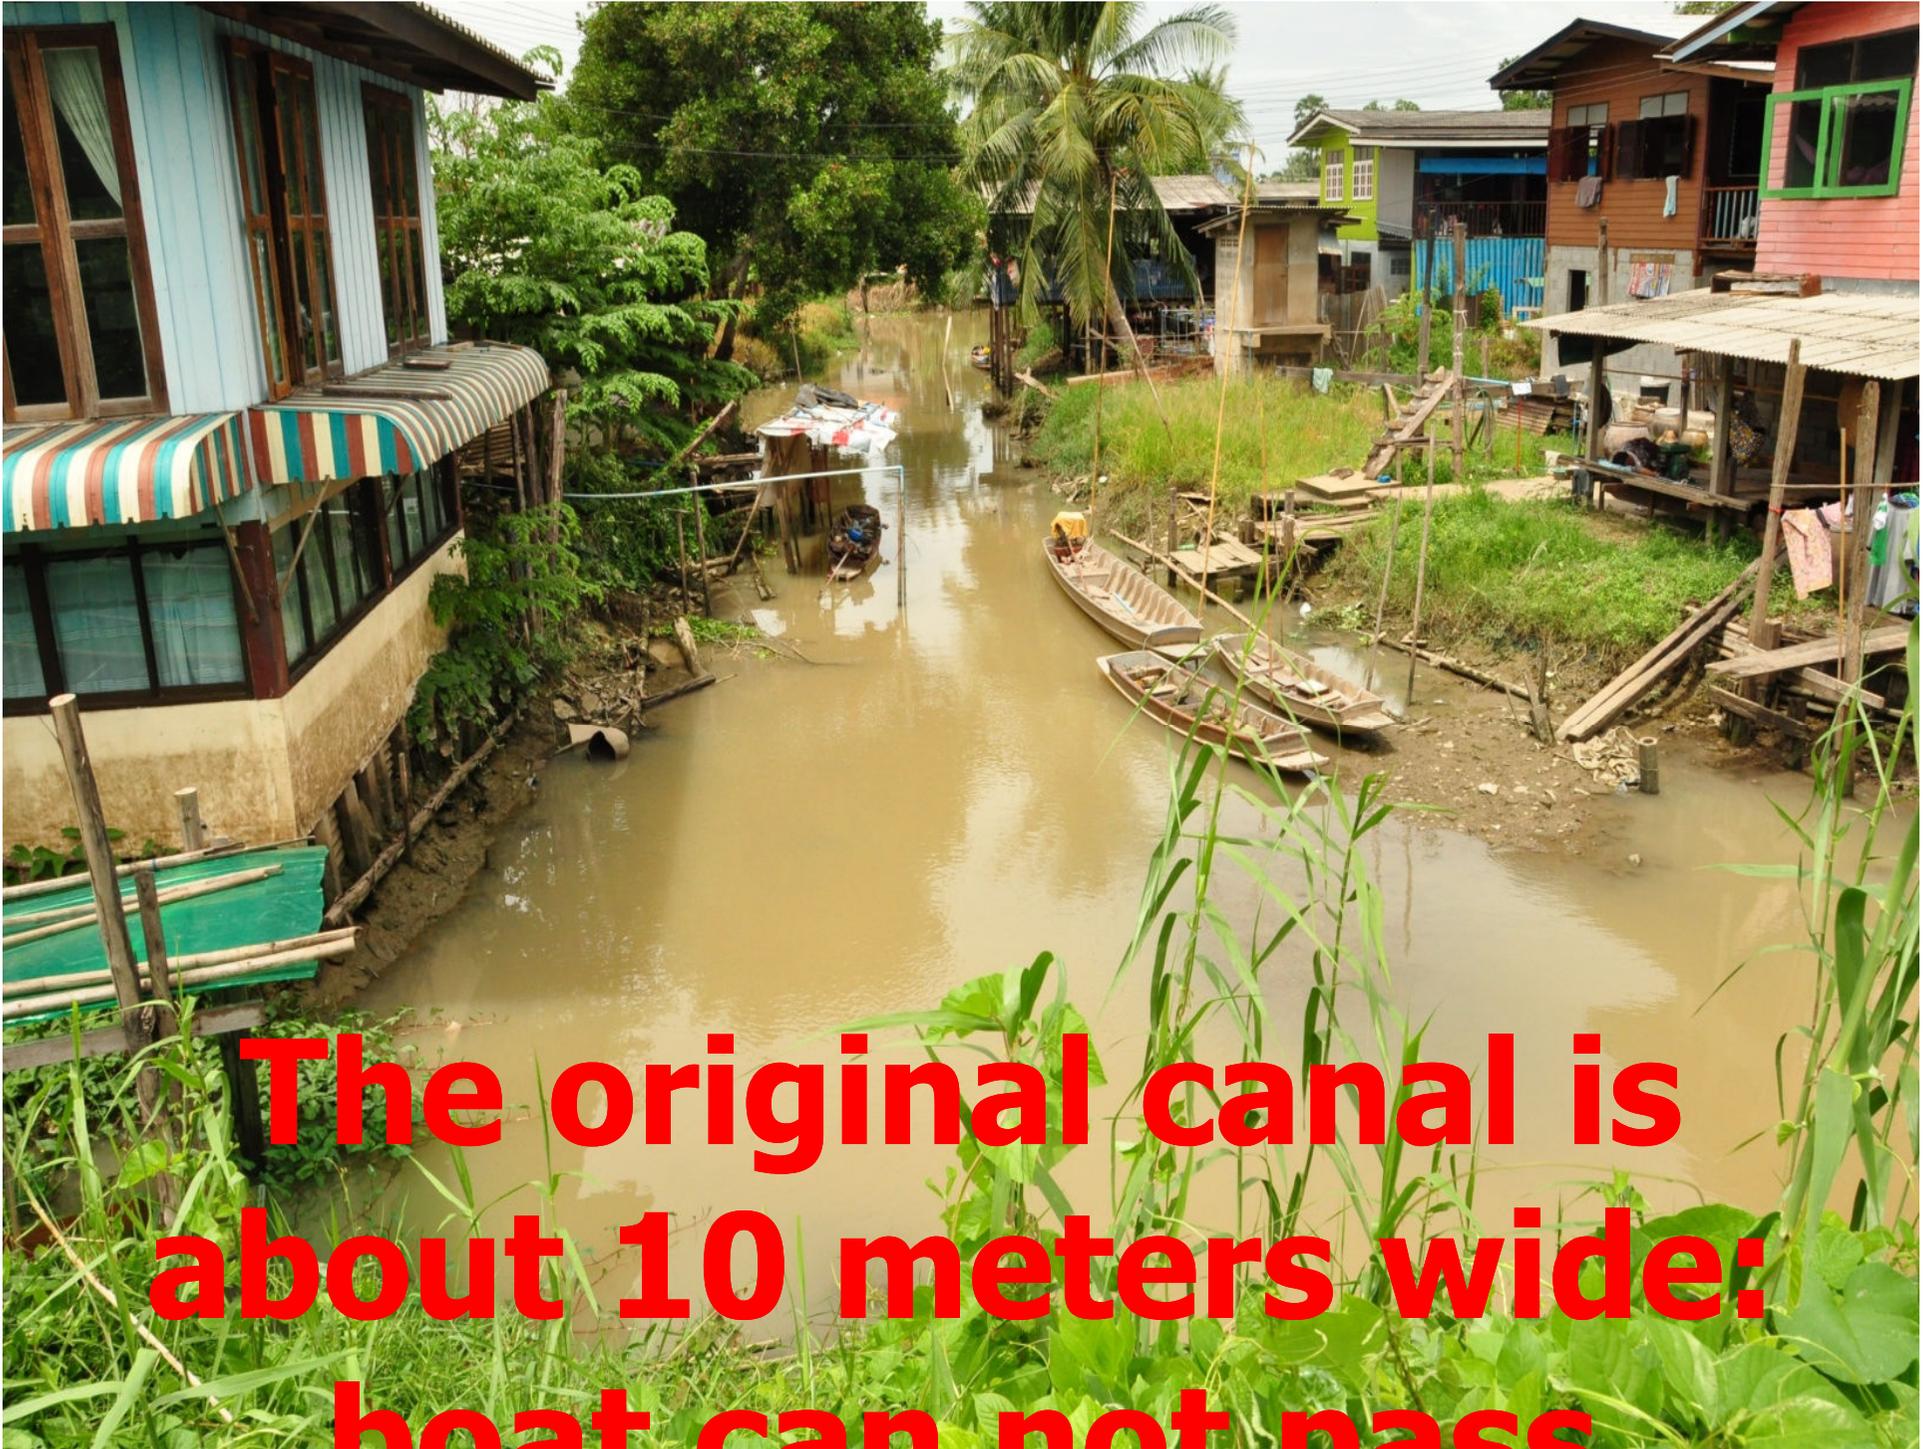
**The original canal is
about 10 meters wide:
boat can not pass**

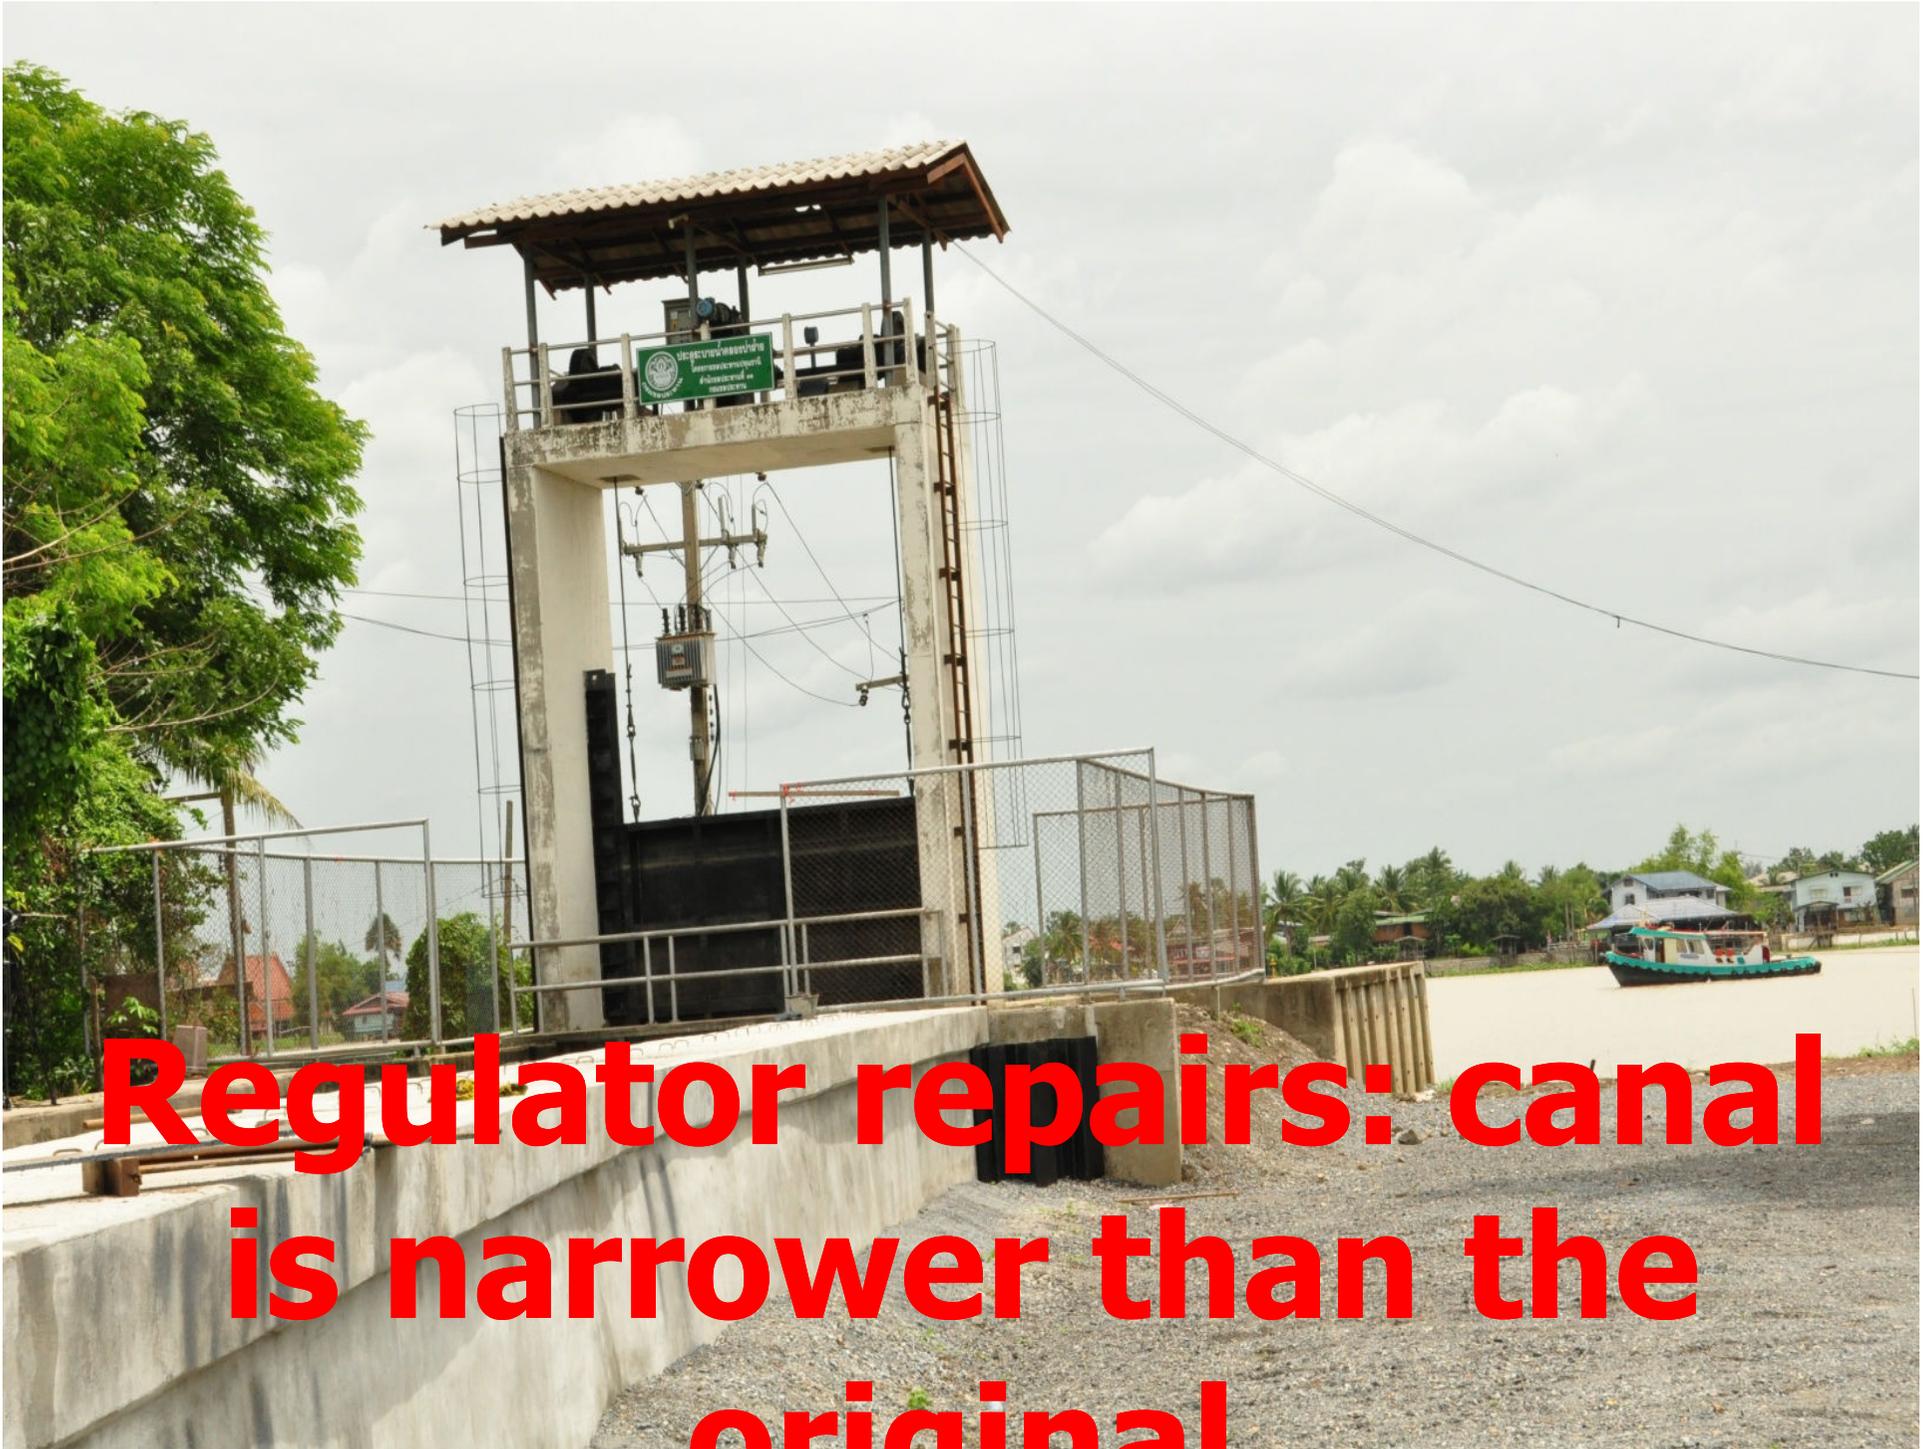
Regulator repairs: canal is narrower than the original

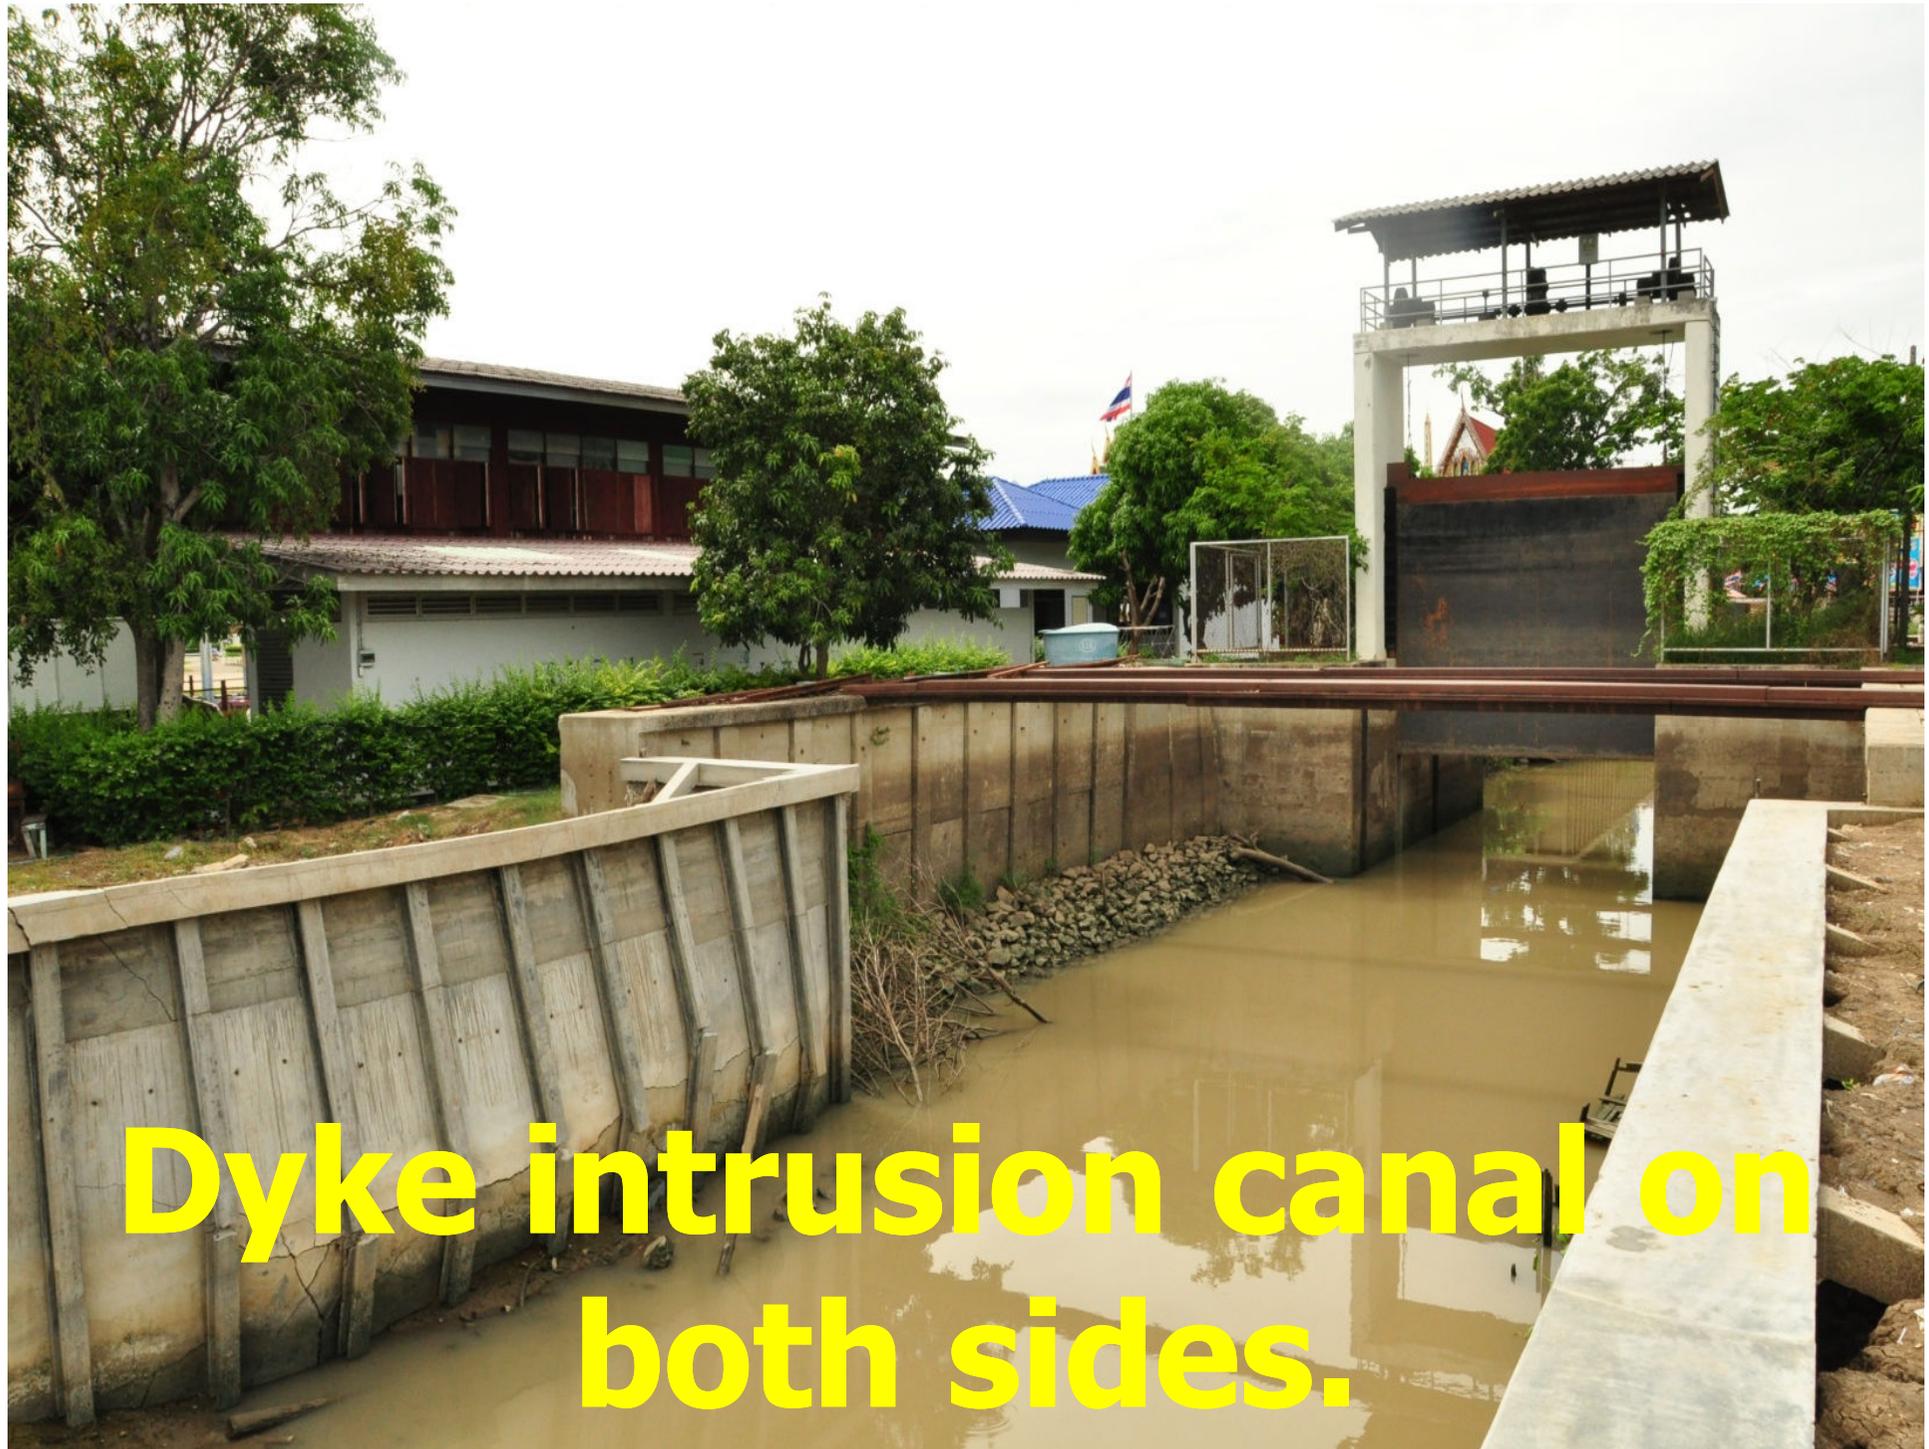
Dyke intrusion canal on both sides.

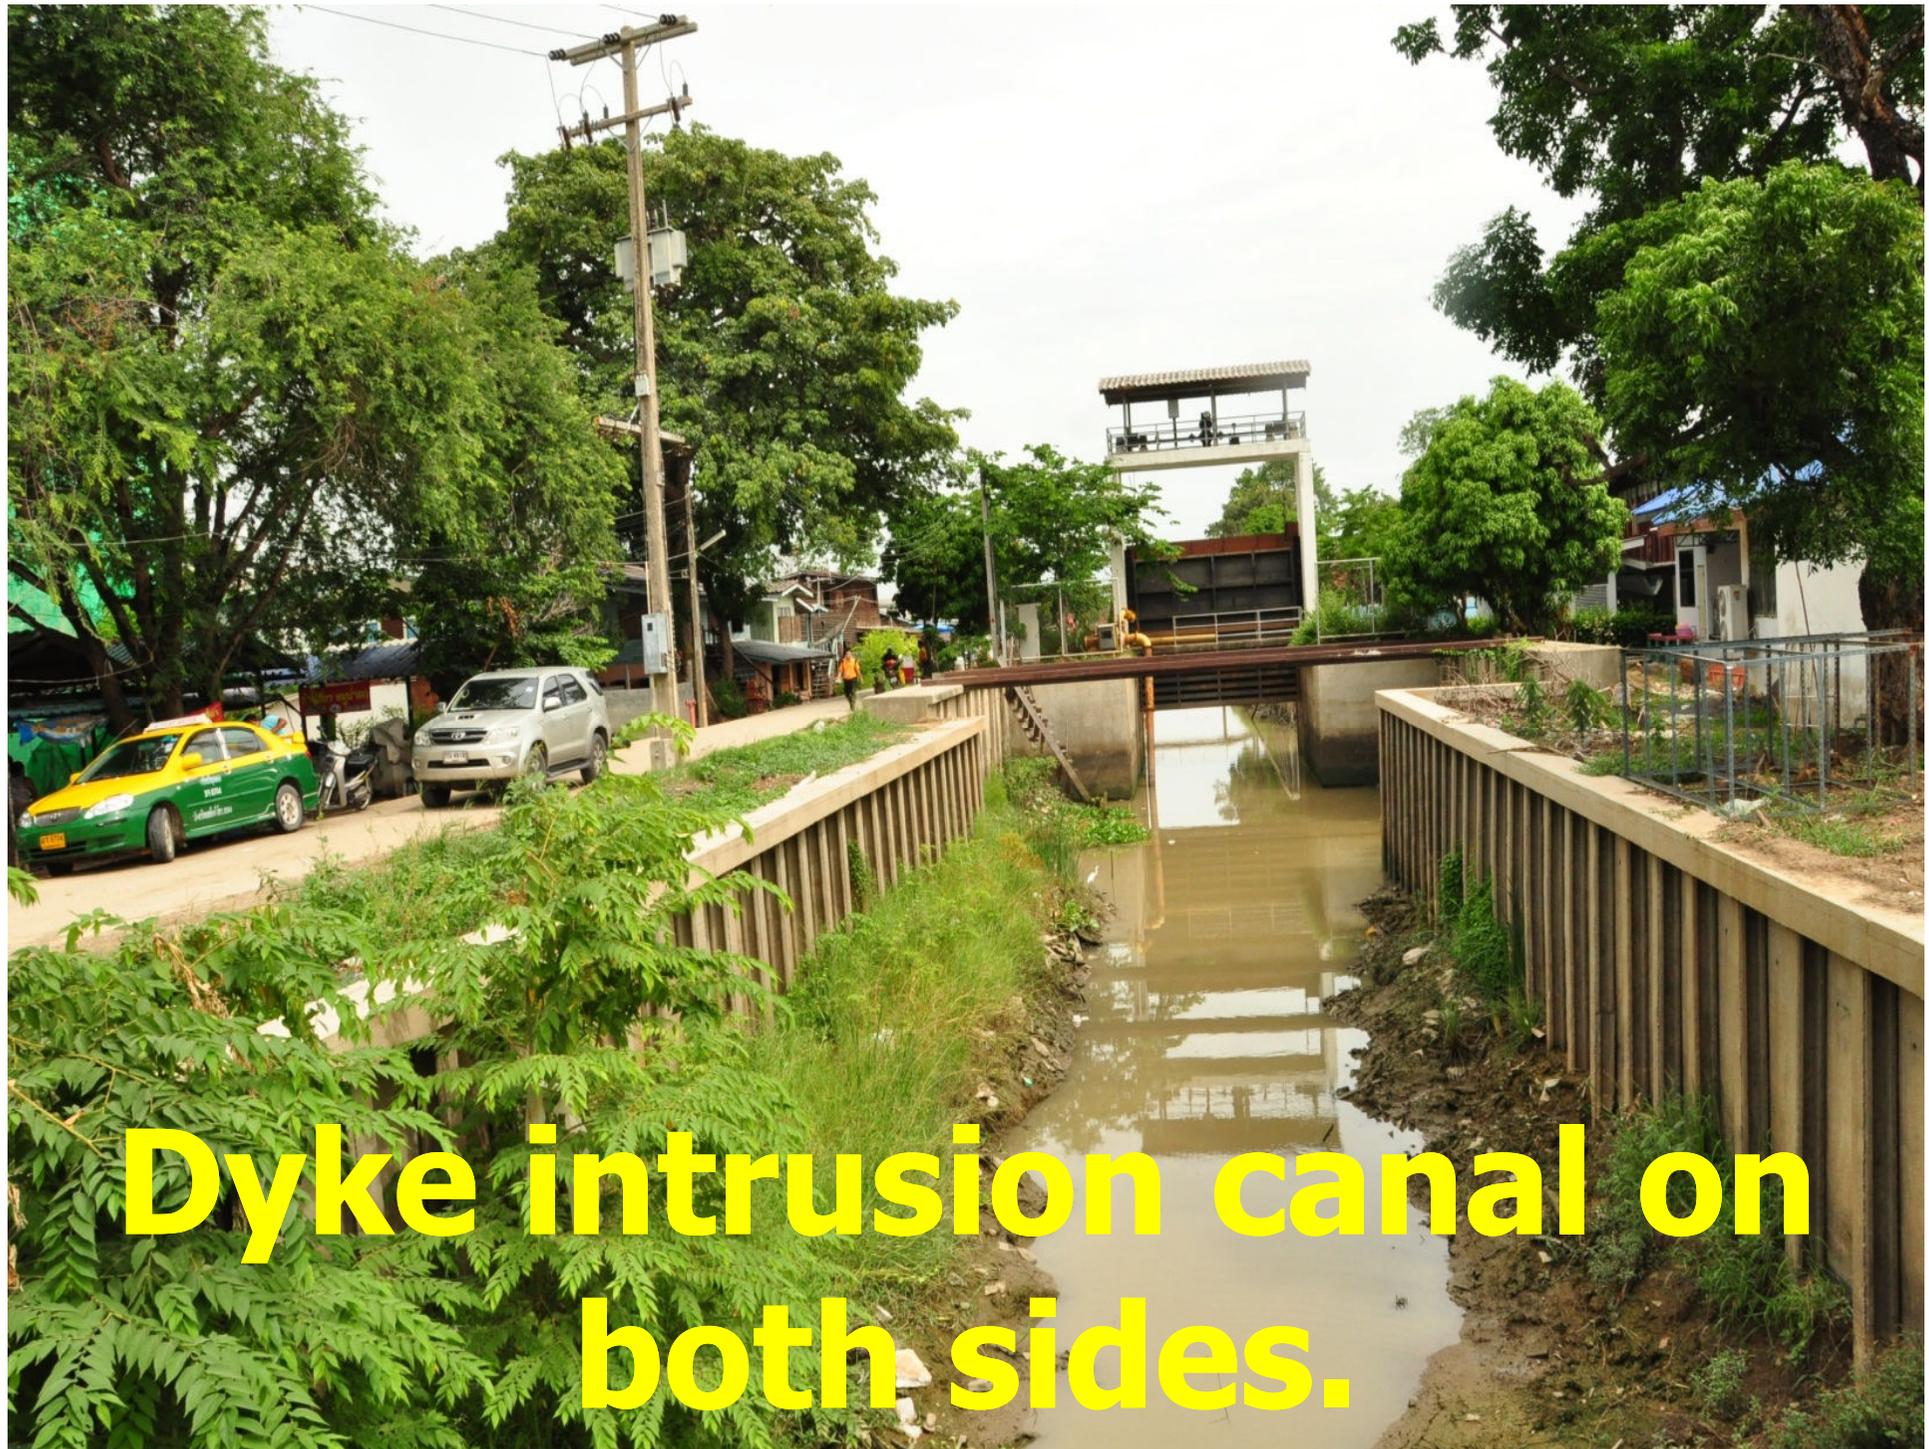
Dyke intrusion canal on both sides.
