RAPID FLOOD MANAGEMENT ASSESSMENT

**Lesson Learn and Future Direction for Water Policy:
Structure and non-structure flood prevention**

River and Canal Dredging

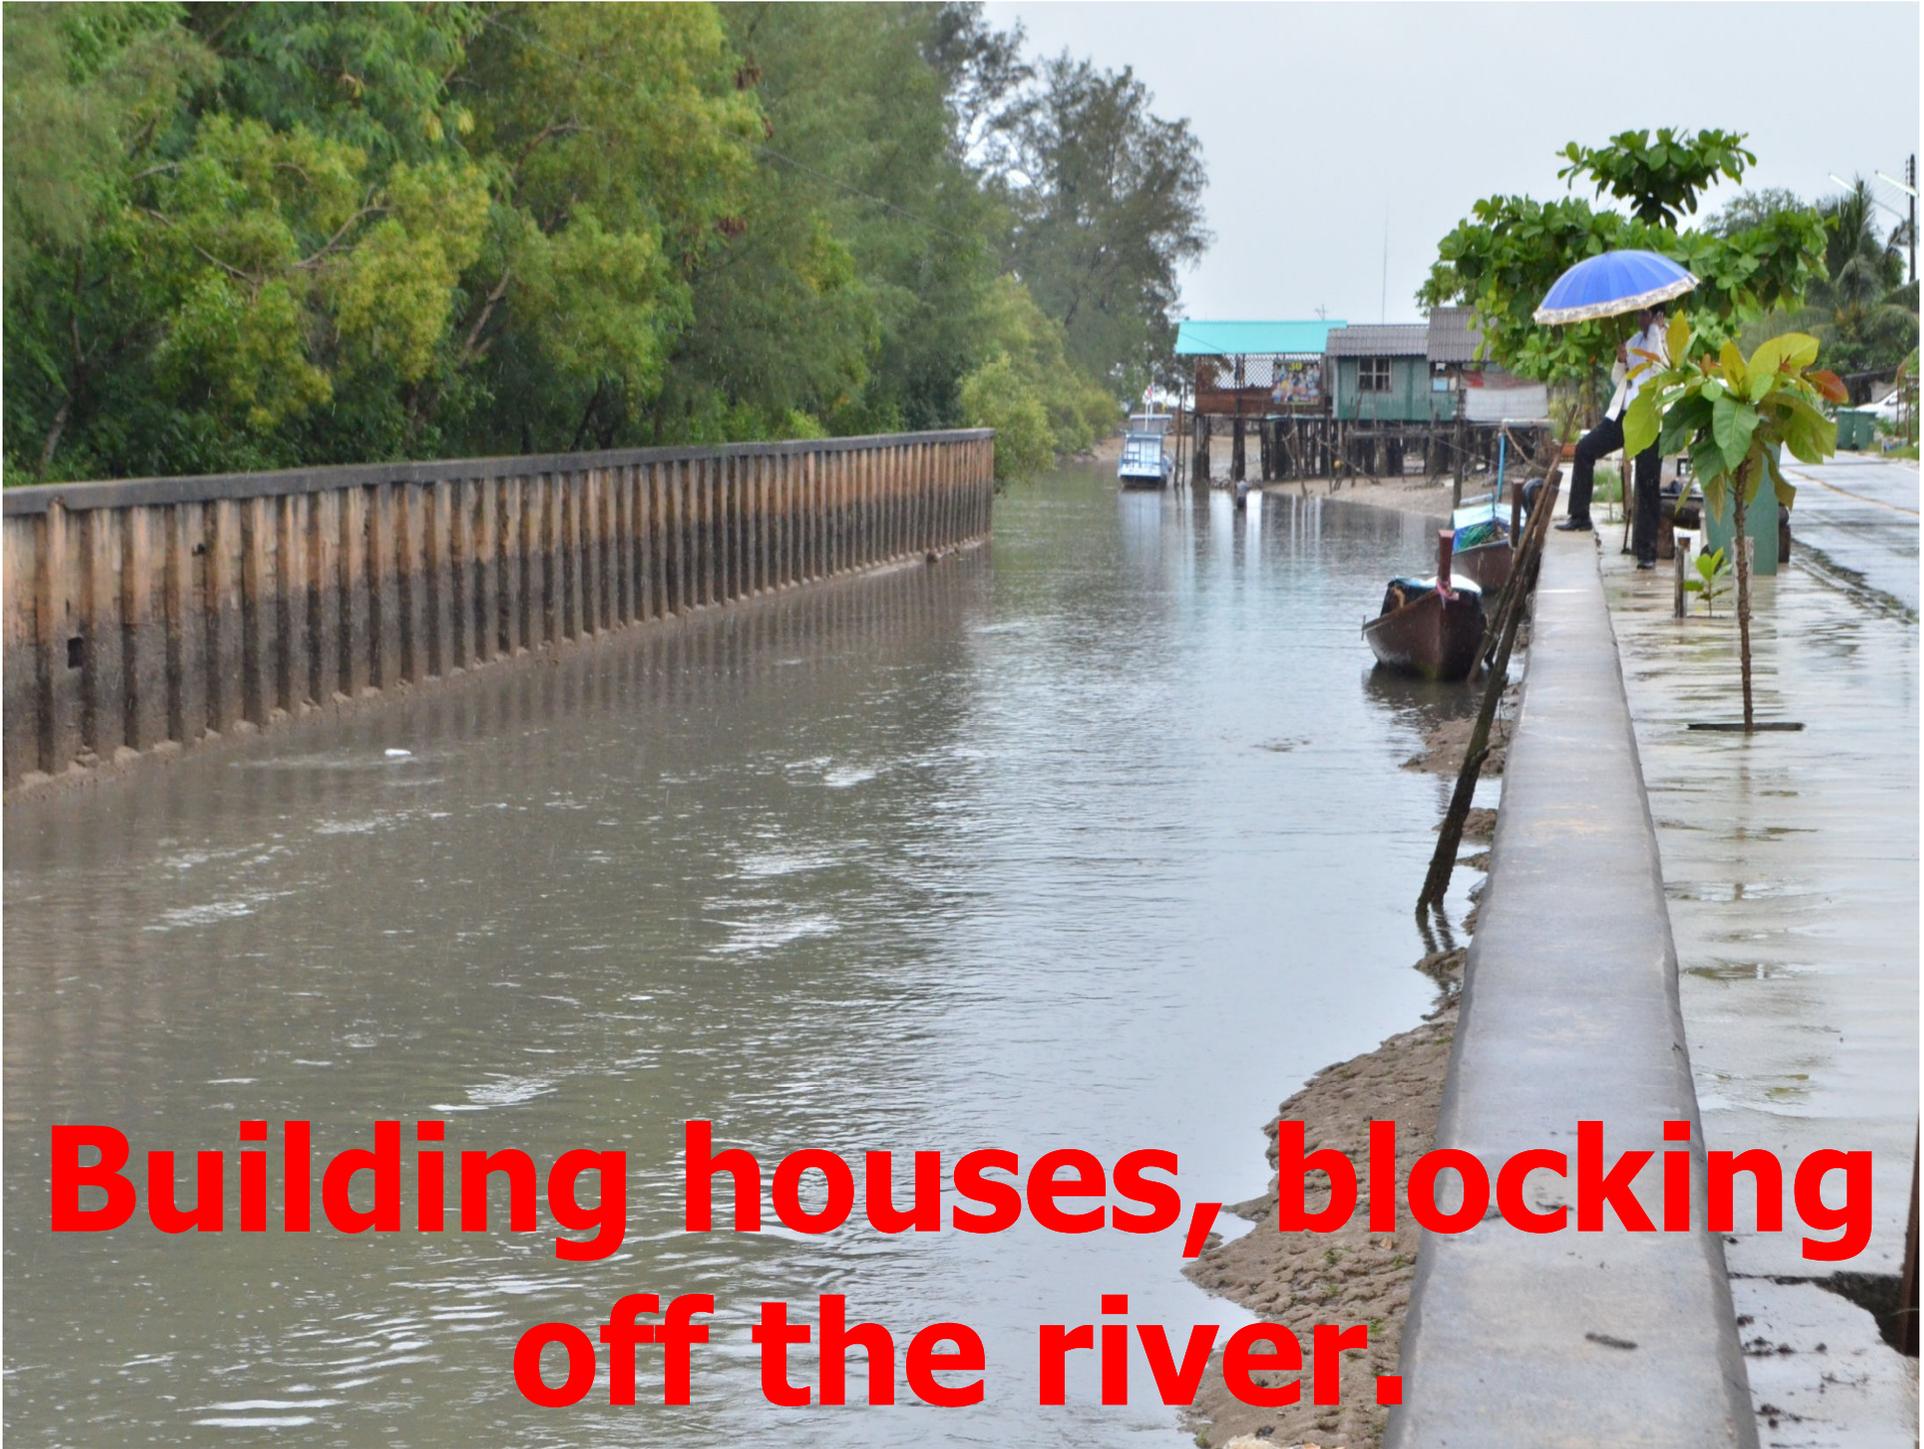
**Building houses, blocking
off the river.**

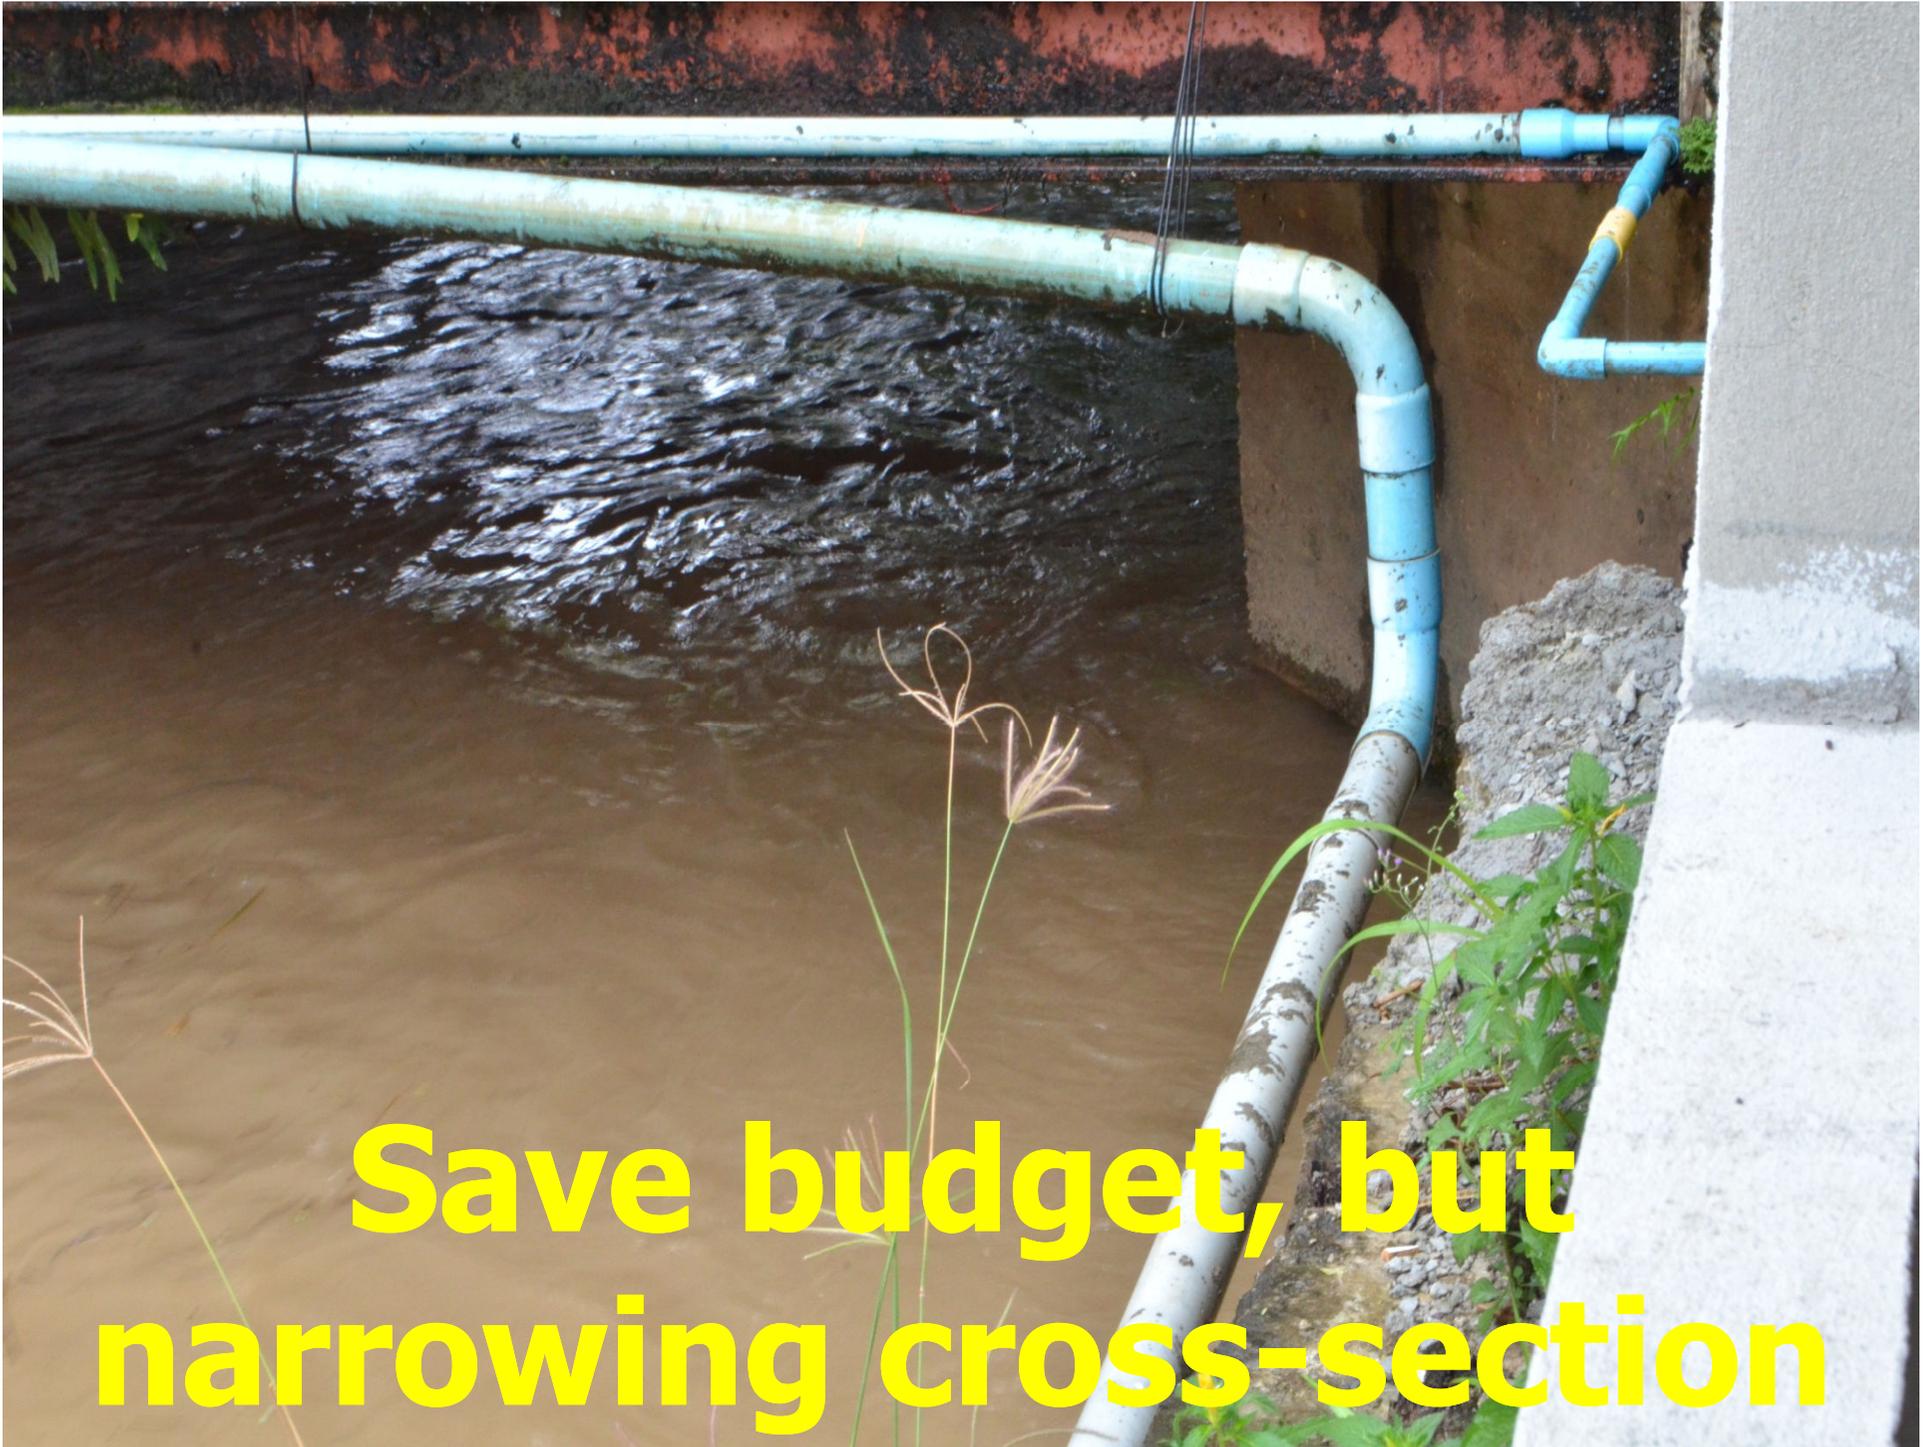
**Save budget, but
narrowing cross-section**

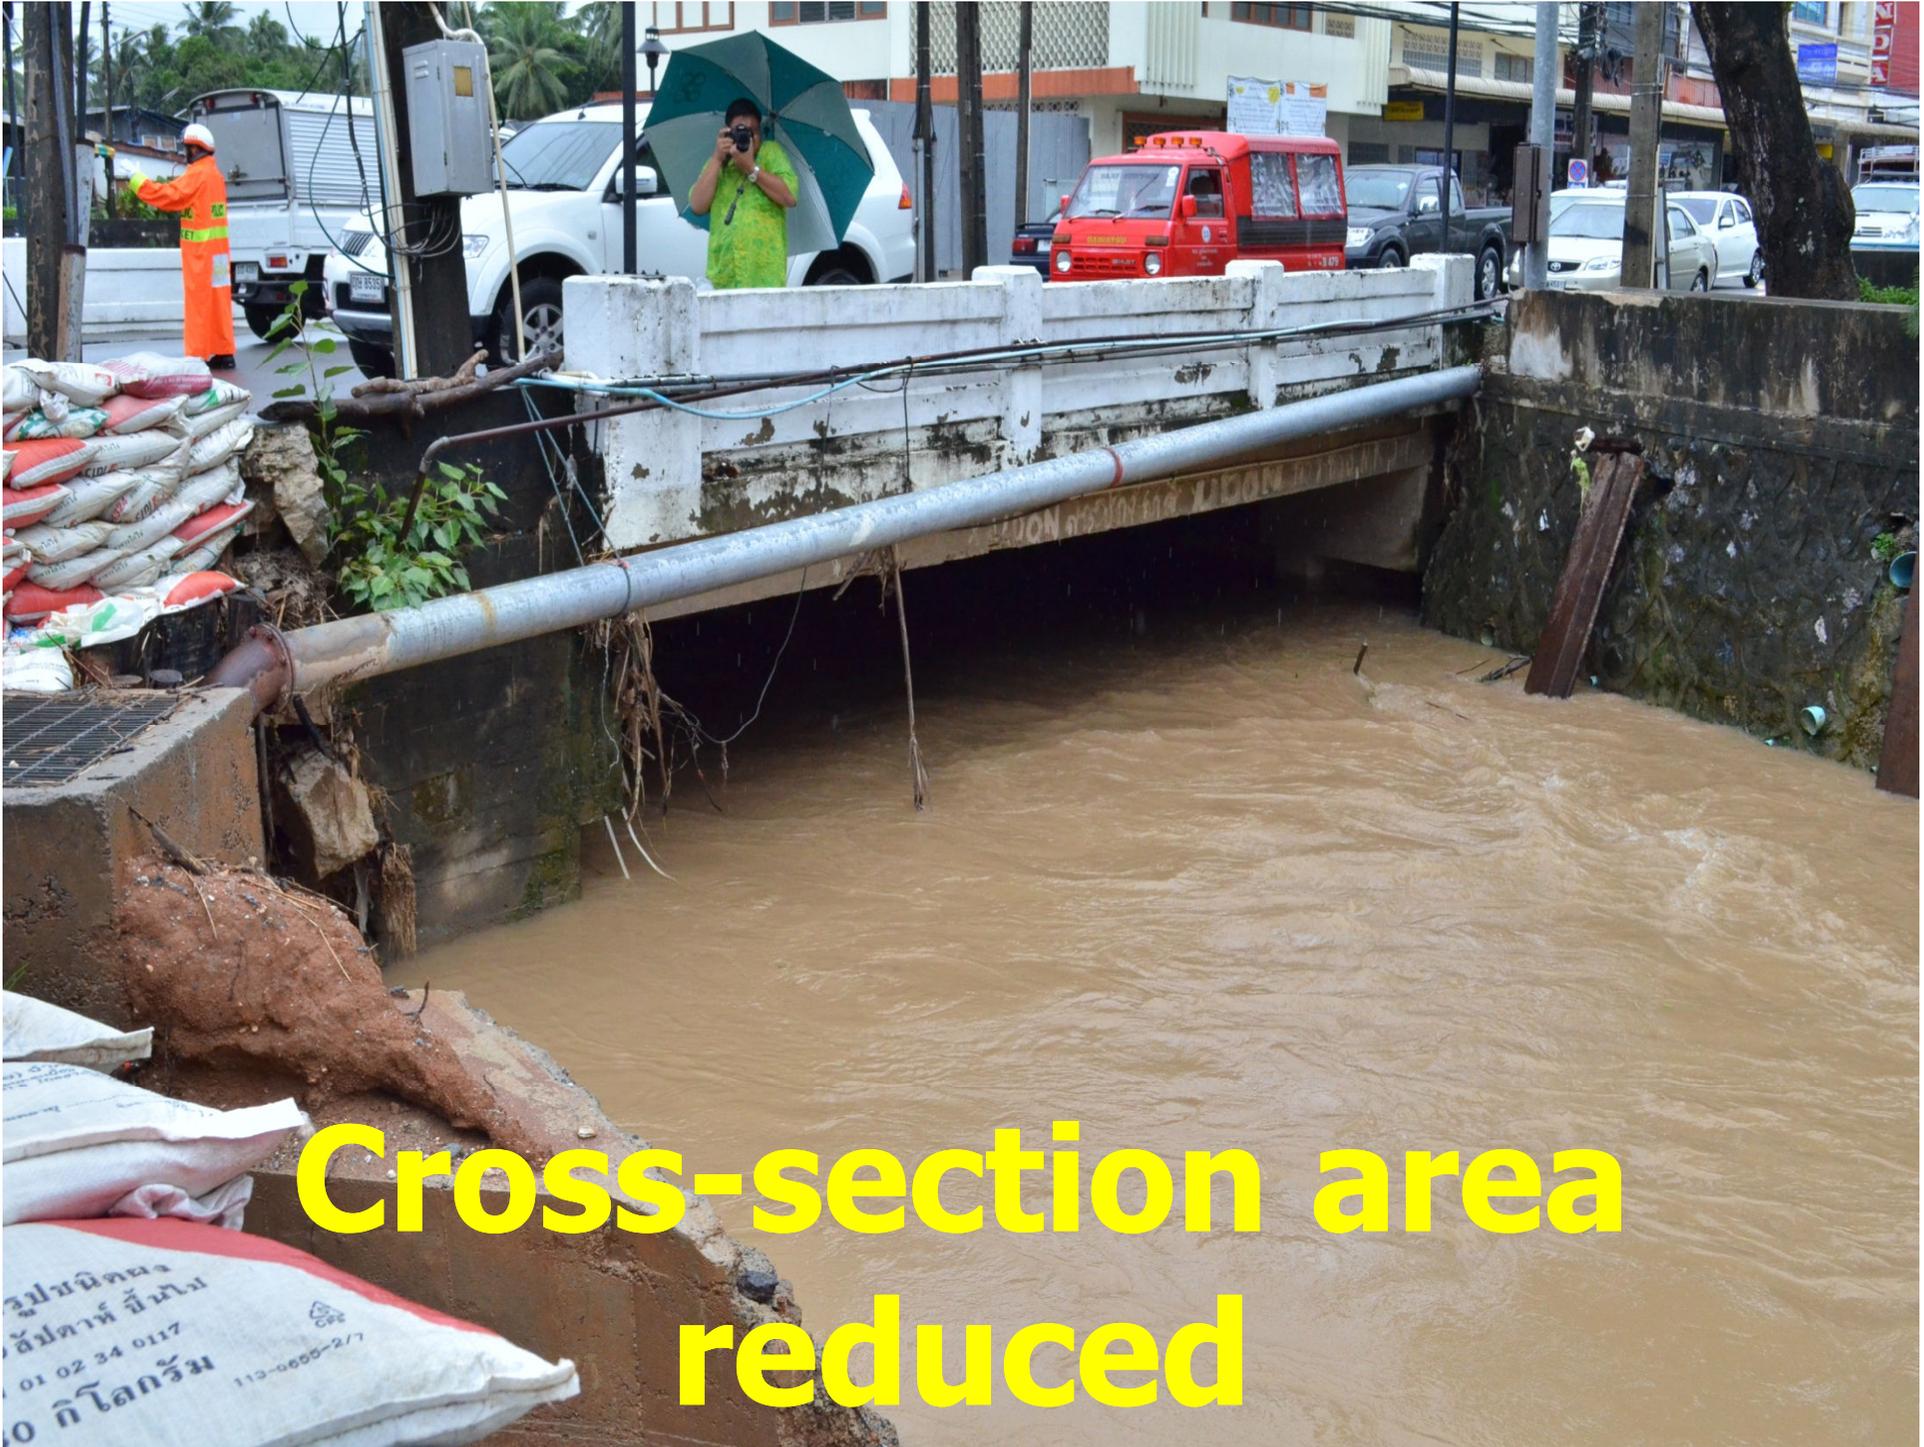
**Cross-section area
reduced**

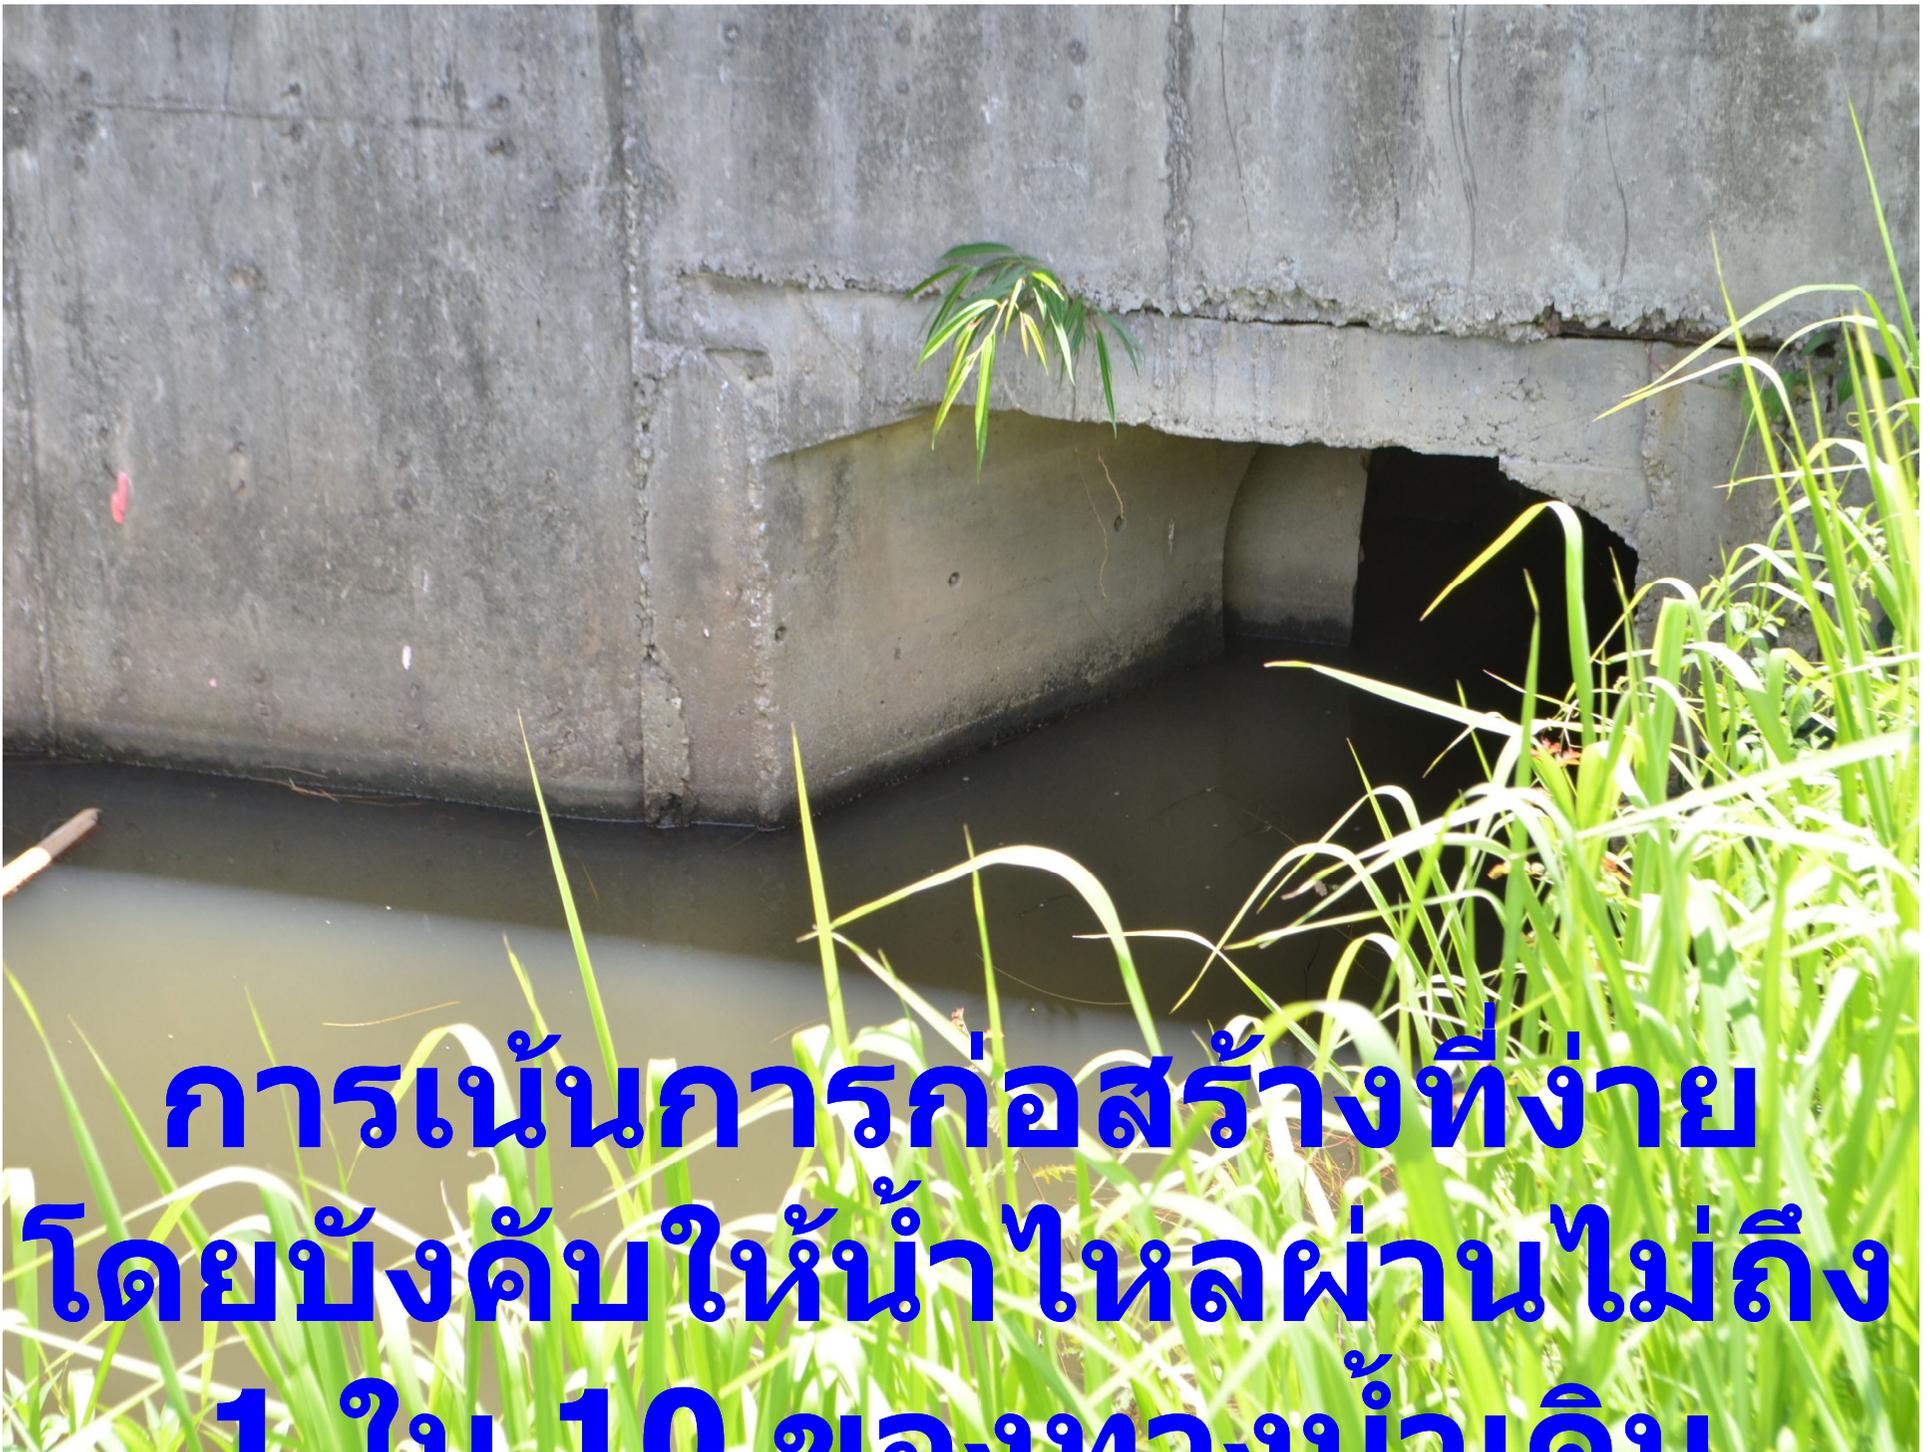
**การเน้นการก่อสร้างที่ง่าย
โดยบังคับให้น้ำไหลผ่านไม่ถึง
1 ใน 10 ของทางน้ำเดิม**

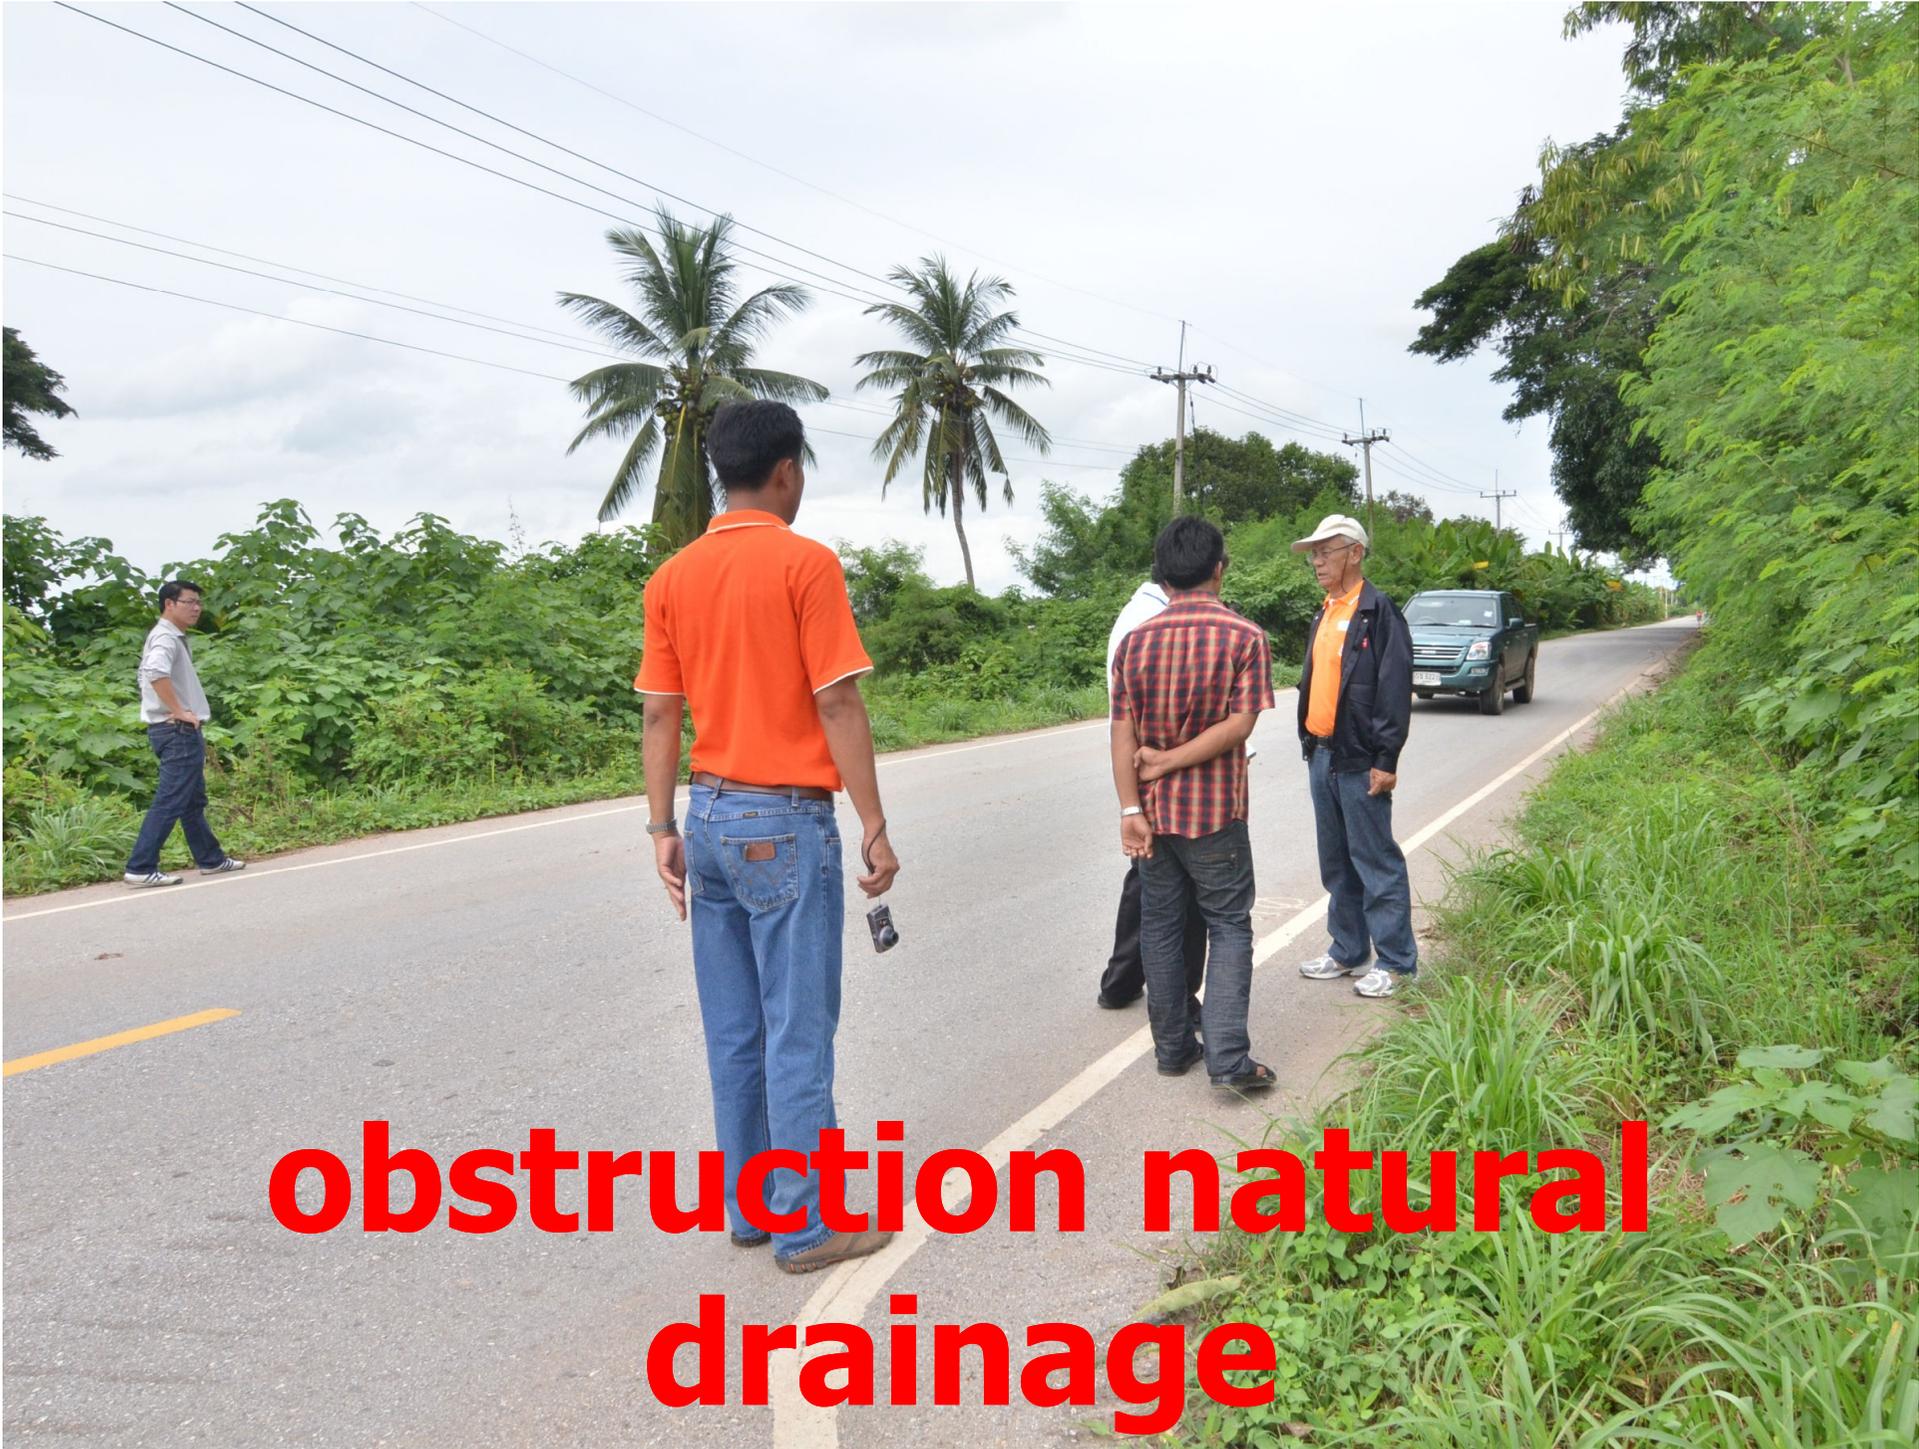
**obstruction natural
drainage**

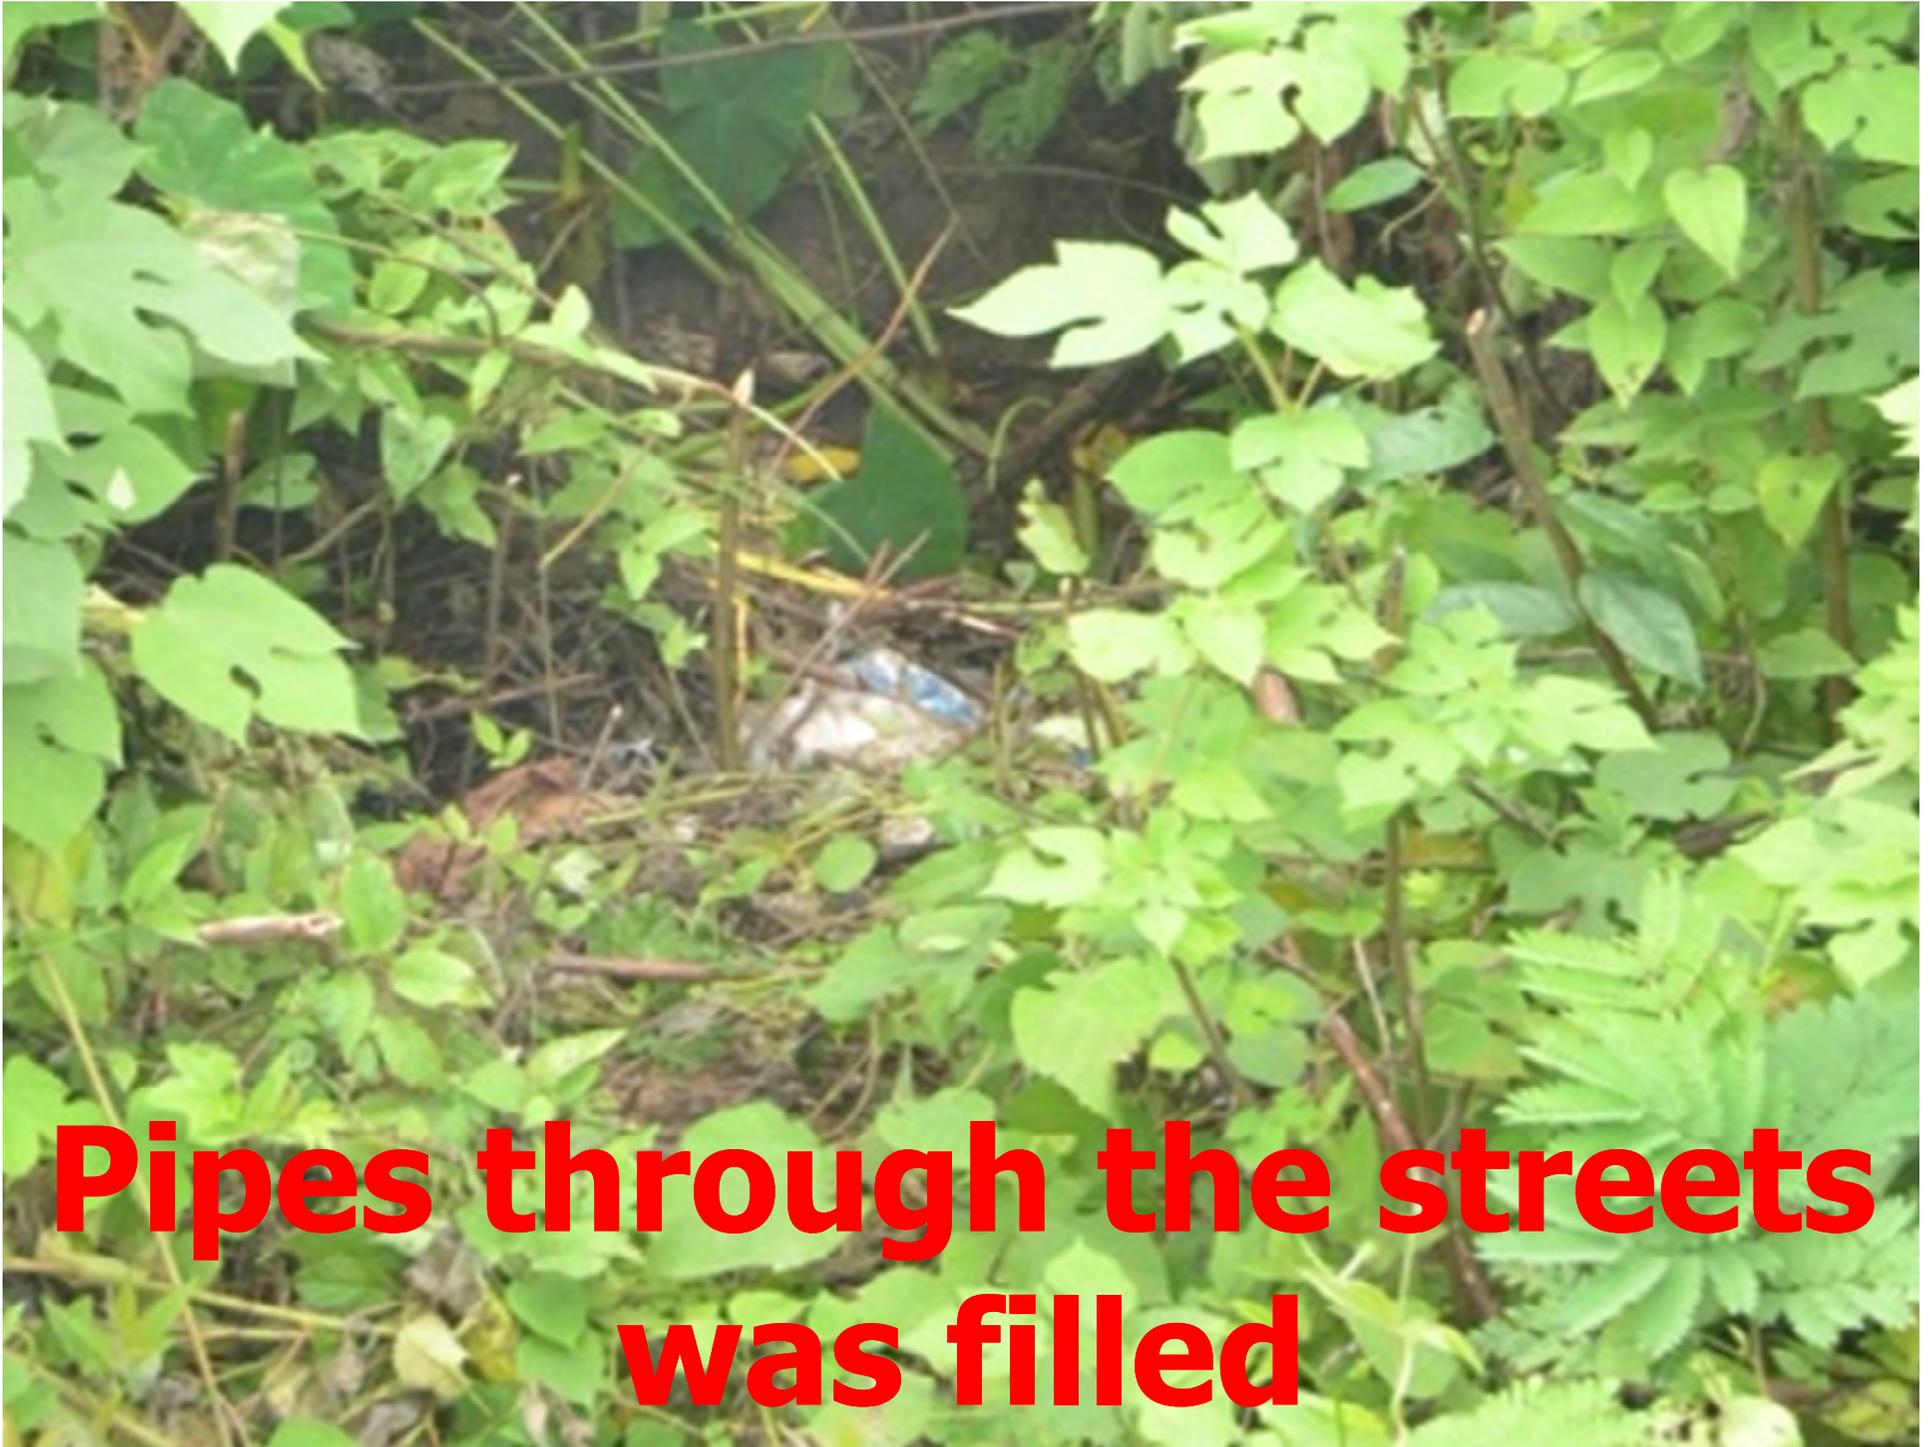
**Pipes through the streets
was filled**

**ท่อลอดกลม
สำหรับให้น้ำ
ไหลผ่านใต้
ถนน มีดิน
ทรายอุดจน
เกือบตัน**

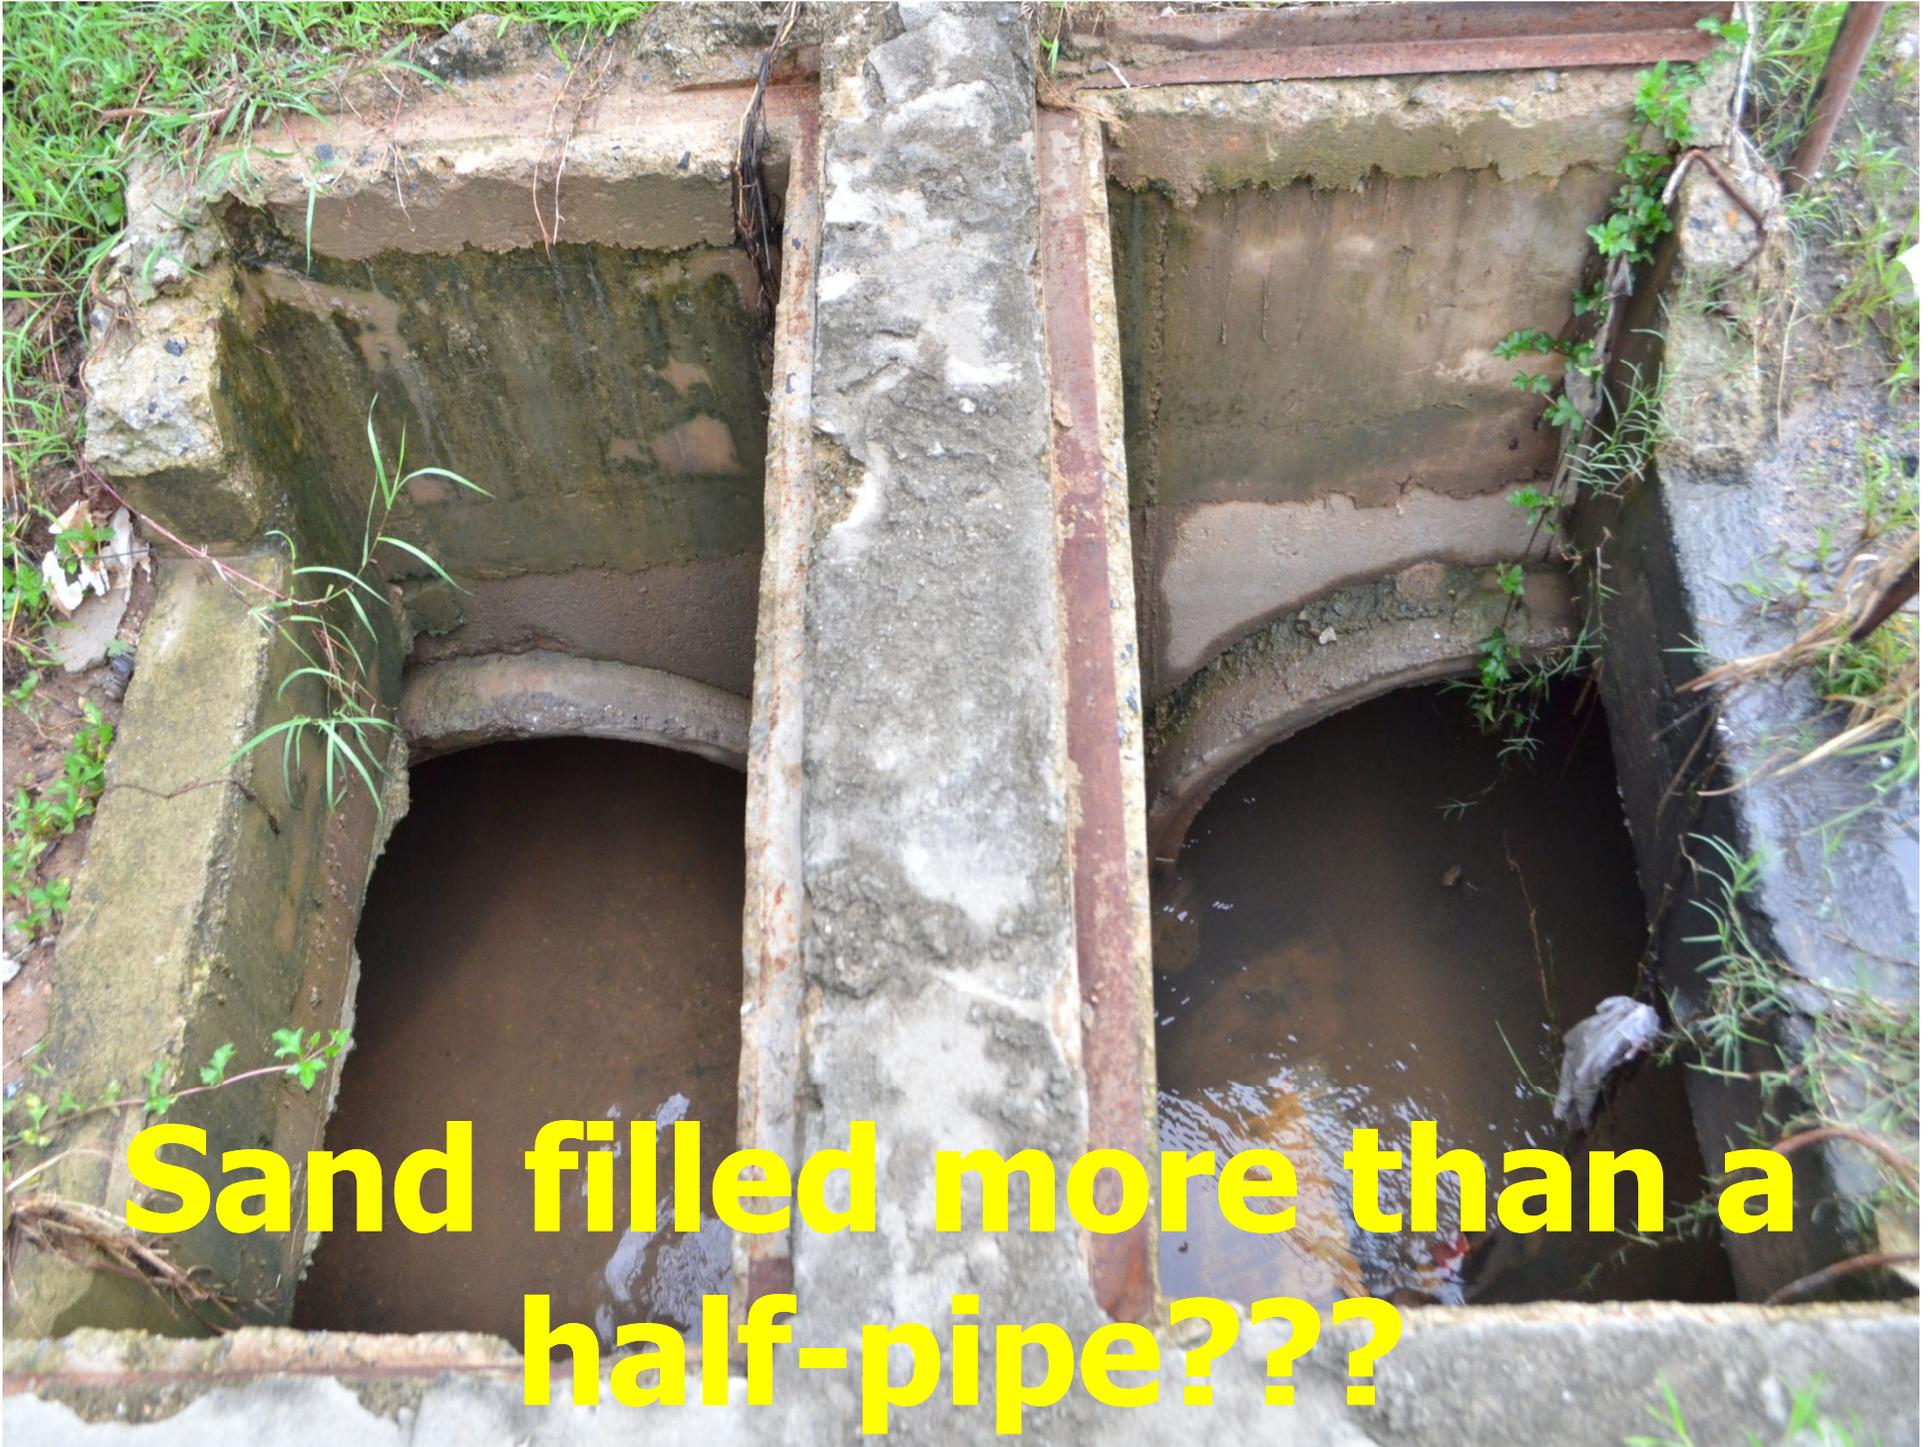
**Sand filled more than a
half-pipe???**

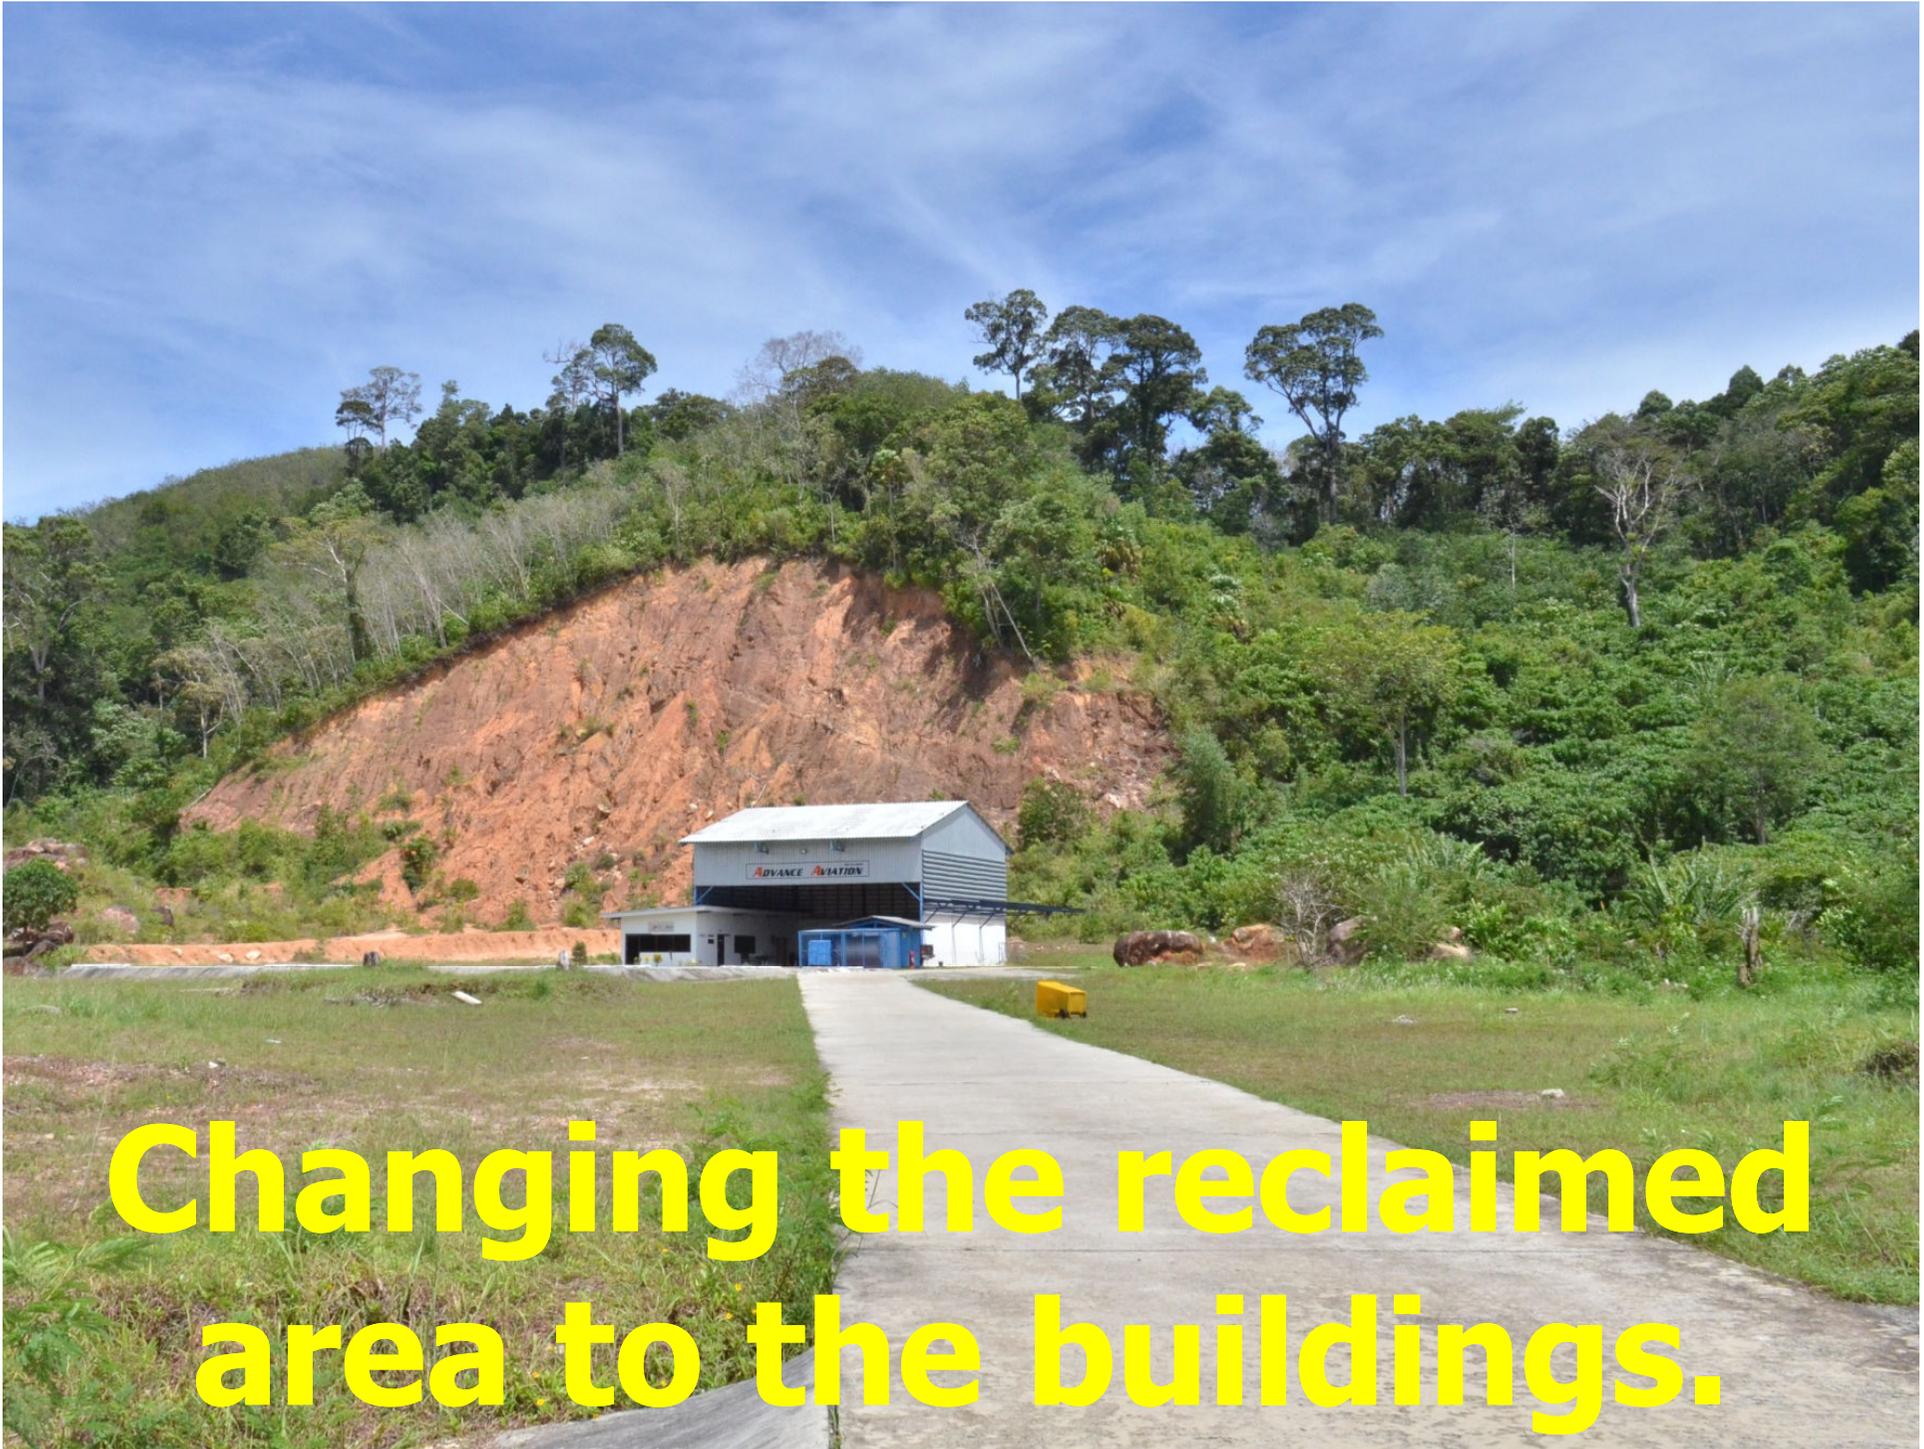
Changing the reclaimed area to the buildings.
