RAPID FLOOD MANAGEMENT ASSESSMENT

**Lesson Learn and Future Direction for Water Policy:
Structure and non-structure flood prevention**

River and Canal Dredging

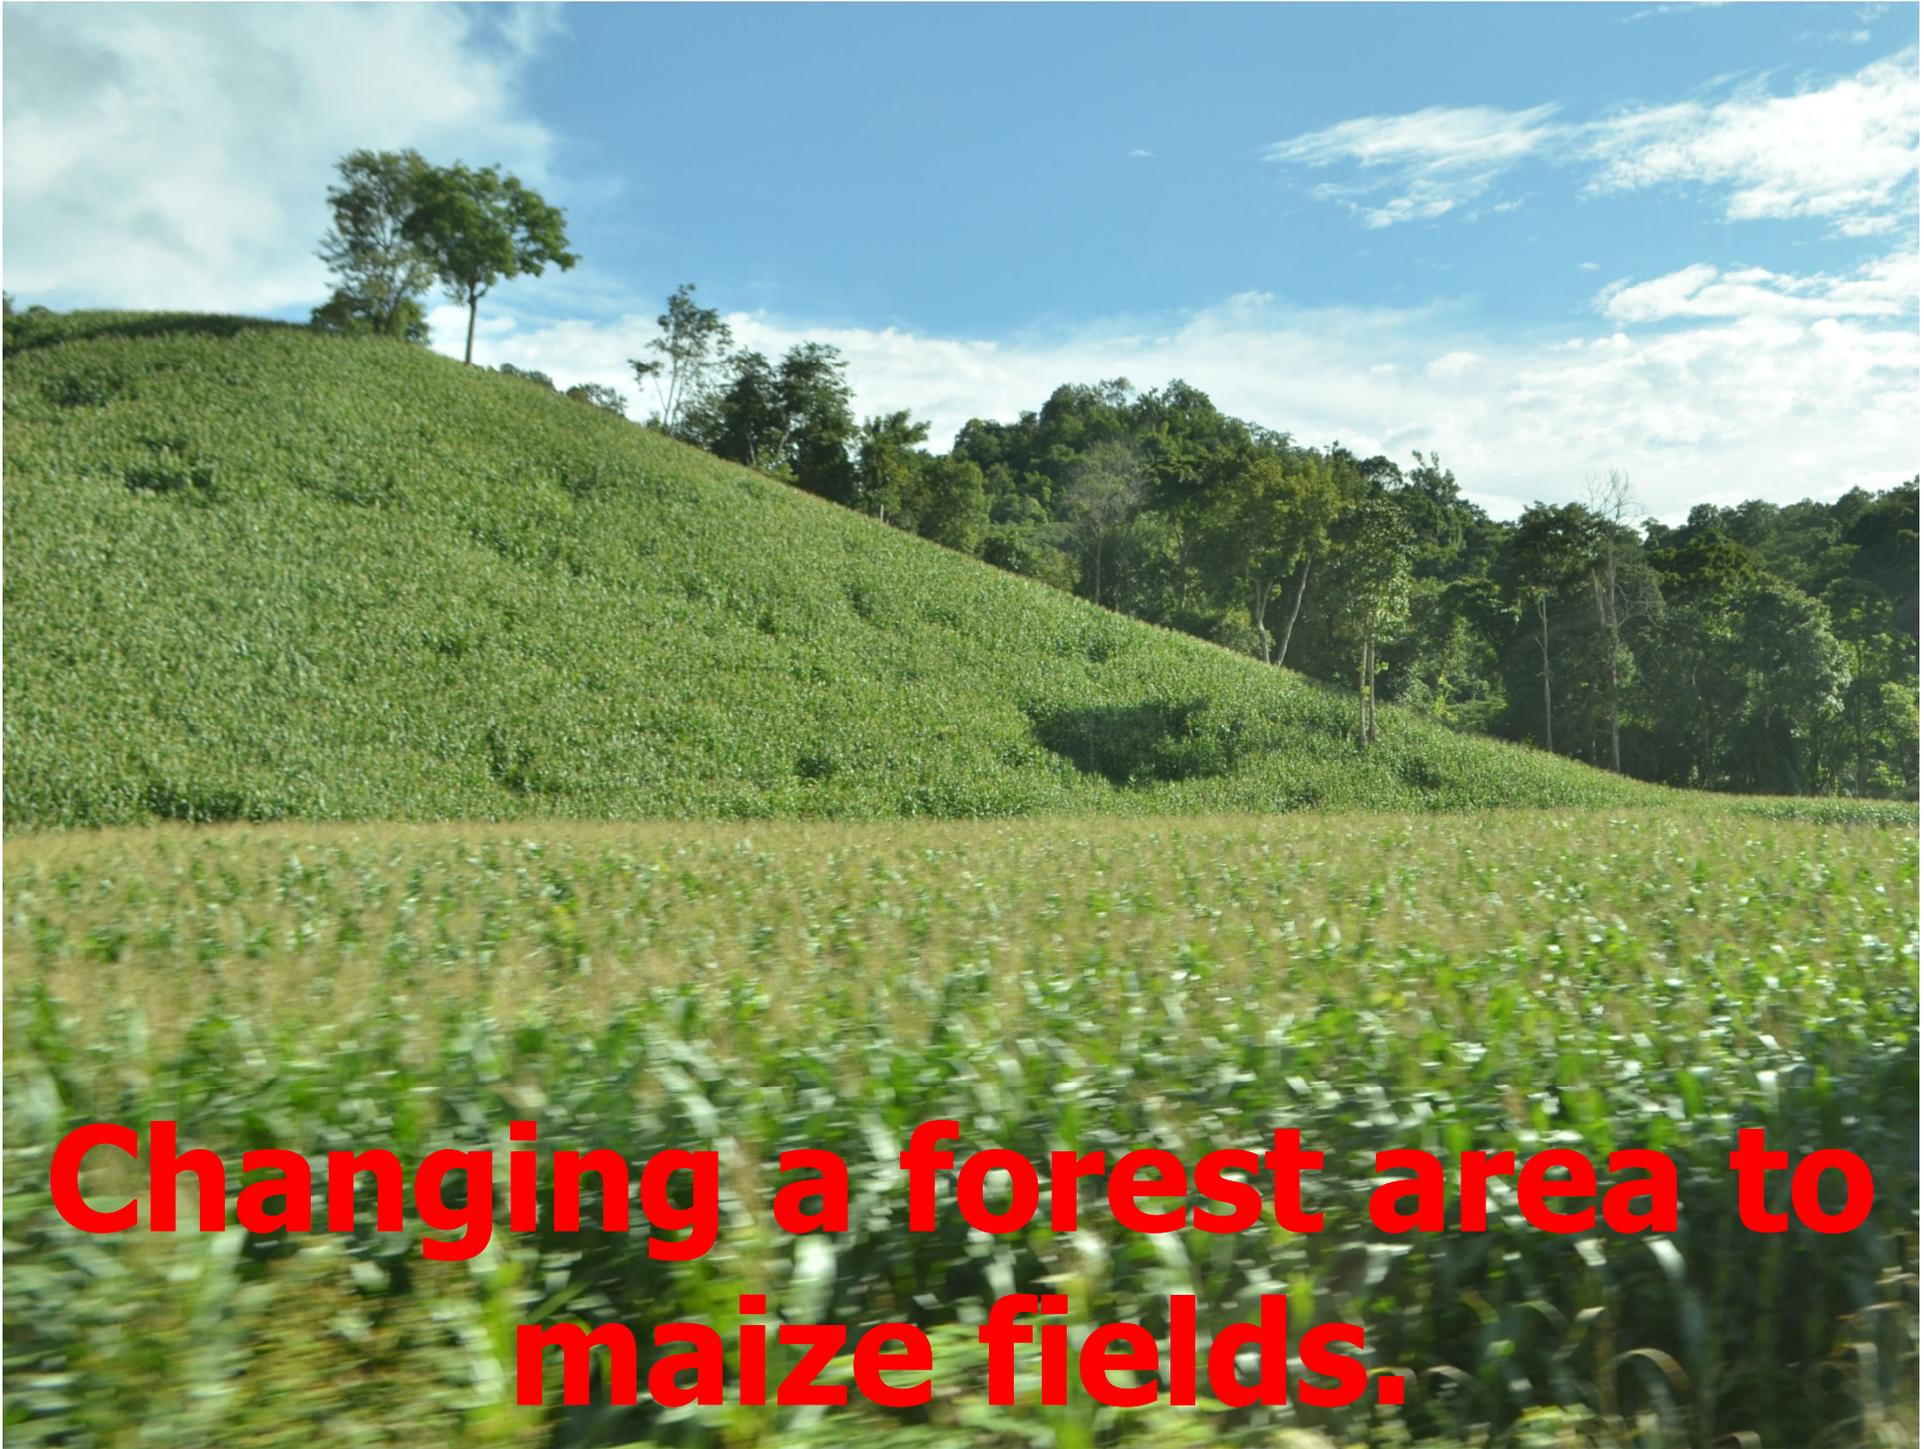
**Changing a forest area to
maize fields.**
