Case Study JENEBERANG RIVER BASIN, SOUTH SULAWESI, INDONESIA

1.RIVER BASIN 2.CALDERA OF MT. BAWAKARAENG **3.SEDIMENT CONTROL PLAN 4.BILI-BILI DAM** 5. PROBLEMS OF DOWNSTREAM AREA OF BILI-BILI DAM

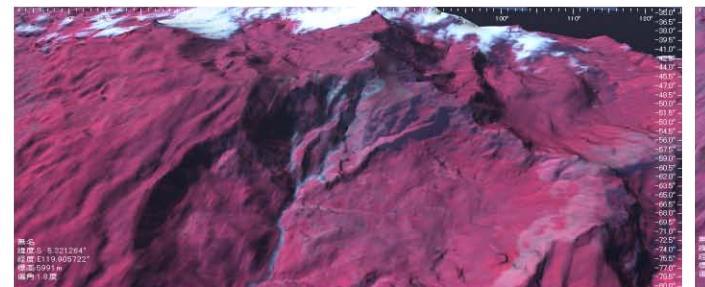
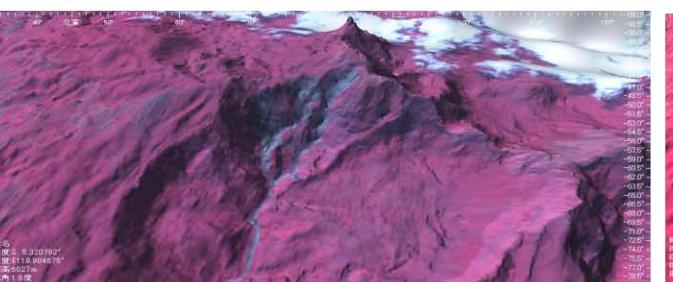
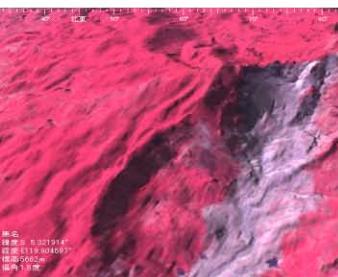
A gigantic caldera-wall collapse occurred on March 26, 2004, at the northeast of caldera of Mt. Bawakaraeng (hereinafter the Collapse). The volume of collapsed mass is estimated at 200 to 300 million m³. The caldera-wall collapse brought tremendous damage to the area, accounting for 32 people death and missing, 635 cows losing, many houses, elementary school and about 1,500 ha of agricultural land buried. Total damage was estimated at about Rp. 22 billion.

ASTER (07 Jul. 2001)

ASTER (25 Mar. 2004)

ASTER (07 Sep. 2006)

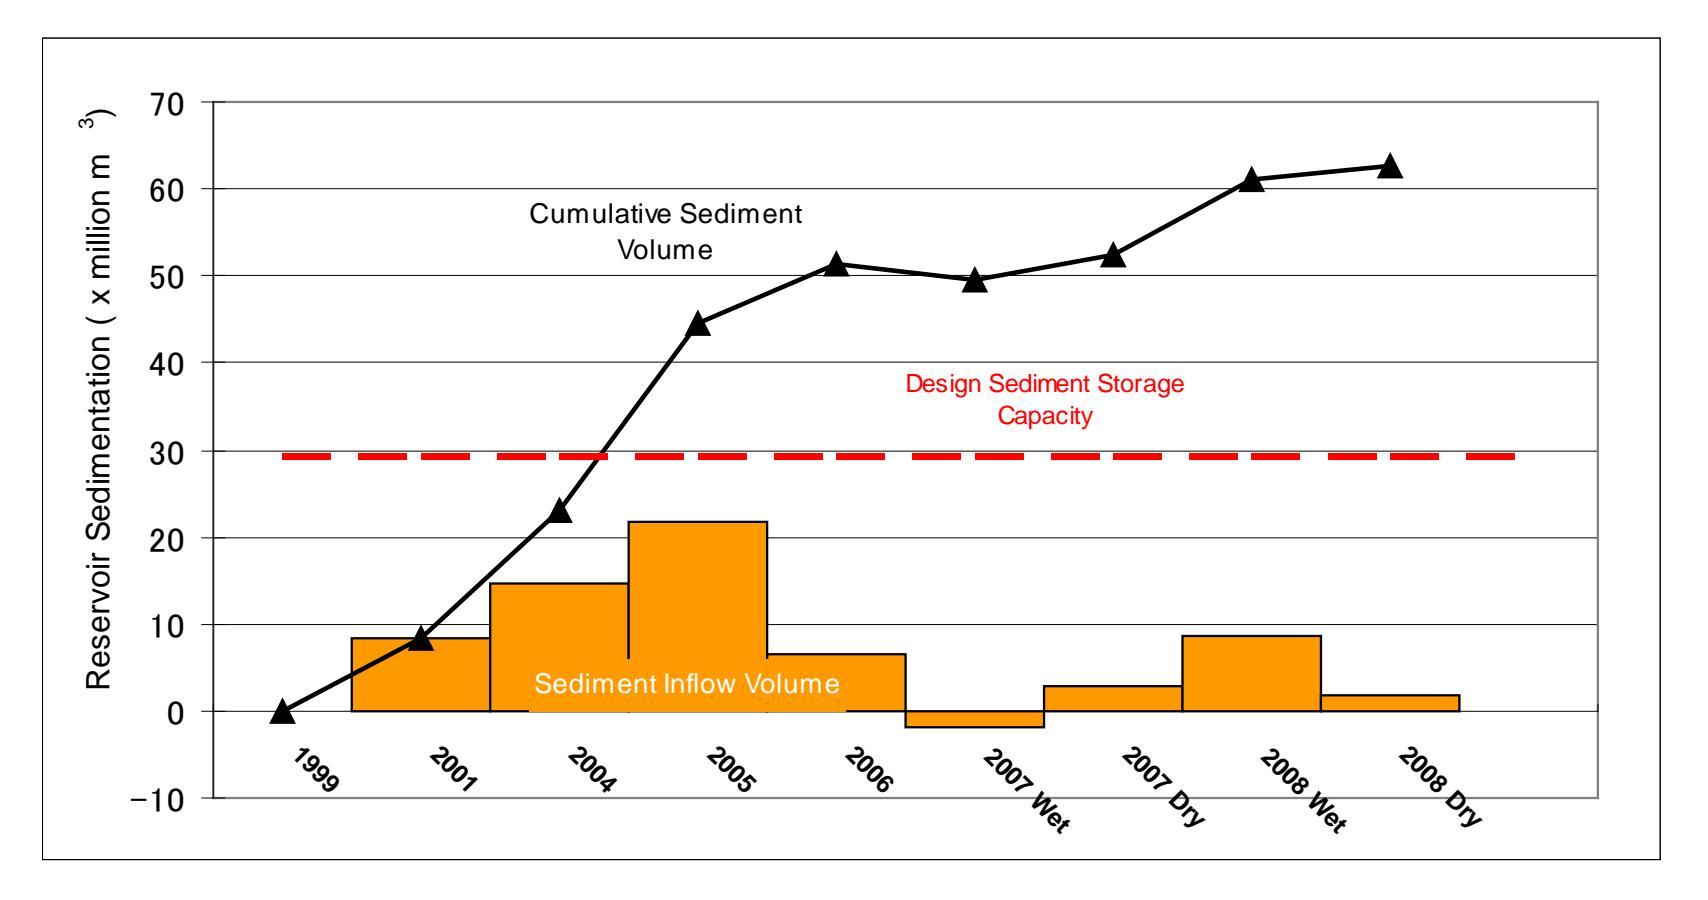
The cumulative reservoir sedimentation curve since 1997shown on following figures and cumulative sedimentation volume had reached 62,744,000 m³ as of November 2008.

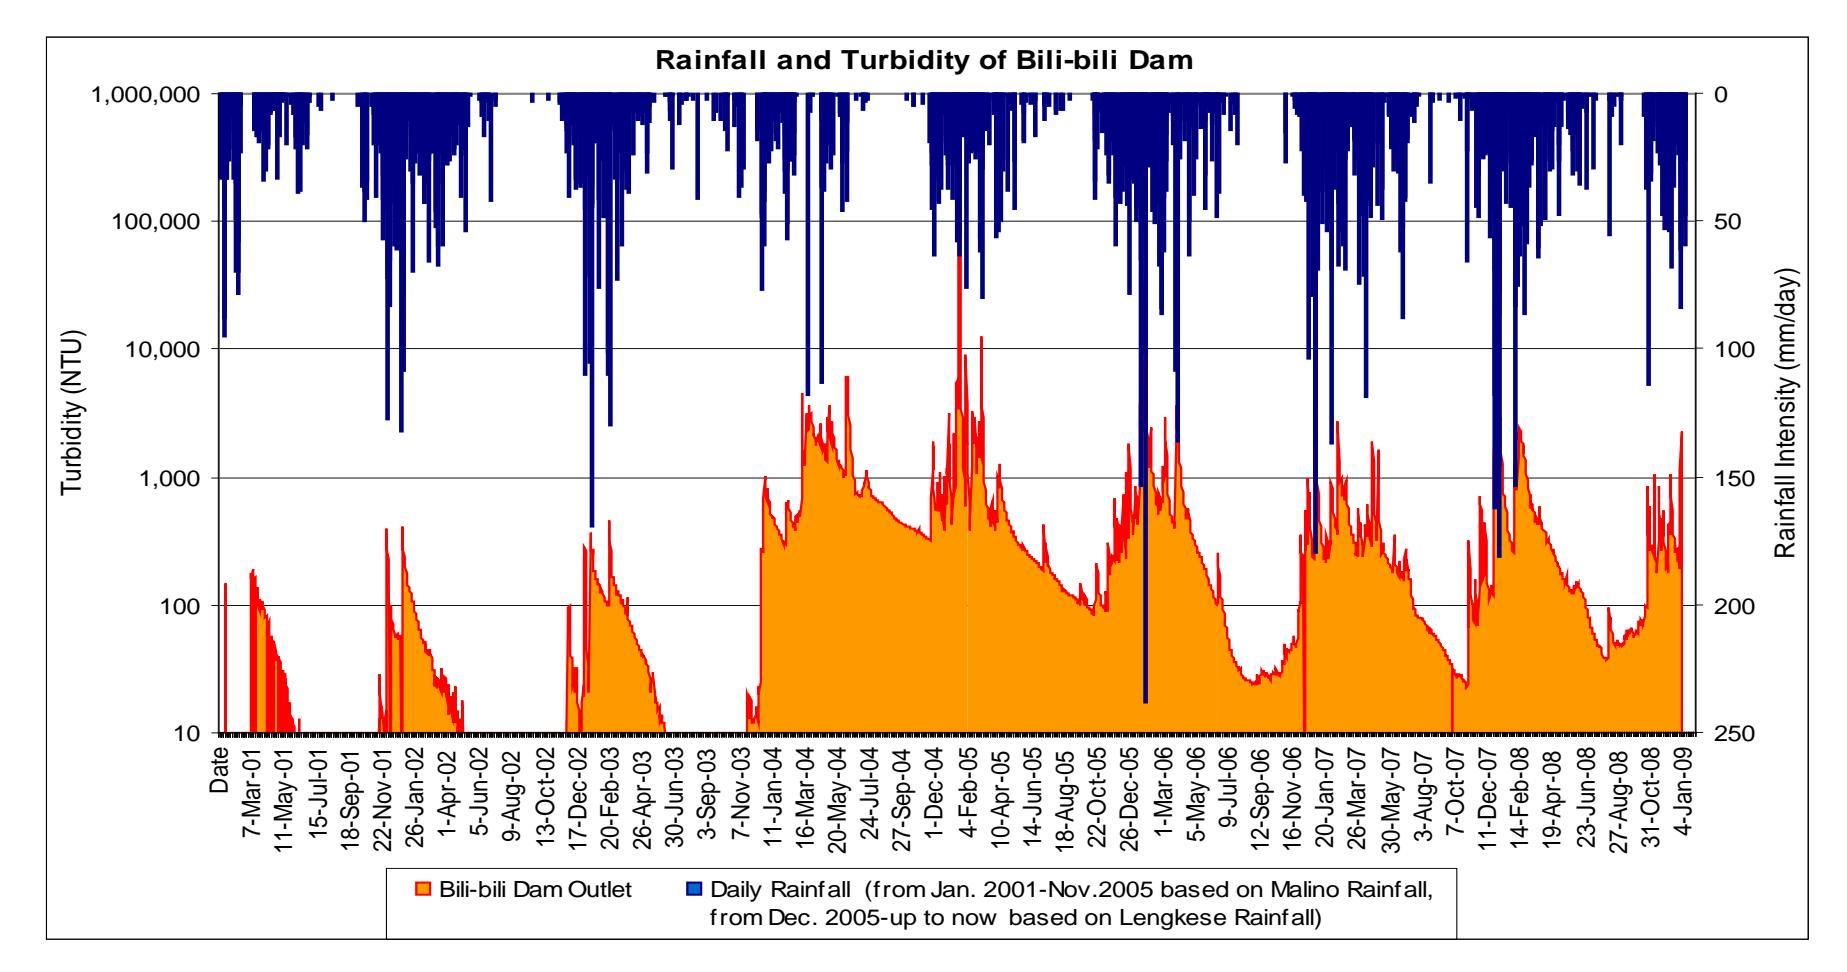
The following graph shows raw water turbidity records before and after the collapse. High turbidity rates occurred during the rainy season in the month of December and January. The maximum turbidity rate declined to 33,000 NTU in 2006 and about 4,000 NTU in 2007.

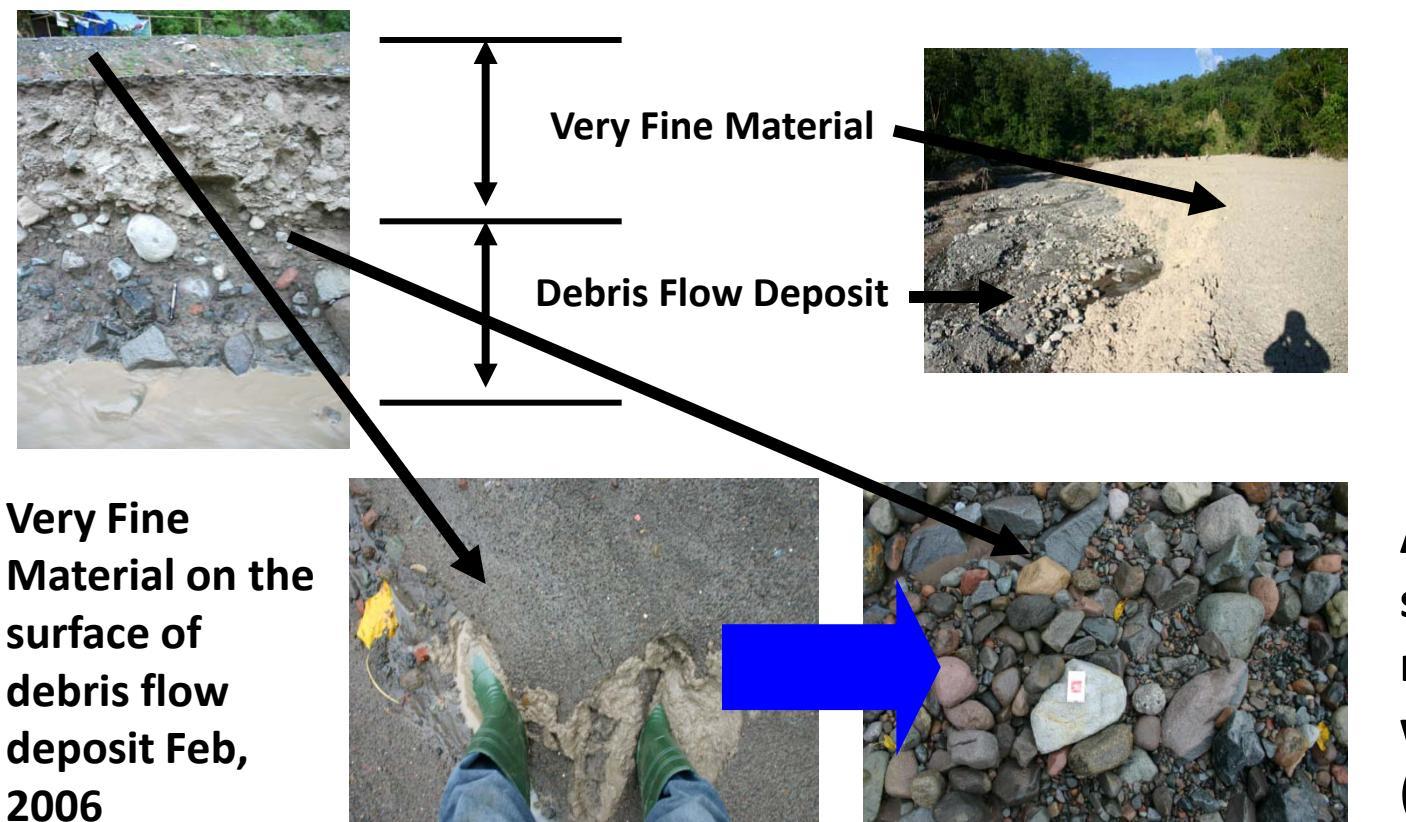
Large-Scale of **Sediment Flow Occured** (July 2005, Dry Season)

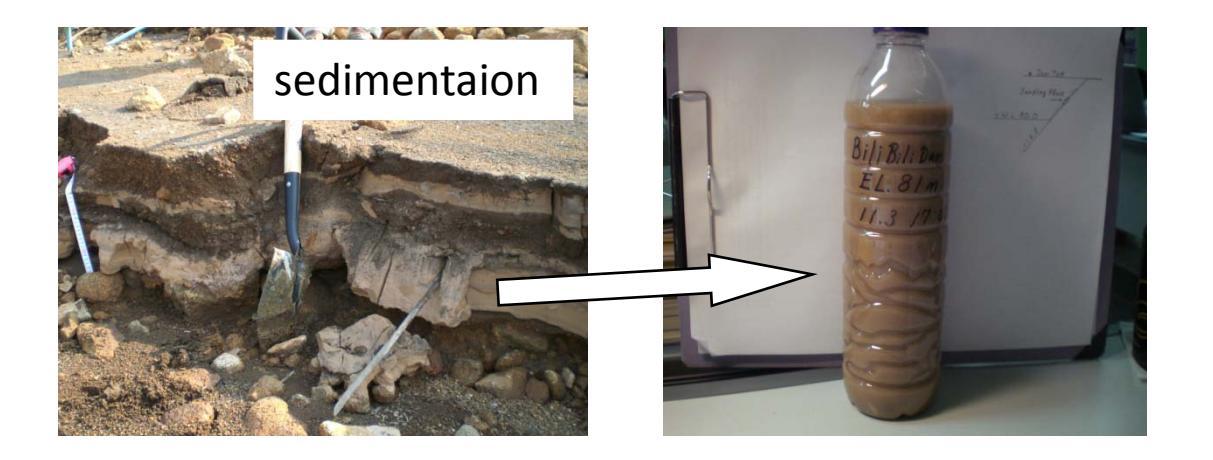
Appereance of sand gravel materials after washed away (Mar, 2—0)

Very fine material at inlet structure of Bili-Bili Dam (el.82 m, November 3, 2006)

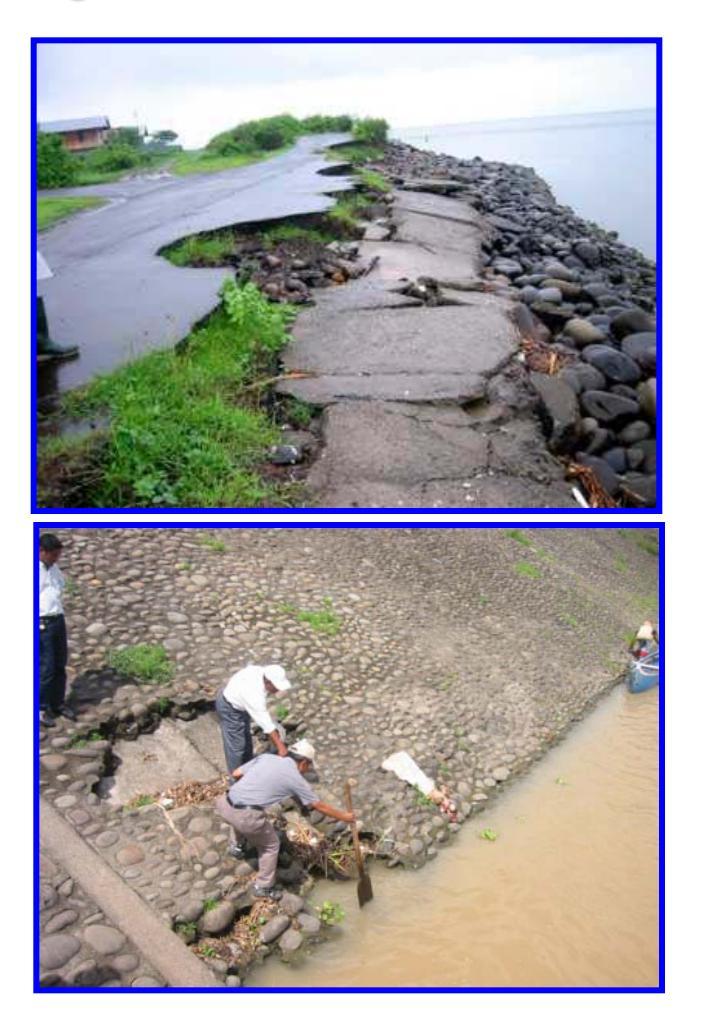
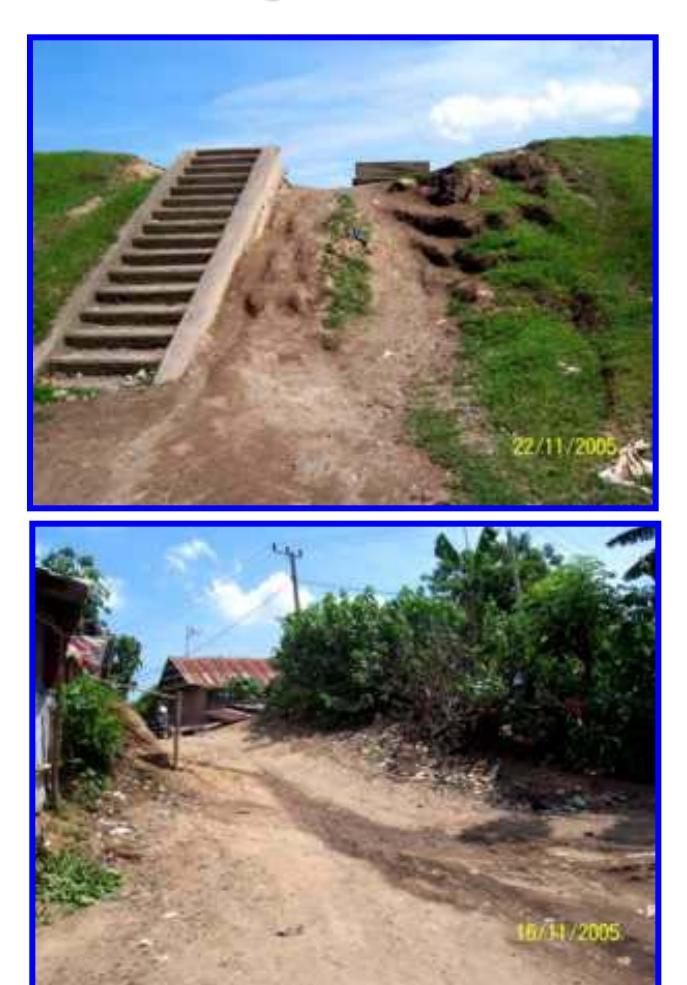
Figure 26. Man-Made Break and Natural Damage of River Dike

♦ Flood risk to residents

♦ Reduction of River Flow Capacity

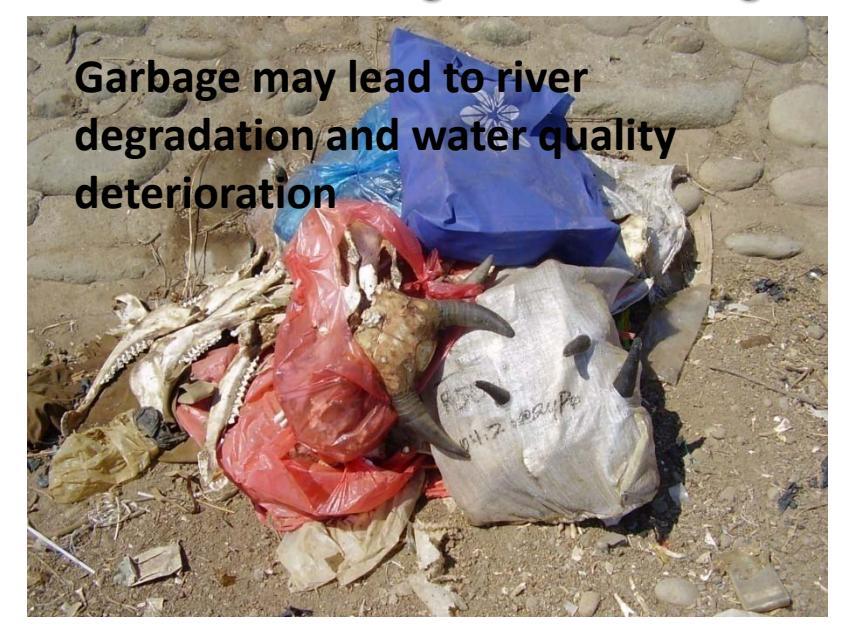
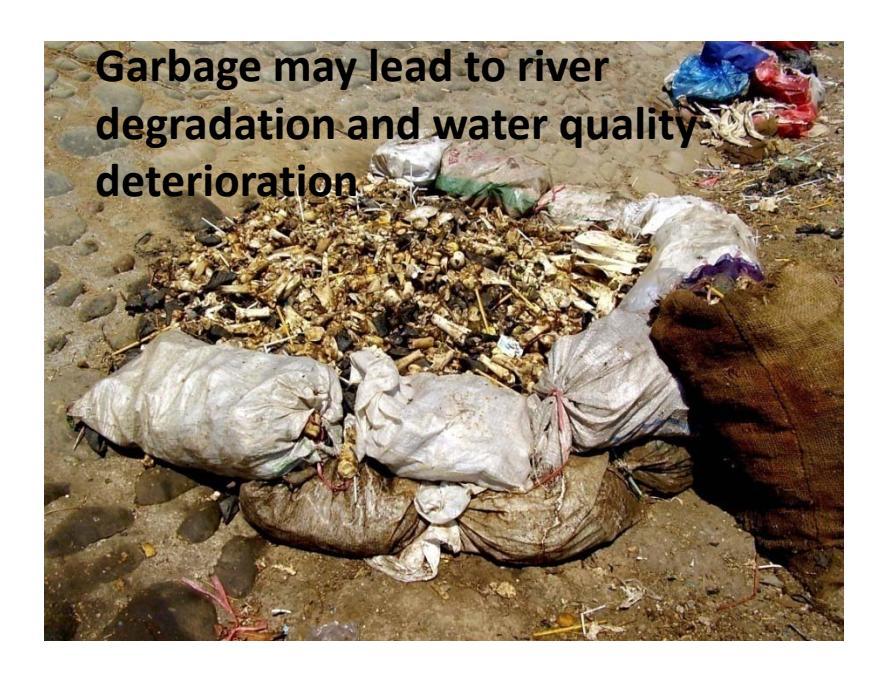
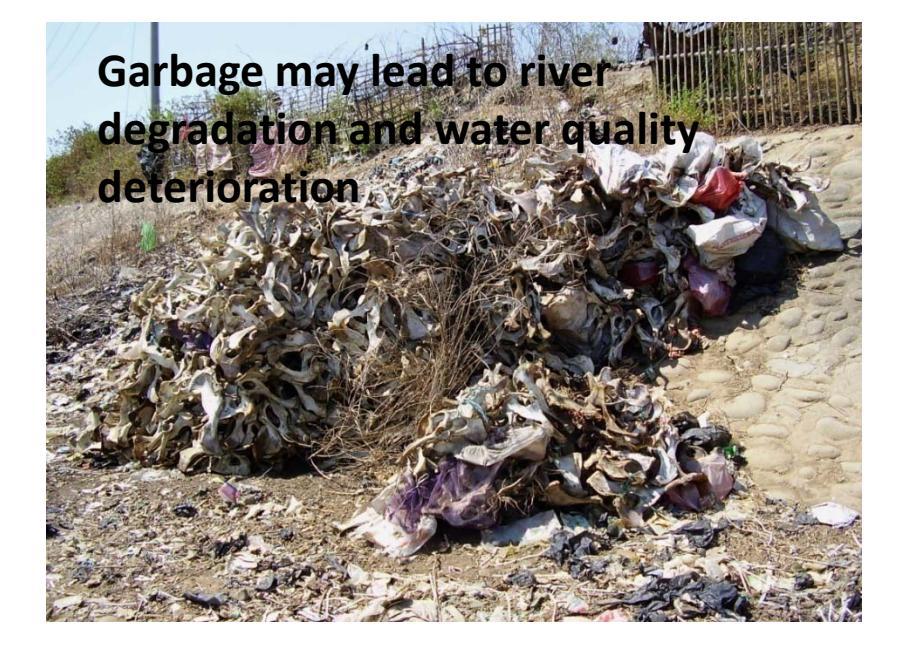
Figure 27. Garbage Dumping Into River Body

- 1. Illegal buildings and high trees hamper water flow (reducing wet area of river section);
- 2. Solid and liquid waste disposal causes water quality deterioration;
- 3. Safety of residents who reside in the river area;
- 4 Excessive sand mining may cause river bed degradation.

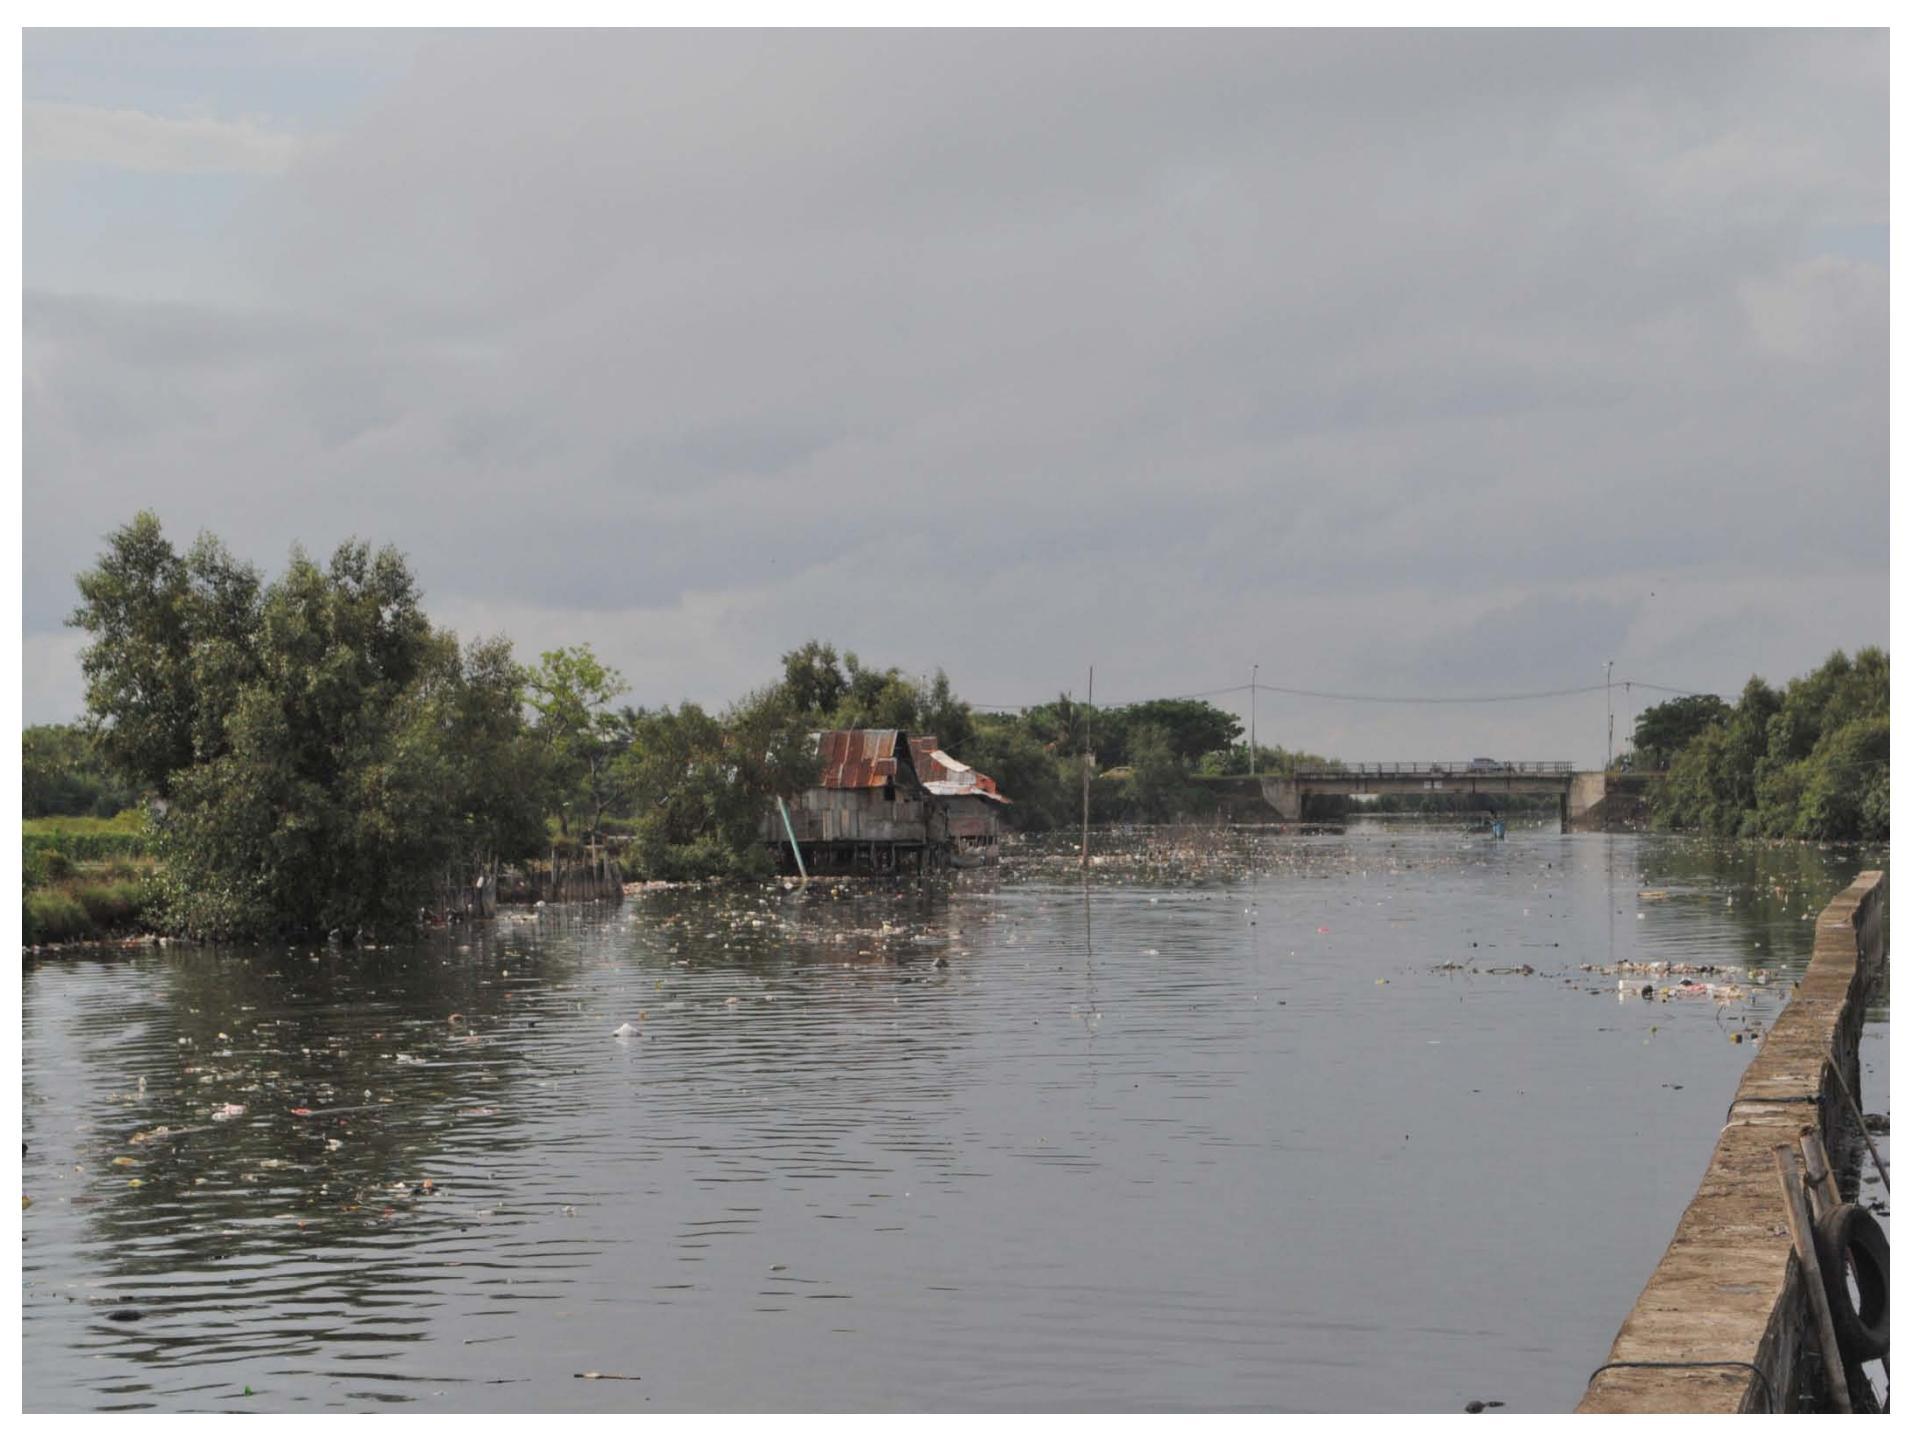
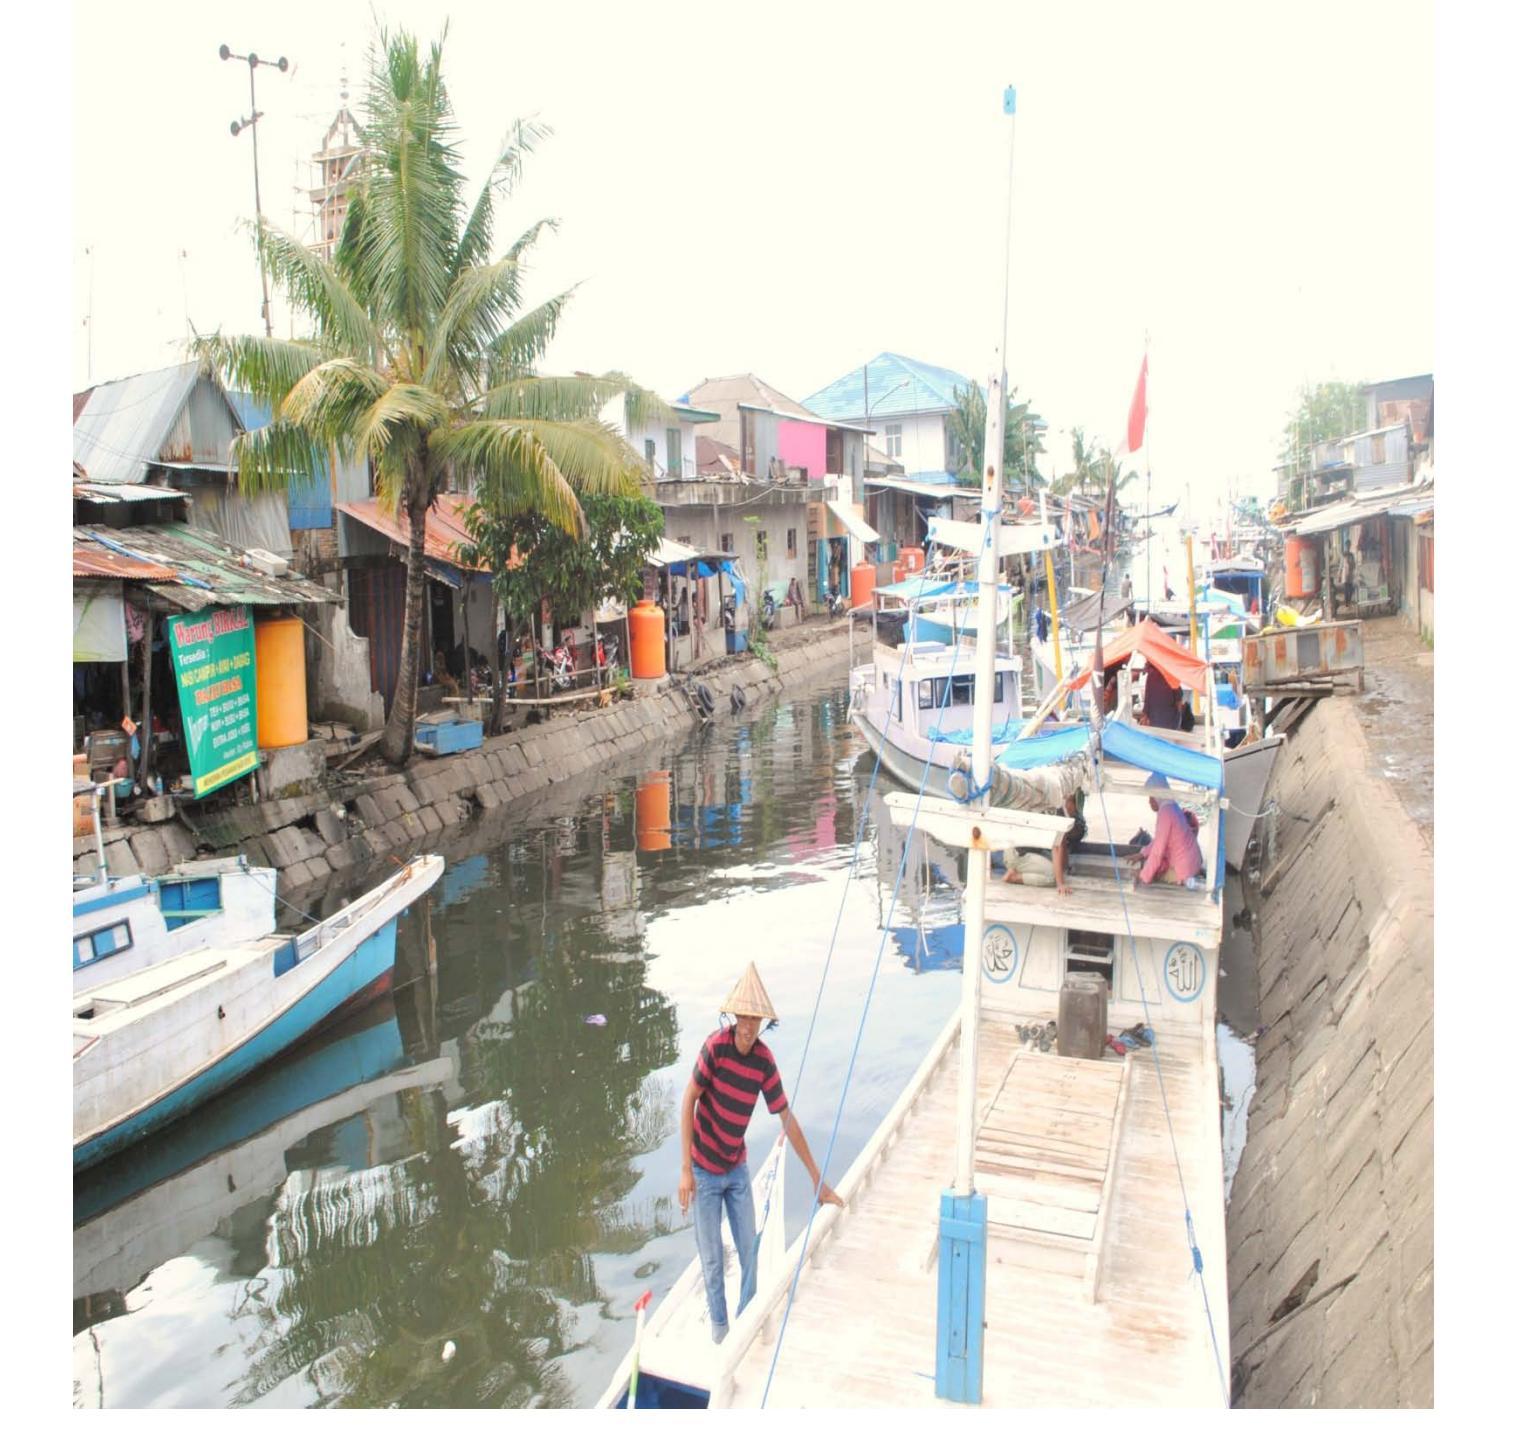
Building ruins may decrease river channel capacity for accomodating flood water
