Water Related Disaster/Risk Management in Sri Lanka

By Sudharma Elakanda, Mahaweli Authority of Sri Lanka

2nd Thematic Workshop on Water-Related Disaster & Its Management in Asian Countries

6th -10th October 2008, Manila, Philippines

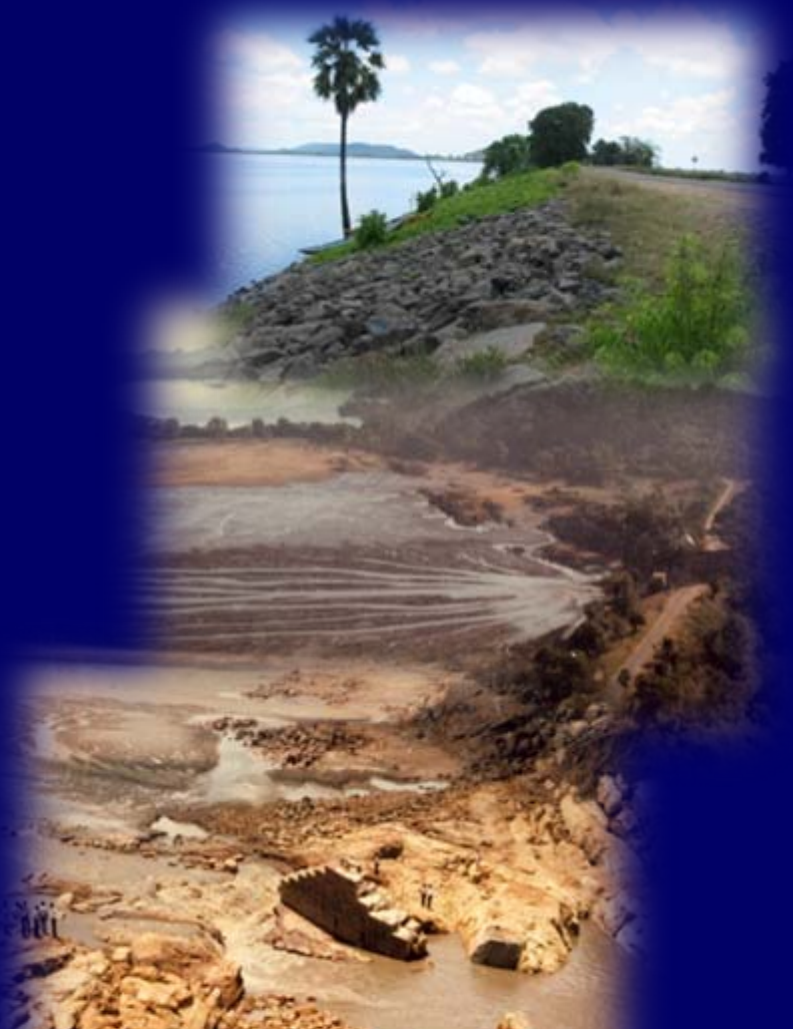
1. The Kantale tank bund breached in 1986 resulting in a massive dam disaster;

- killing 127 people,
- affecting 10864 residents,
- destroying 1200 houses and substantially damaging agriculture,
- commercial and public infrastructure sector.

The cost to the Government's relief, rehabilitation, and re-housing expenditures for the affected downstream residents was about three times the cost of all the rebuilding the breached section (Rs186 M).

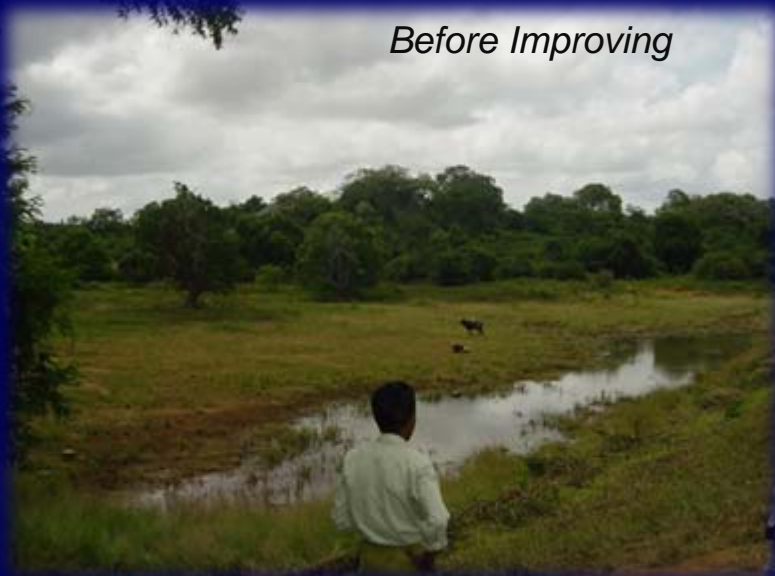
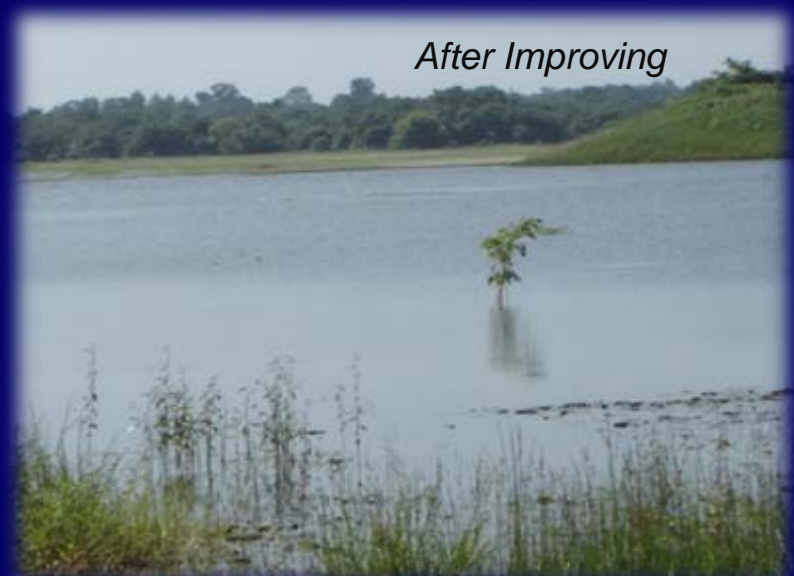
1. Small tank & irrigation system improvement - Cascade Based development (Mahagalkadawala Cascade)

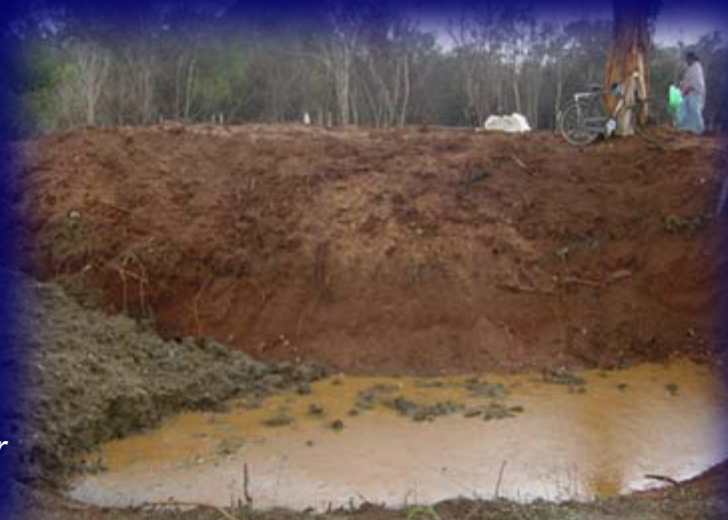
"Pathaha" Construction

2. Rainwater Harvesting & Homestead Development

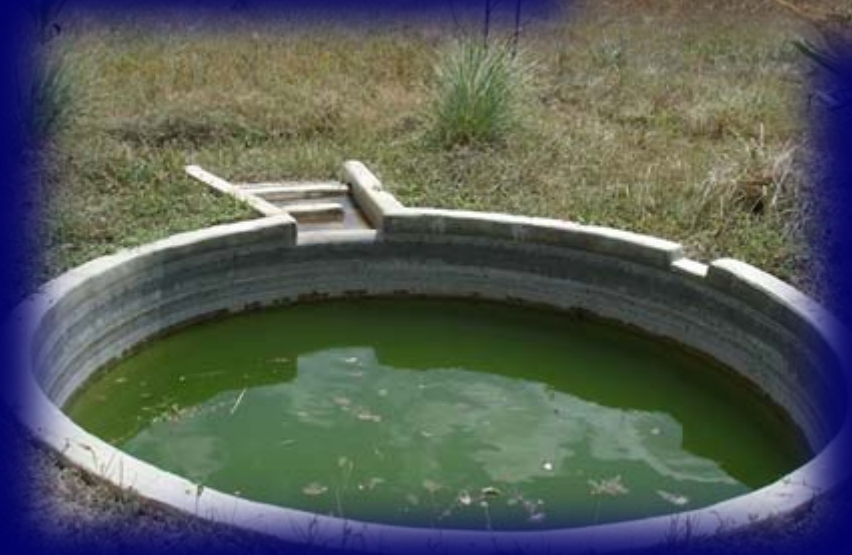
Pond Construction for Agriculture

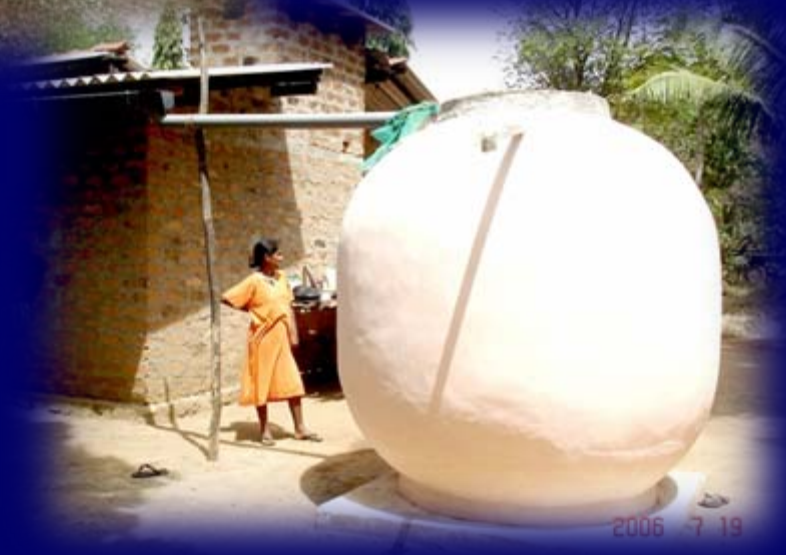
Ferro Cement Tank For Drinking Water

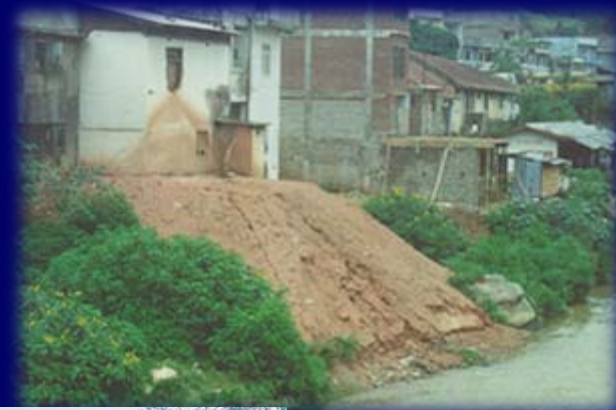
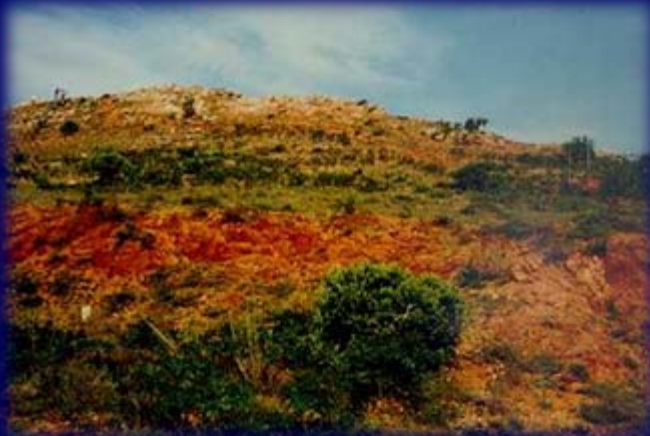
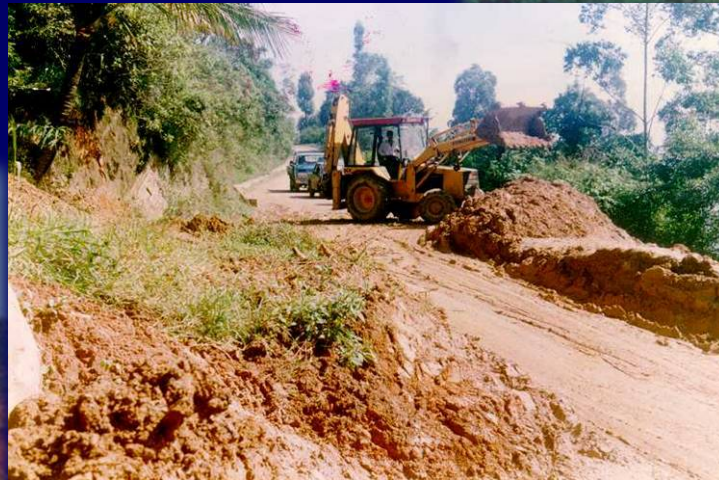
Landslides in Upper Mahaweli Catchment

- Vegetable Cultivation on steep slope
- Deforestation
- Home development on steep slope due to increase Population density
- Infrastructure development

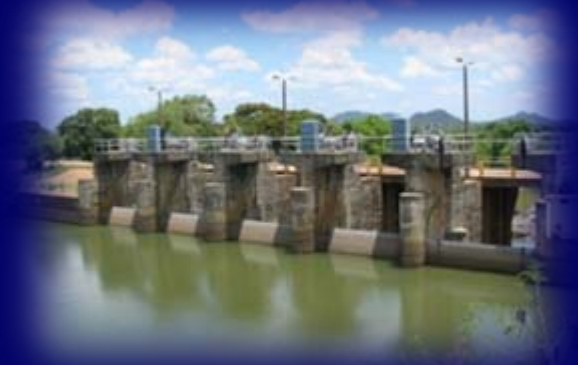
Multiple signs of Aging Over 350 Large/Medium Dams, Headworks and Trans-Basin Canals of the country are now visible and they are suffering from various structural deficiencies and shortcomings in operation and monitoring of such facilities which affect largely on Public Safety.

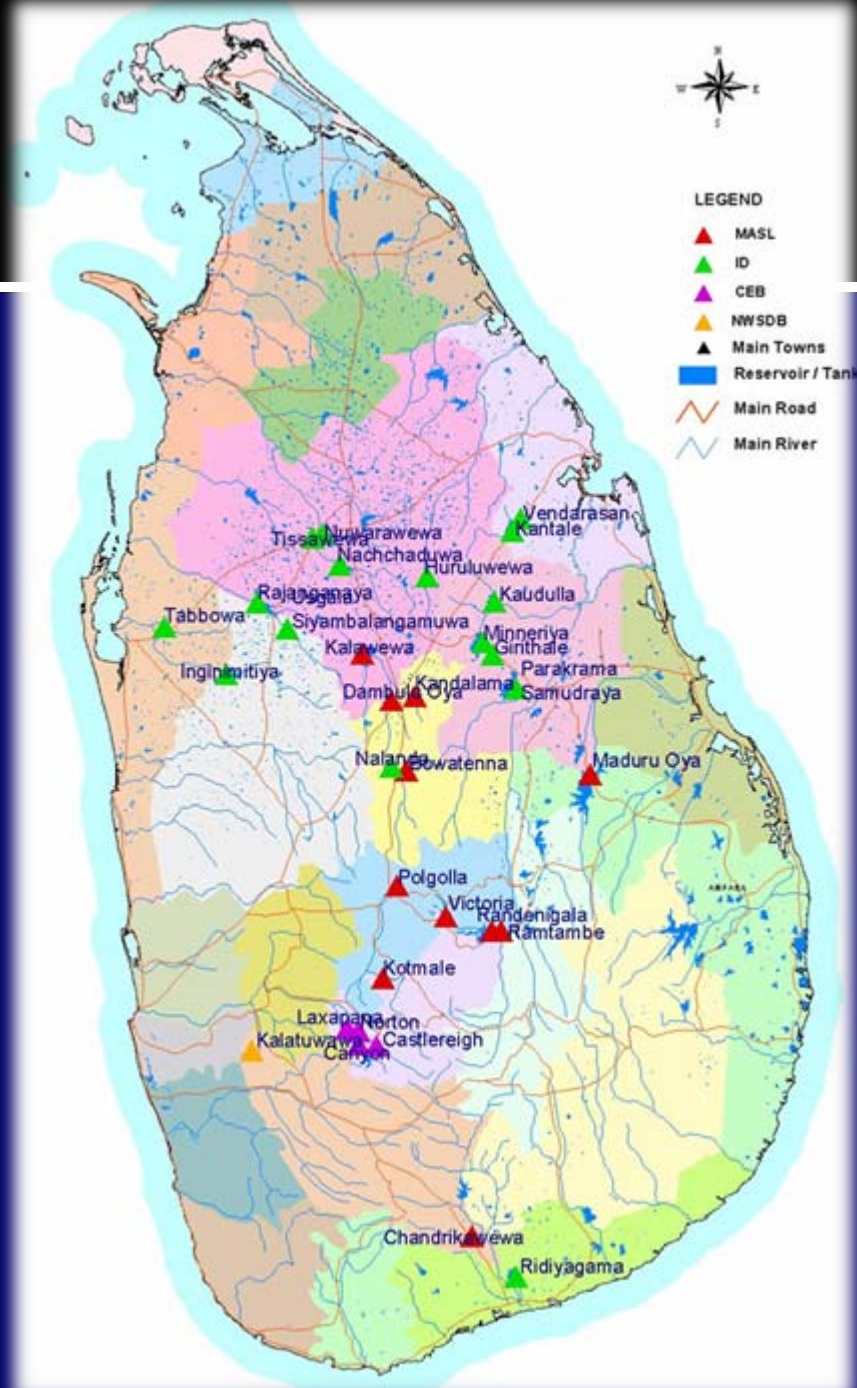
Locations of 32 High Risk Dams

Dams under Mahaweli Authority - 11

Dams under Ceylon Electricity Board - 04

Dams under Irrigation Department - 16

Dams under Water Supply & Drainage Board - 01
