# **The Nagaragawa Estuary Barrage**

**Japan Water Agency**

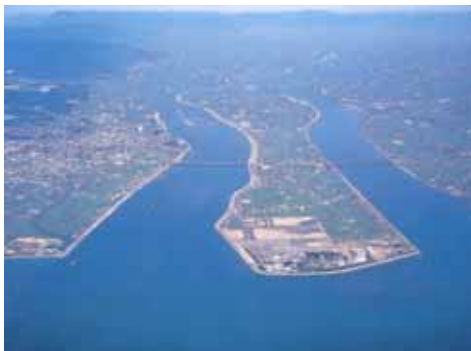
(Fig.1-2)

The area along the lower reaches of "the Kiso three rivers"(Fig.1-2:the Kiso, the Nagara, the Ibi) facing Ise Bay have long been invaded by saltwater, and the residents have suffered from salt damage (by salinization) of both river water and ground water used as domestic and agricultural water supplies, and of soils on farmlands. While, to make up for water invaded by saltwater, very large amounts of ground water was drawn. As a result, The ground subsidence caused by drawing ground water led to saltwater intrusion further upstream and to aggravating the salt damage.(Fig.1-3)

The area, which is located in the estuary area of the river Nagara, is called “Waju” (Fig.1-2). Waju is a communal society bounded by a bank (the ringed bank), built to enclose a community and its cultivated land entirely for the purpose of protecting them from floods. The bank was built by the residents themselves, so the history of the development of Waju is a history about how these communities fought the ever-present threat of floods. In the upstream of Nagara River, there are not many suitable areas for dam construction. For this reason, water volume has to be controlled only by the capacity of river flow. The basic plan for the Kiso River Water System Project involves the adjustment of peak discharge of 8,000m<sup>3</sup>/s (with 500m<sup>3</sup>/s controlled by upstream dams, only 7,500m<sup>3</sup>/s) to flow down safely to the river. River improvement is now in progress based on this plan. To allow flood volumes of 7,500m<sup>3</sup>/s to flow down safely, it is necessary to increase the cross-sectional area of the river.

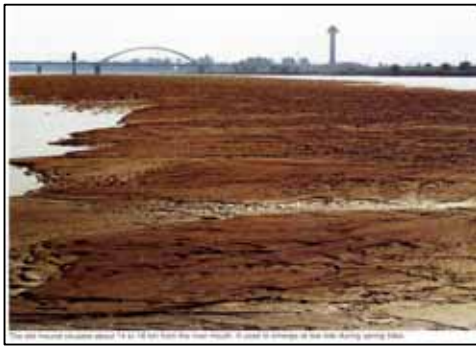
(Fig.1-4)

Before the construction of the barrage and dredging work in the Nagara River, if the flow rate of the river decreased, the reverse flow of the seawater into the river were held back by a relatively high section of the bed known as "mound"(Fig.1-4), which was located about 14 to 18km upstream from the river estuary. But if dredging is carried out for flood control, Saltwater is expected to intrude further upstream about 30km from the river estuary. With Nagaragawa Estuary Barrage serving as a barrier, therefore, it was expected to prevent from salt damage and proceed dredging operations freely (Fig.1-5).

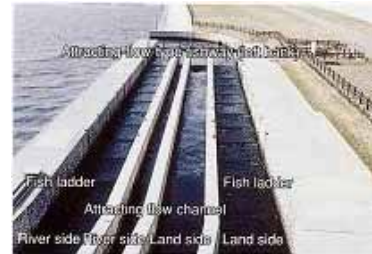
(Fig.3-1-4)

① Attracting-flow-type Fishway (Fig.3-1-4~5)

The attracting-flow-type fishway consists of attracting flow channels in the center and stair fishways (fish ladder) on both sides. Fish are attracted by the flowing water from the attracting flow channels, and travel upstream via the fish ladders.

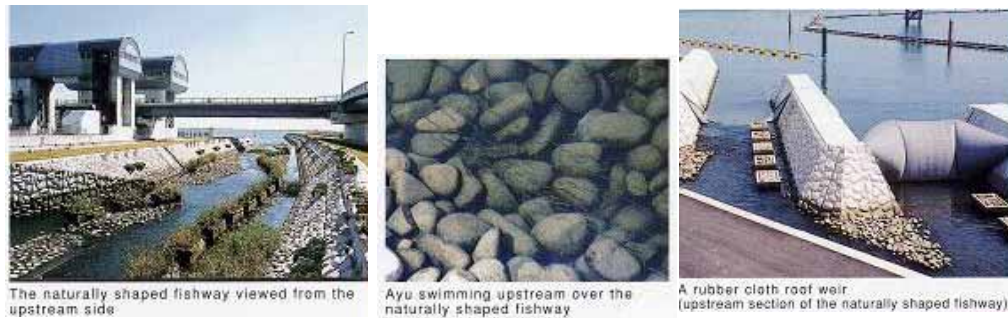
(Fig.3-1-7)

### ③ Naturally Shaped Fishway(Fig.3-1-7)

The naturally shaped fishway is about 320m long and 15m wide (including a water surface of 3m in width) provided on the overflow bank on the right bank of the estuary barrage. The fishway resembling a natural stream was created to allow a wide range of fish to travel upstream. The fishway is given a gentle slope, and cobblestones and other natural stones are placed in it. At the exit (upstream end) of the naturally shaped fishway, four roof weirs made of rubber cloth were provided to deal with a change in the water level on the upstream side.

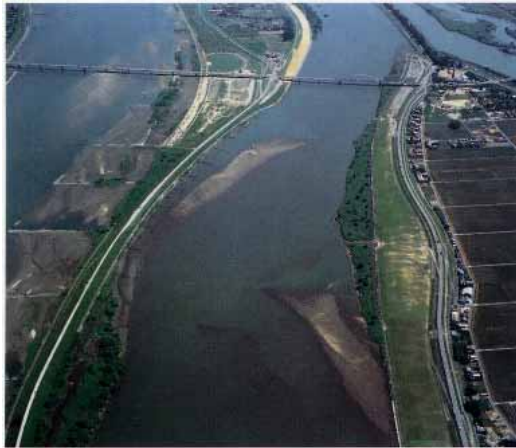
(Fig.3-4-1)

The mound section of the Nagara before dredging

As the reason mentioned in Background, Dredging in the mound section of the river began on the day after the operation of the estuary barrage went into operation (Fig.3-4-1:July 6,1995) and was completed in July 1997.(Fig.3-4-2)

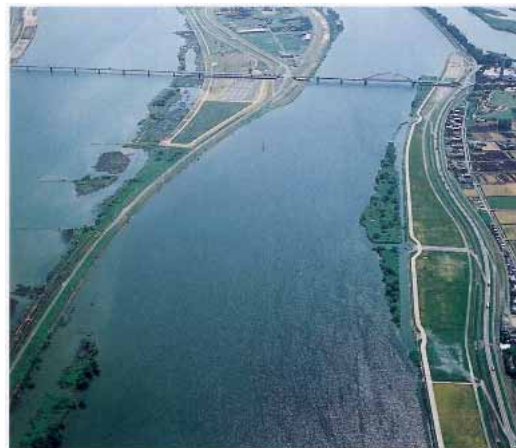
(Fig.3-4-2)

The mound section after dredging (photographed in September 2000)

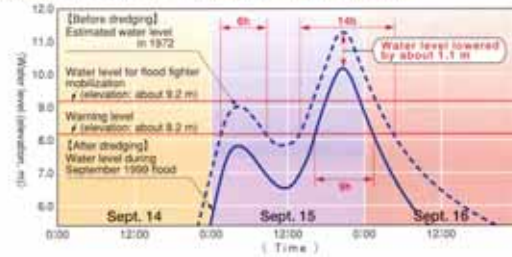
(Fig.4-2)

Comparison of flood stage durations before and after dredging

The flood flow caused by the front and Typhoon No.16 of September 14 and 15, 1999, reached a maximum discharge of about  $5,900\text{m}^3/\text{s}$  (estimate) at Sunomata point (39.2km from the river mouth). Though this was the maximum discharge that had occurred since the barrage went into operation, it is estimated that water level was lower than before dredging by about 1.1m (Fig.4-1), and the period of time during which the river water level at Sunomata point stayed above the warning stage was reduced from 20 hours before dredging to 9 hours after dredging.(Fig.4-2)
