Bawakaraeng Urgent Sediment Control Project (The Most Urgent Components)

August 2005

Bawakaraeng
Urgent Sediment Control Project

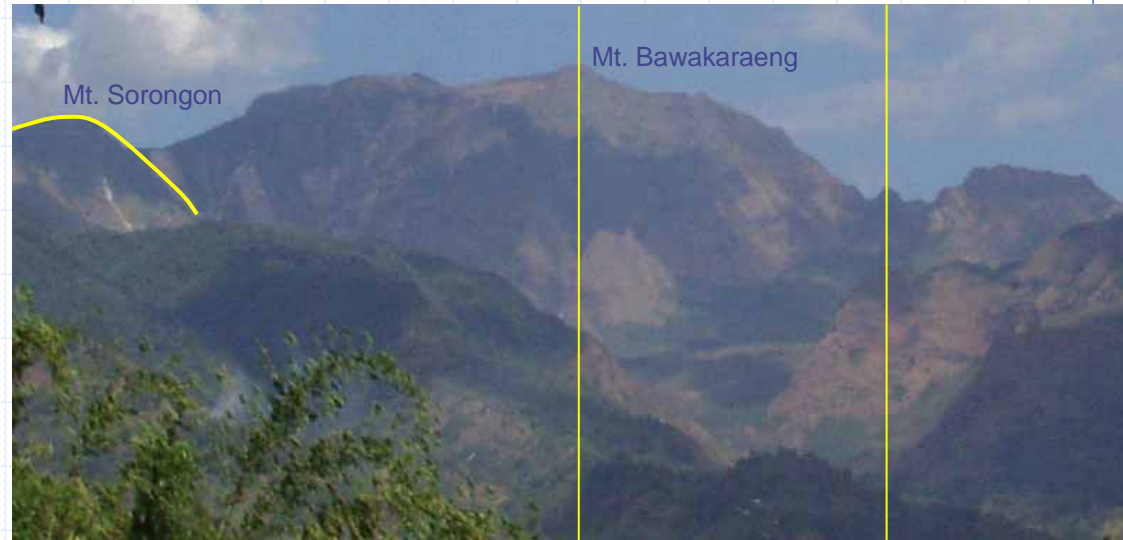
Before the Collapse
As of July 2002

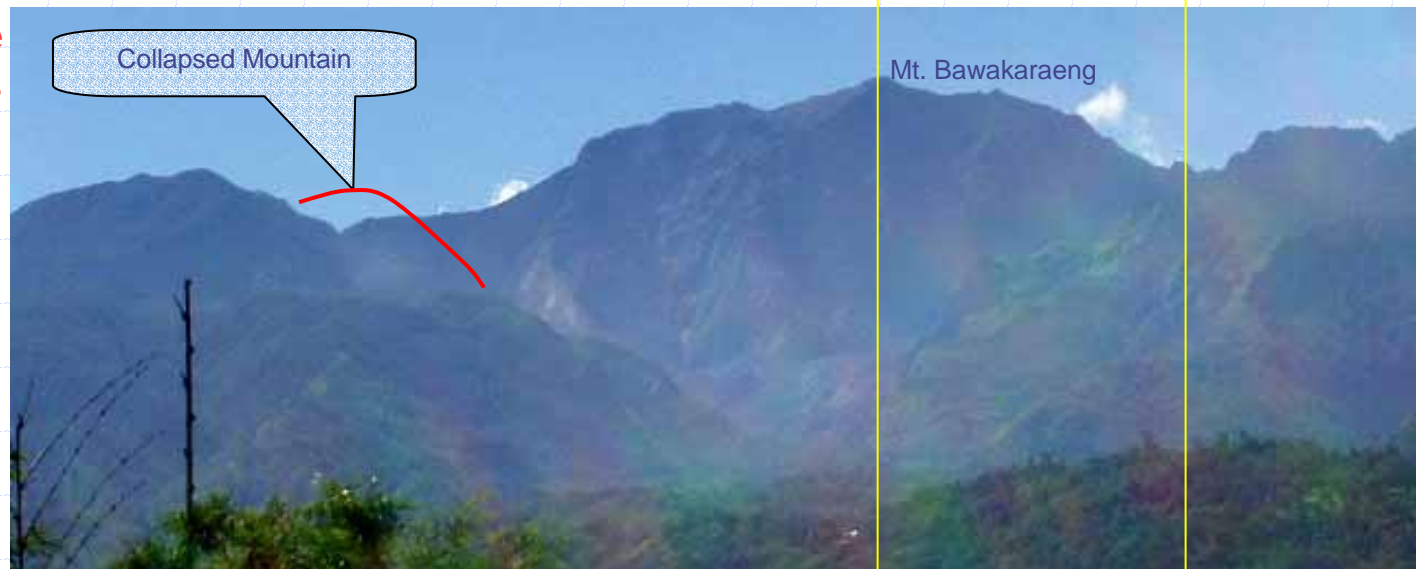
After the Collapse
As of March 2004

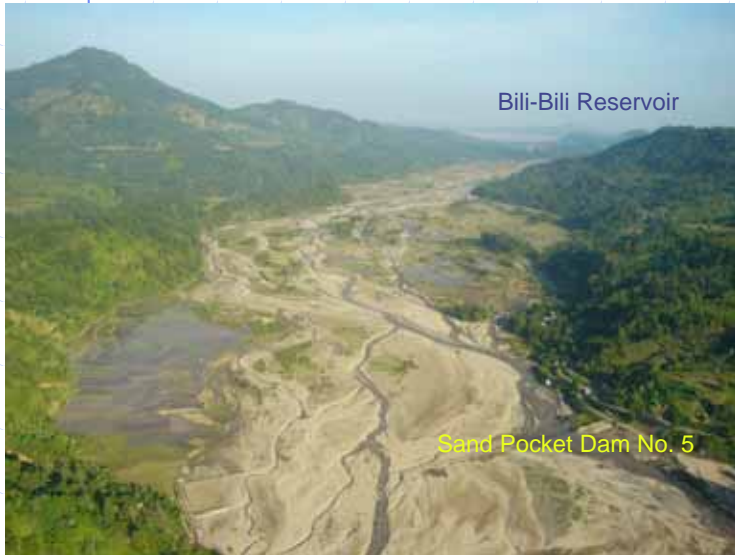
Jeneberang River Channel

Paddy fields along the river were buried. The damage expands day by day.

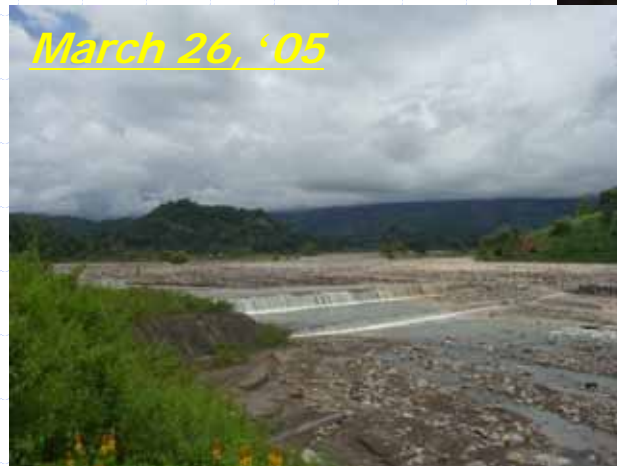
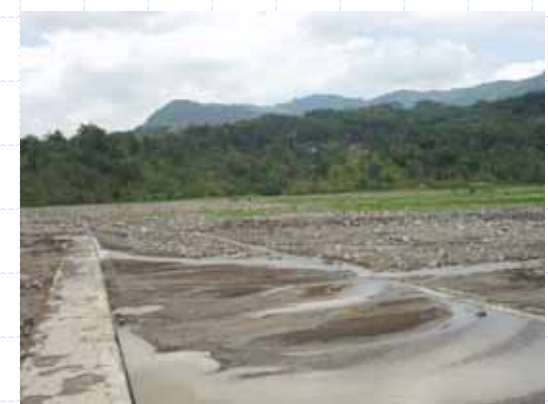
The left abutment of SP No. 5 was completely buried by debris.

At the downstream of SP No.5, village people start cultivating.

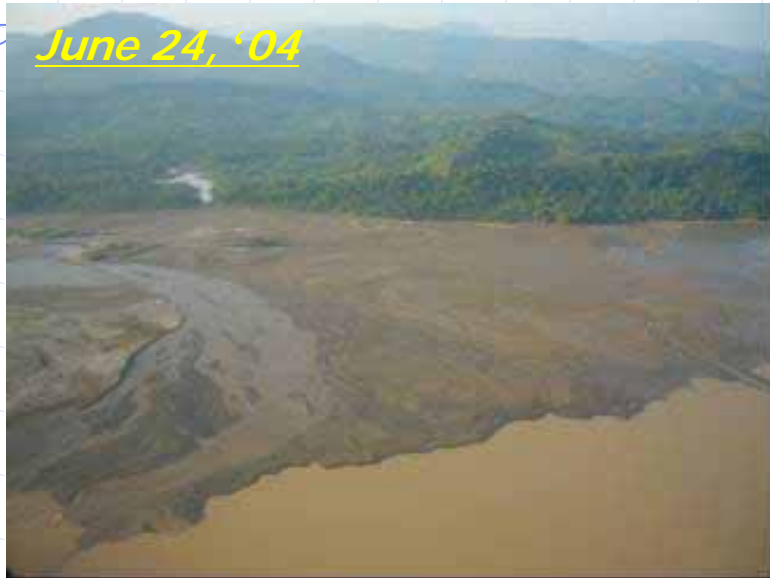
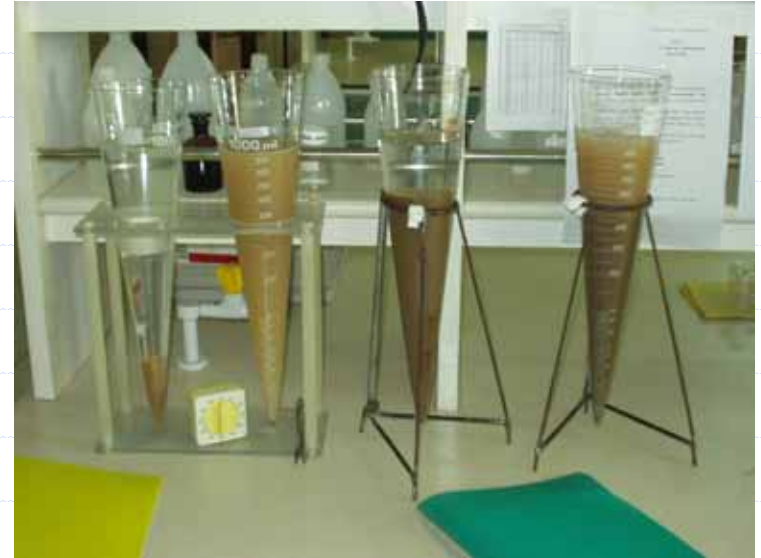
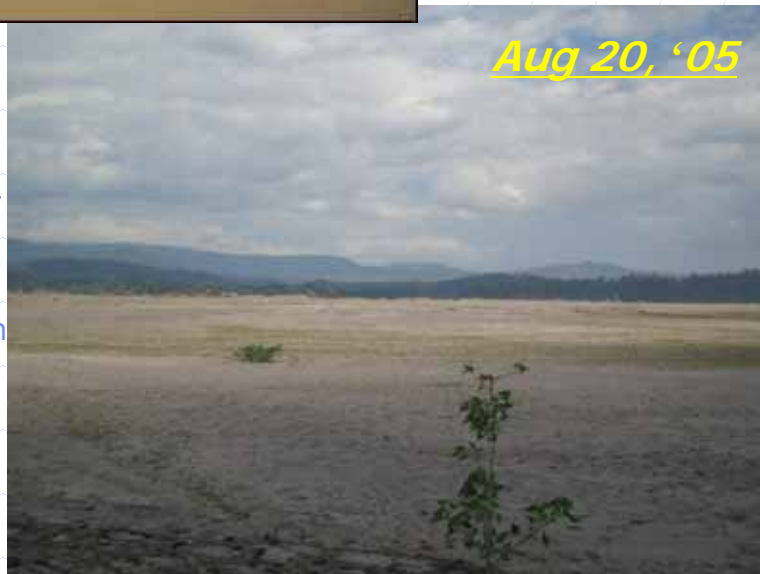
Damages – Sedimentation of Bili-Bili Dam

Sedimentation at
Upstream of the
Bili-Bili Reservoir
at present, the sediment
volume is estimated at
10mil m³ while the design
sediment volume is set at
29mil. m³.

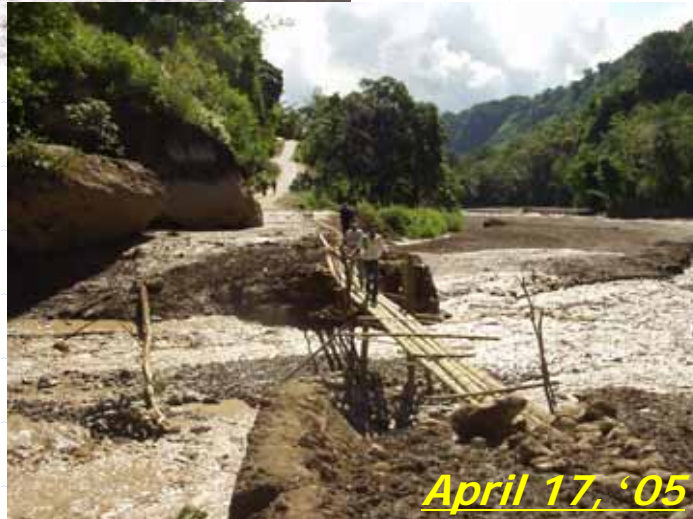
Daraha Bridge was flushed out by debris flow on 14 April 2005. Trans 13,000 village People has been affected.

Daraha Bridge
Flashed away
on April 17, '05

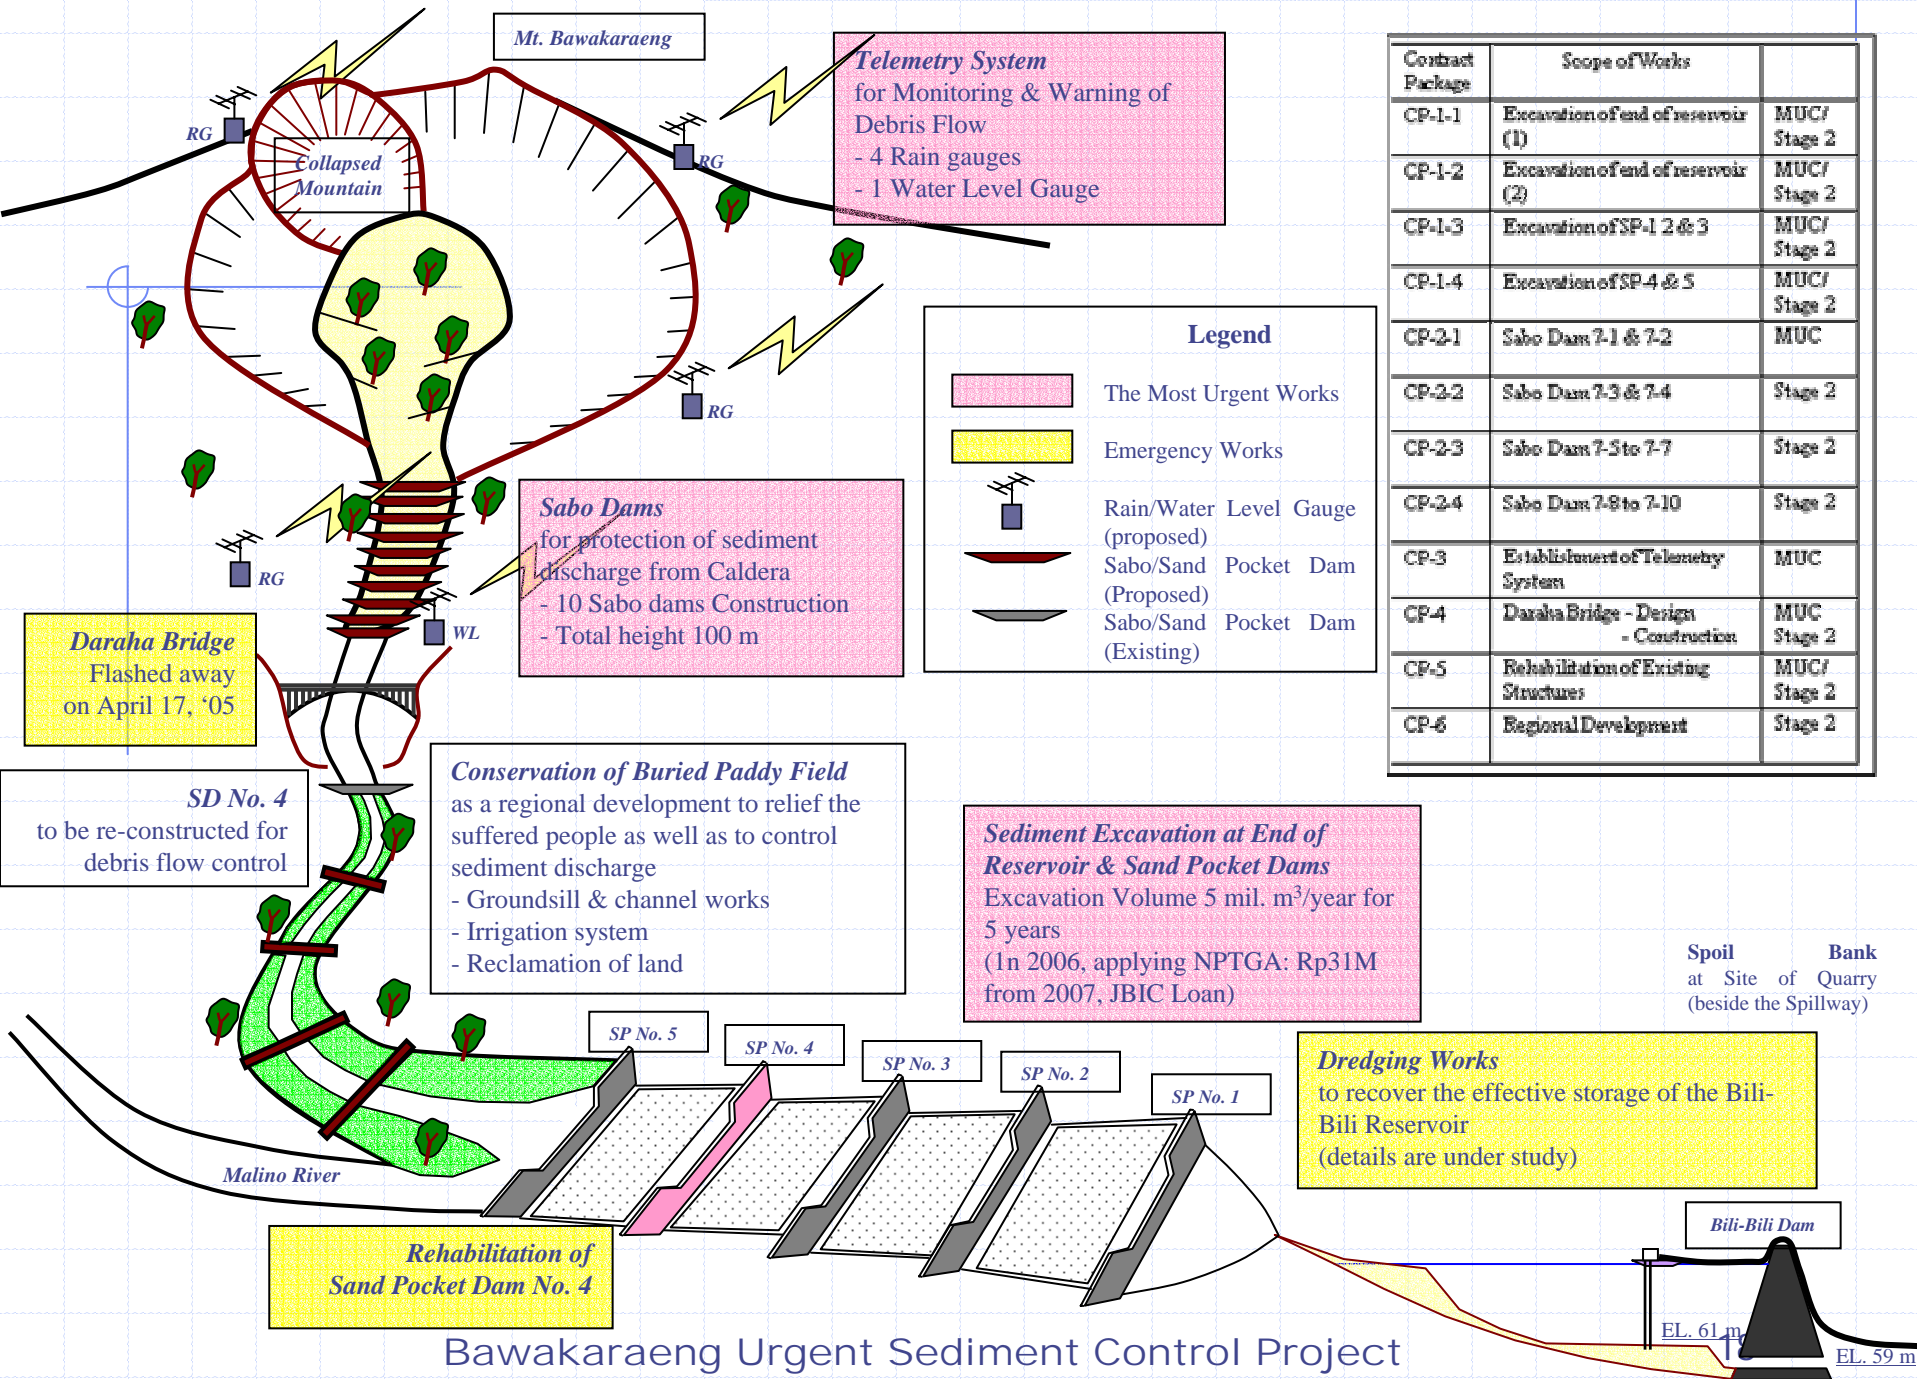
General Map of the Project

Telemetry System
for Monitoring & Warning of
Debris Flow
- 4 Rain gauges
- 1 Water Level Gauge

Sabo Dams
for protection of sediment
discharge from Caldera
- 10 Sabo dams Construction
- Total height 100 m

Conservation of Buried Paddy Field
as a regional development to relief the
suffered people as well as to control
sediment discharge
- Groundsill & channel works
- Irrigation system
- Reclamation of land

Sediment Excavation at End of Reservoir & Sand Pocket Dams
Excavation Volume 5 mil. m³/year for 5 years
(In 2006, applying NPTGA: Rp31M from 2007, JBIC Loan)

SD No. 4
to be re-constructed for
debris flow control

Dredging Works
to recover the effective storage of the Bili-Bili Reservoir
(details are under study)

Spoil Bank at Site of Quarry (beside the Spillway)

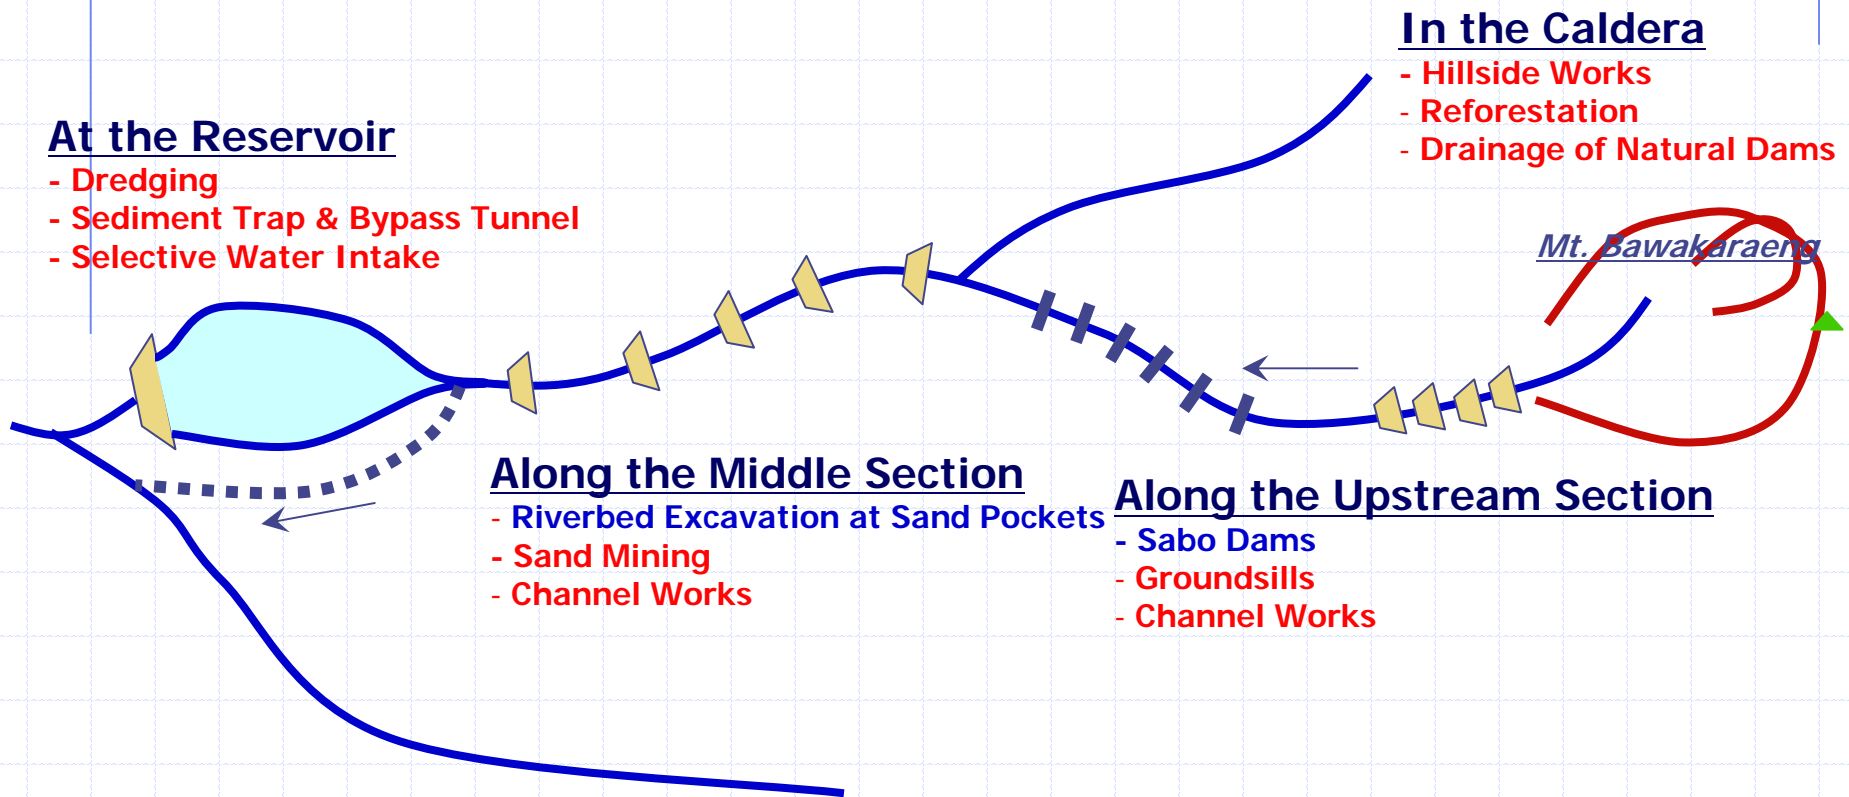
Proposed Additional Sediment Control Measures

- ◆ Works should be conducted immediately
 - Design of Daraha Bridge.
 - Rehabilitation of Sand Pocket Dam No. 4.
 - Sediment Flashing for Bili-Bili Dam.
- ◆ Works to be conducted in Stage II
 - Succeeding works of MUC
 - Construction of Daraha Bridge
 - Regional Development
- ◆ Works to be conducted in future
 - Reservoir Sedimentation Control Measures.
 - Surface Water Intake System.
 - Watershed Management Plan of the JRB.
