KEY POINTS RELATED TO WATER RESOURCE MANAGEMENT IN VIETNAM

*By M.E. Le Van Hoc
Deputy Director of Institute of Water Resources Planning*

Historic large-scale hydraulic works in Vietnam

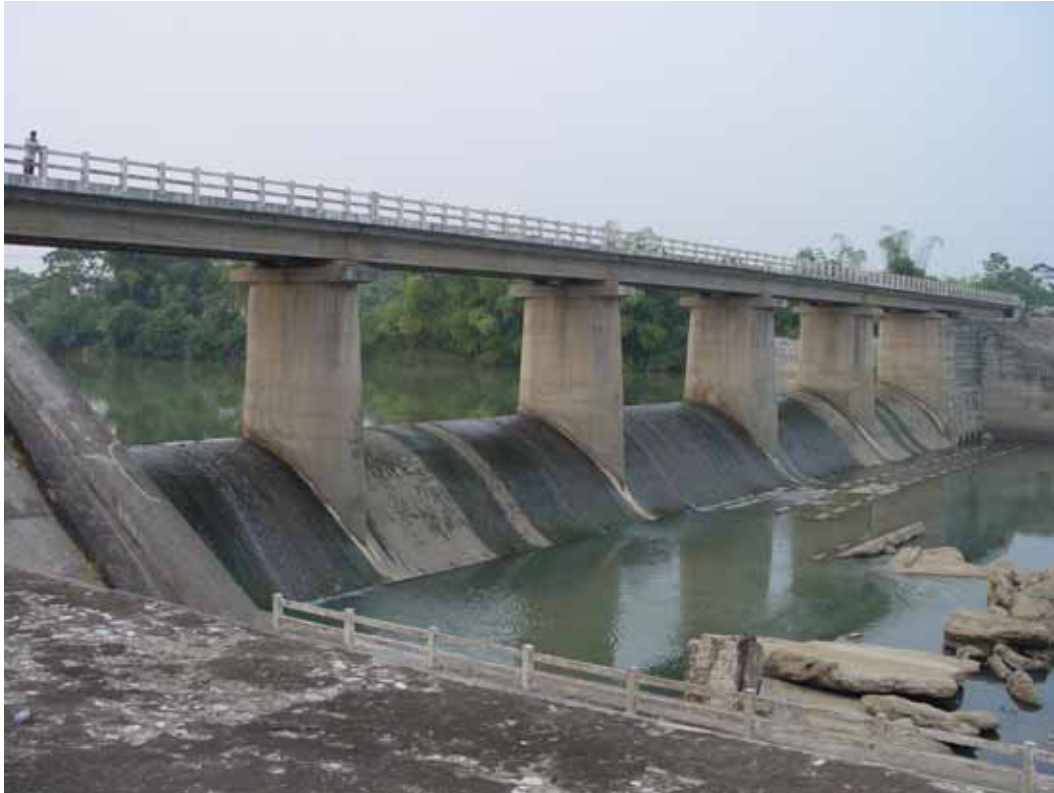
a. Thac Huong scheme

- 2 large dams (Thac Huong, Da Gan)
 - 40 side spillways.
 - 19 head intakes
 - 49 regulators
 - 27 siphons
 - 2 in-drainage sluices
 - 37 concrete bridges
 - 292 submerge sluices
 - 12 ship locks
 - 416 centipede-foot-shaped culverts
- + *Thac Huong dam:*
100m long with 5 compartments
Crest height = 6,5 m.
 ∇ dam crest = 21,13m.
Q designed for spillway = 2580 m³/s.
Sand sluice culvert on the right with 4 gates x 1,1 m x 1,6 m.
- + *Da Gan dam:*
To stop Van Gia stream to divert water into the system.
36m long with 3 compartments
Crest height = 8 m.
 ∇ dam crest = 21,5m.
Q designed for spillway = 1300 m³/s.
Sand flux sluice culvert on the left 1,1 m x 1,65 m.
- + *10 gate sluice:*

constructed in July 1926. To take water in and control flood with 10 gates having dimension of 1,3 x 2,3 m.

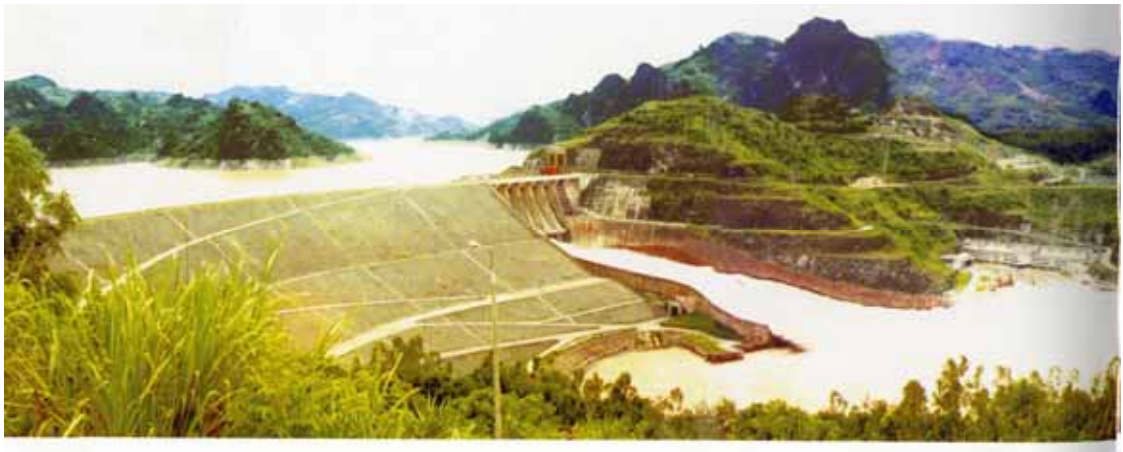
b. Hoa Binh hydropower plant

- Form : mix earth and stone dam
- Height of dam : 128 m
- Length of dam crest : 743 m

- Form : Concrete dam
- Bottom outtake : 12 gates, dimension 10 x 6 m, sill at elevation of 56m. operated by hydraulic shifting structure.
- Face outlet : 6 gates, dimension 15 x 15 m sill at elevation of 102m, upper face at elevation of 117m, operated by goat foot crane (2 x 125 ton).
- Maximum discharge: 35,400 m³/s.

- the hydropower plant is located deep in the mountain. Length: 260m, width: 20m and height: 50m.
- Number of machine units : 8
Turbine style PO 115/810-B-567,2
Capacity 245 MW
Calculated water head 88 m
Minimum water head 60 m
Maximum waterhead 109 m
Discharge when the water head and regulated capacity is 305 m³/s
