# Headworks Division of Mahaweli Authority

## Victoria Dam Sri Lanka

Eng.S.R.K.Aruppola

November 2014

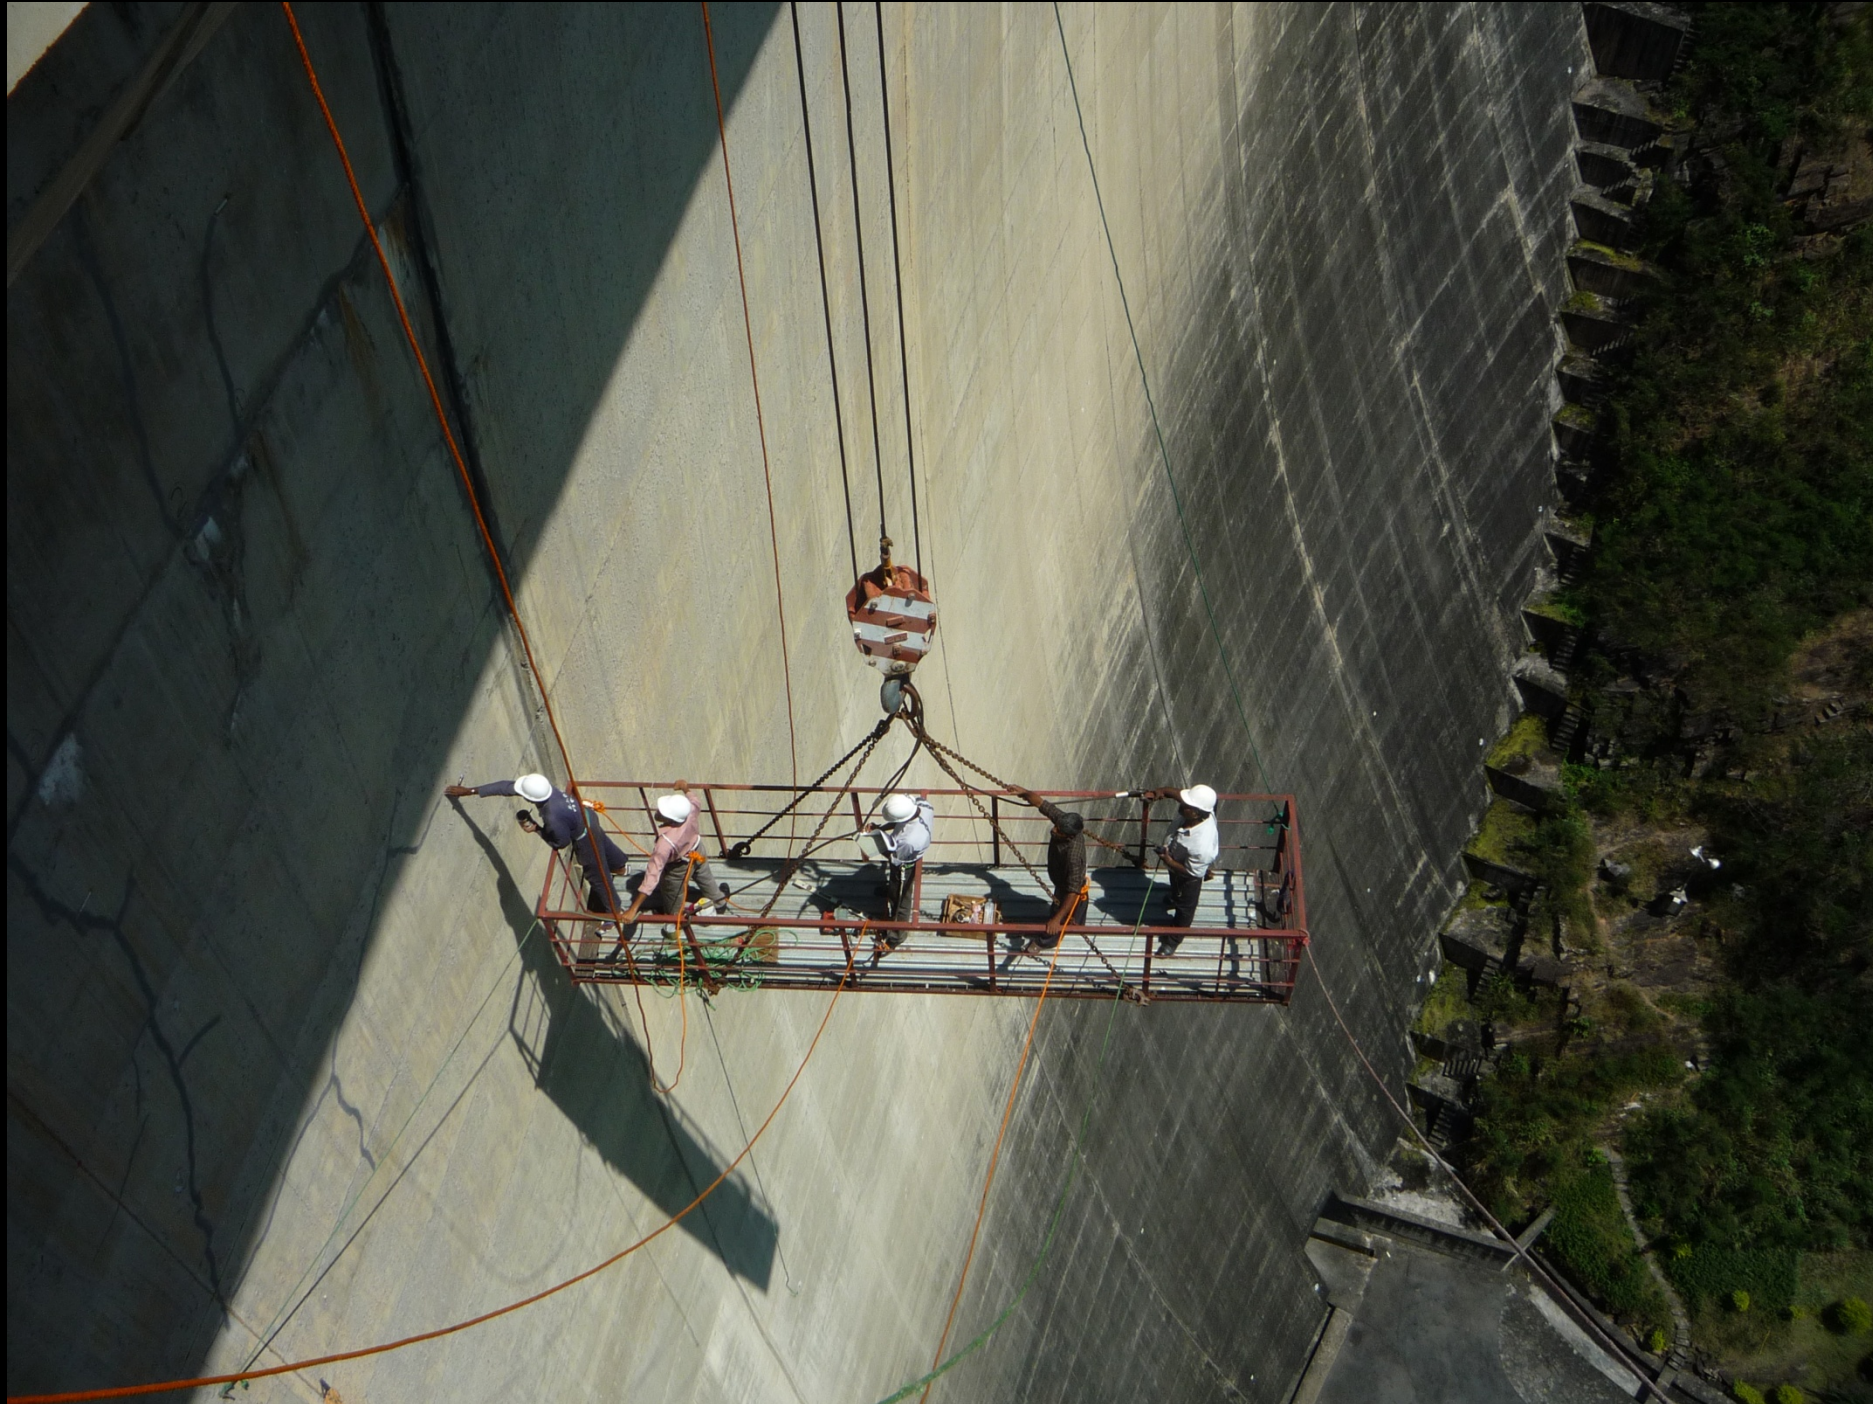
# Increasing of main crack (Block 9) with time (Identified in 1996 and monitored since 2002)
