RAPID FLOOD MANAGEMENT ASSESSMENT

**Lesson Learn and Future Direction for Water Policy:
Structure and non-structure flood prevention**

River and Canal Dredging

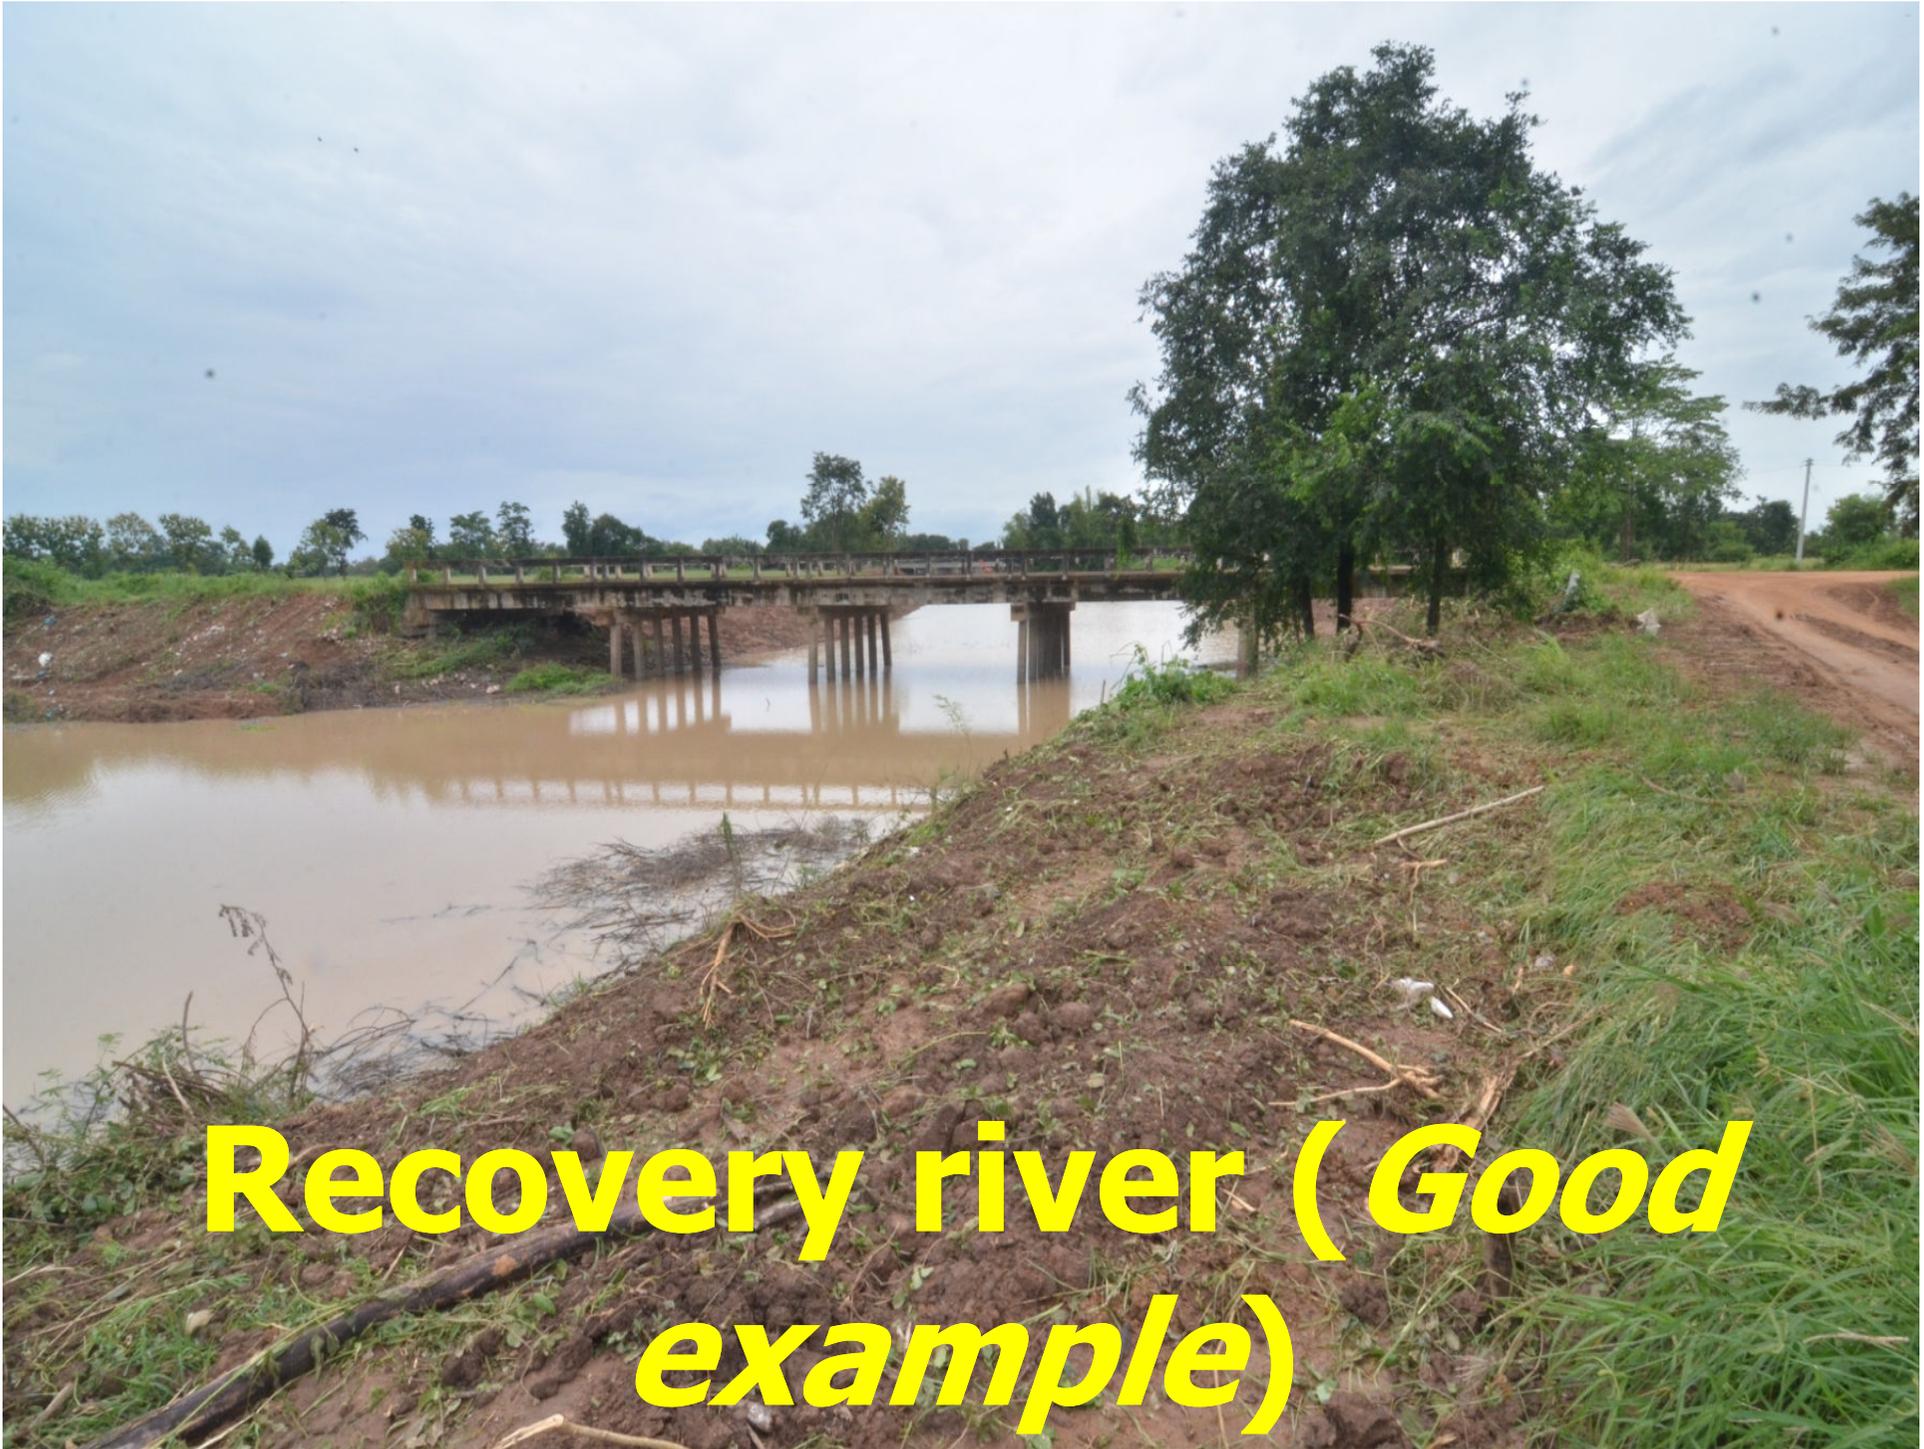
Recovery river (*Good example*)

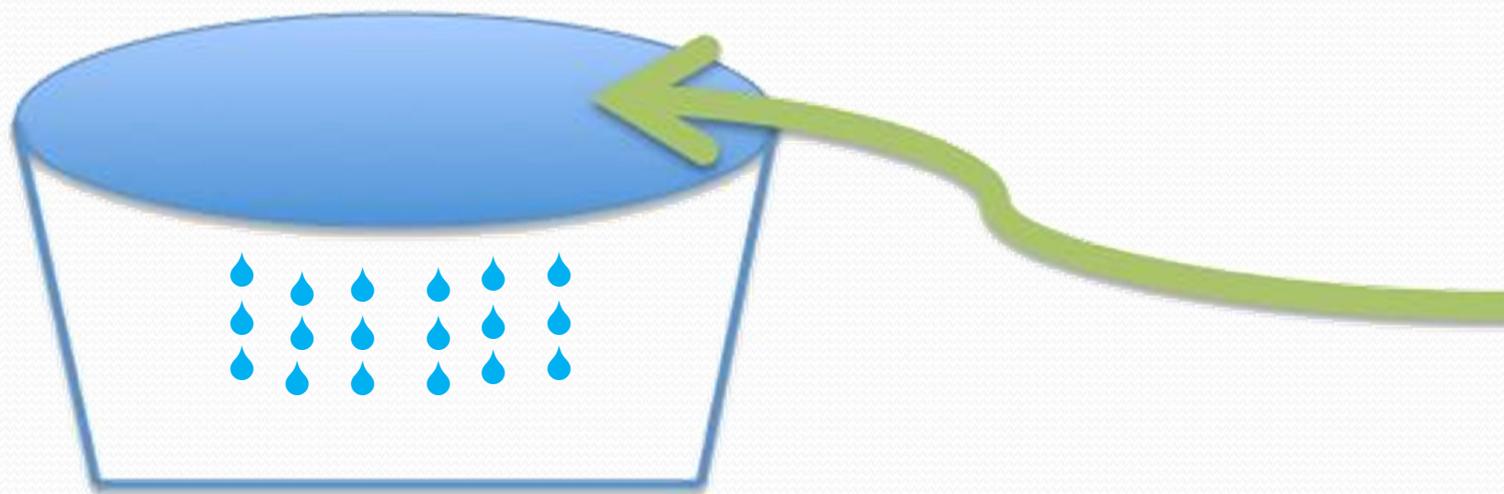
มีทางน้ำเข้าอย่างเดียว
ไม่มีทางระบายน้ำออก จึง
มีโอกาส
น้ำล้นอ่างในที่สุด สร้าง
ความเสียหายให้พื้นที่รอบ

**Inflow
Pond
Type**

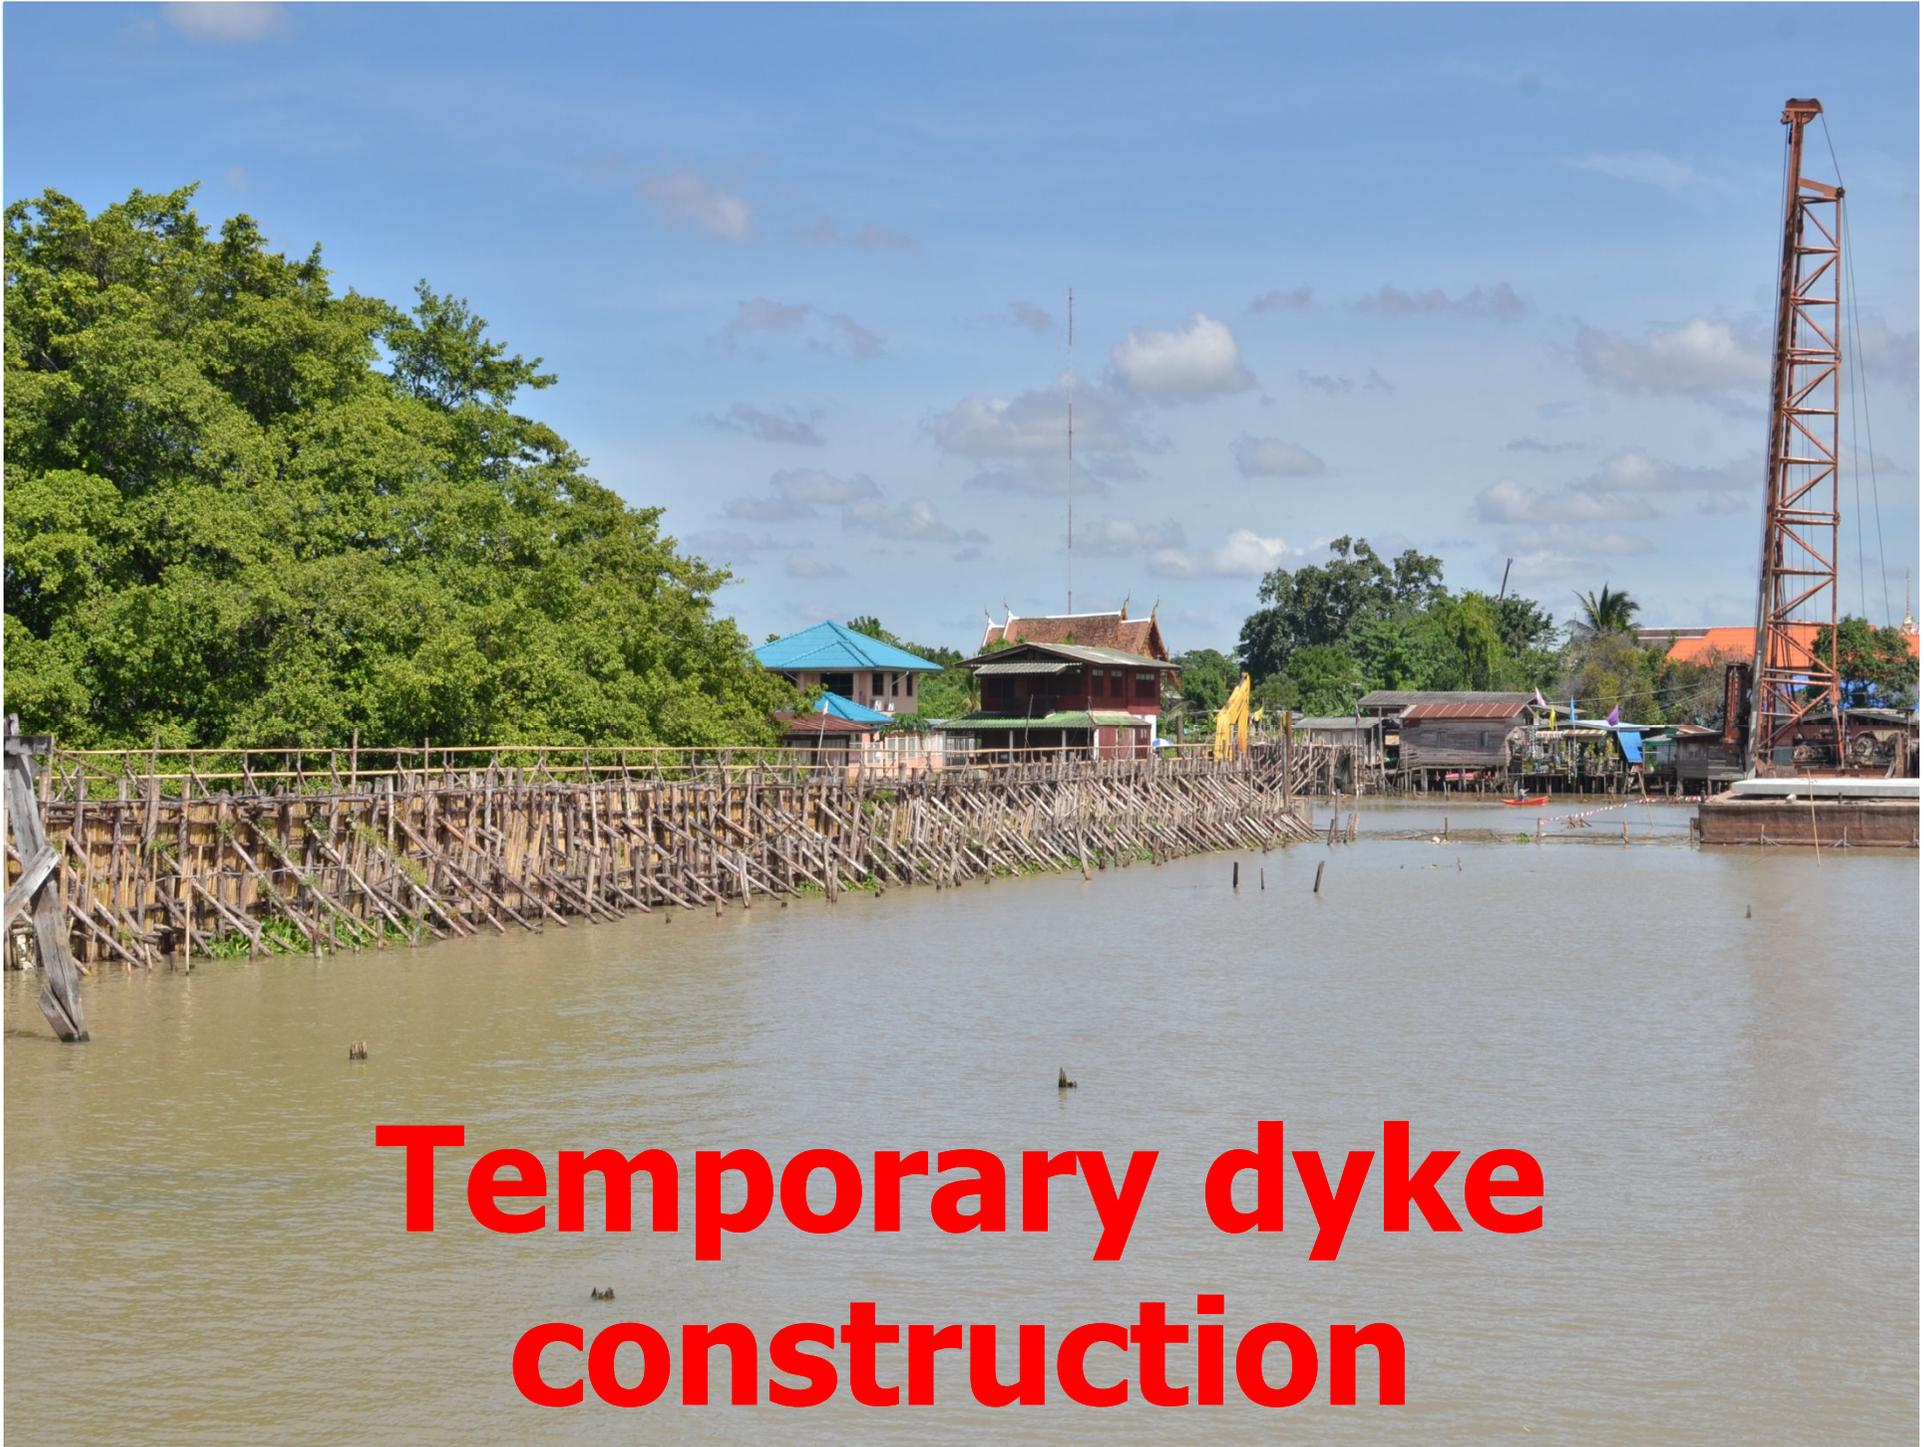
**Temporary dyke
construction**

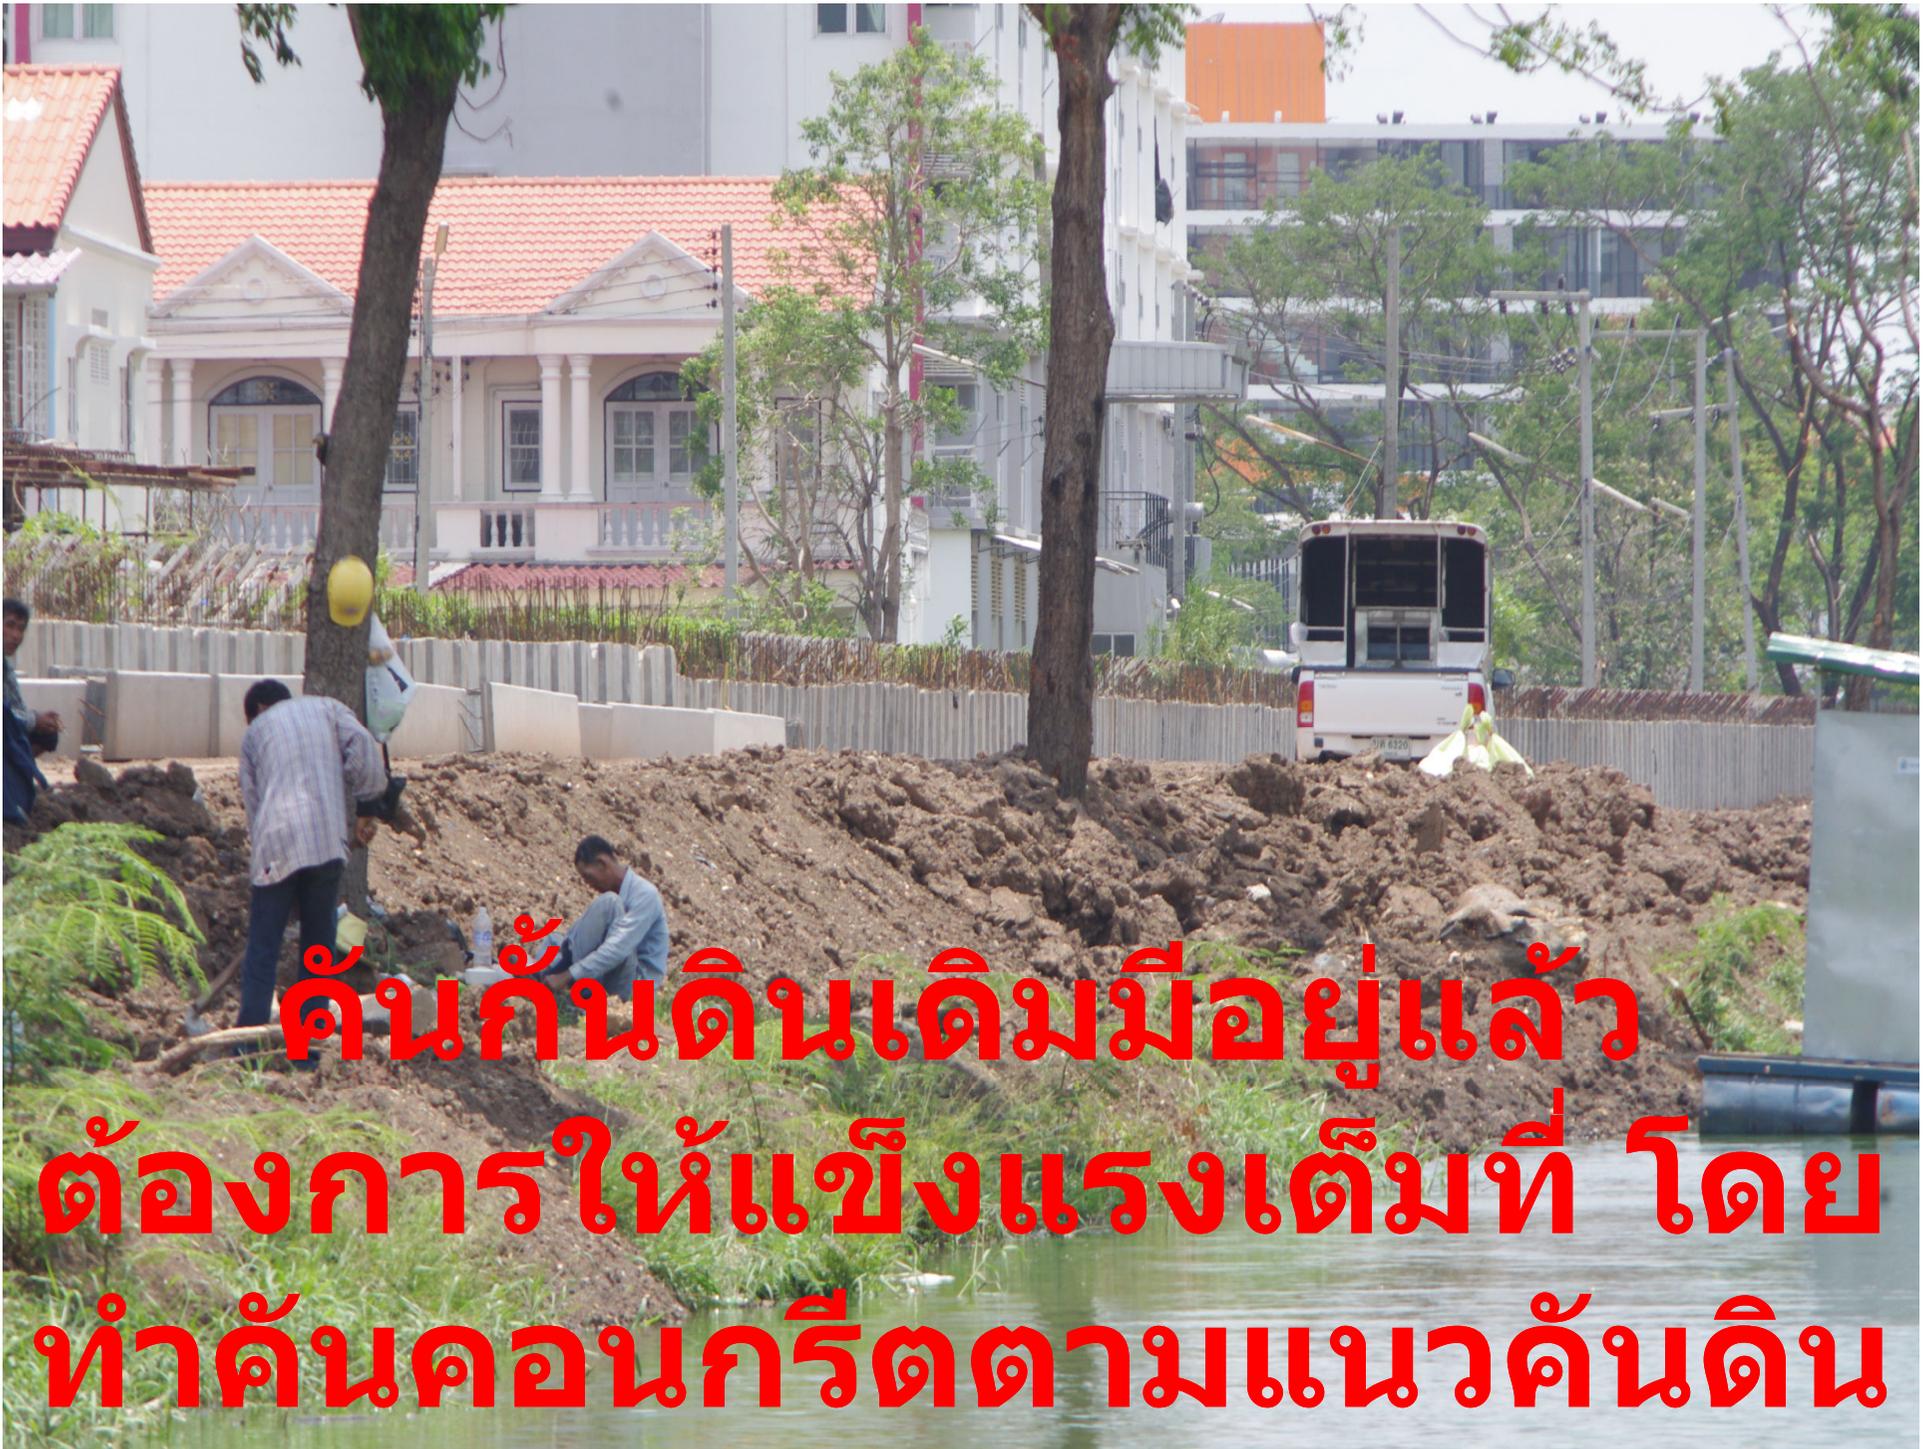
**คั่นกันดินเดิมมีอยู่แล้ว
ต้องการให้แข็งแรงเต็มที่ โดย
ทำคั่นคอนกรีตตามแนวคั่นดิน**

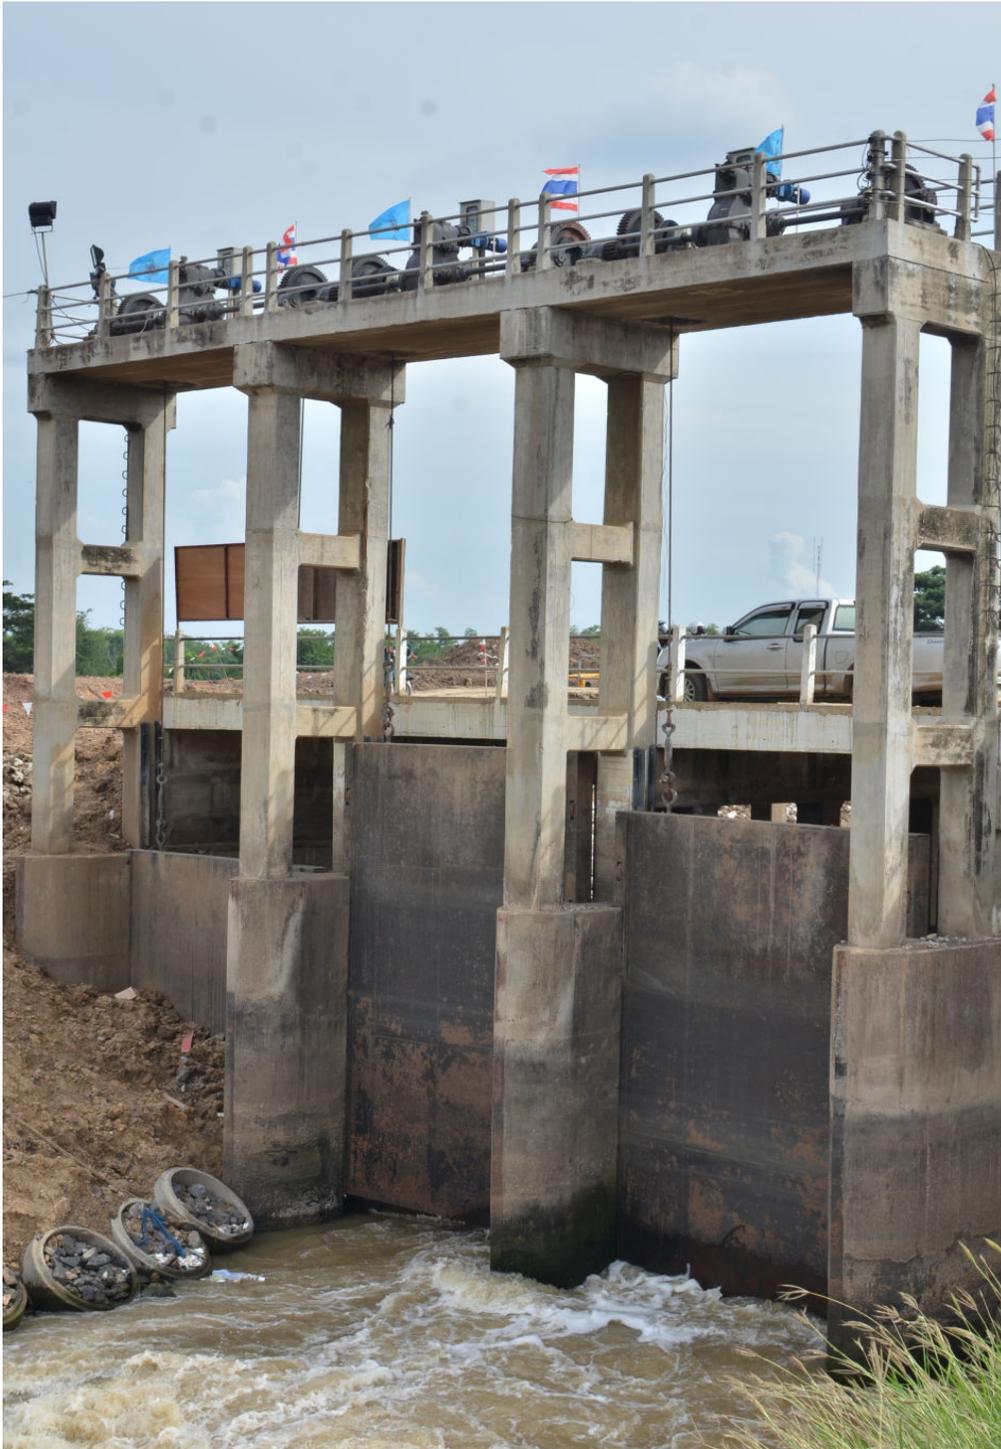
**Should be
kept as a
memorial
or
demolition?**

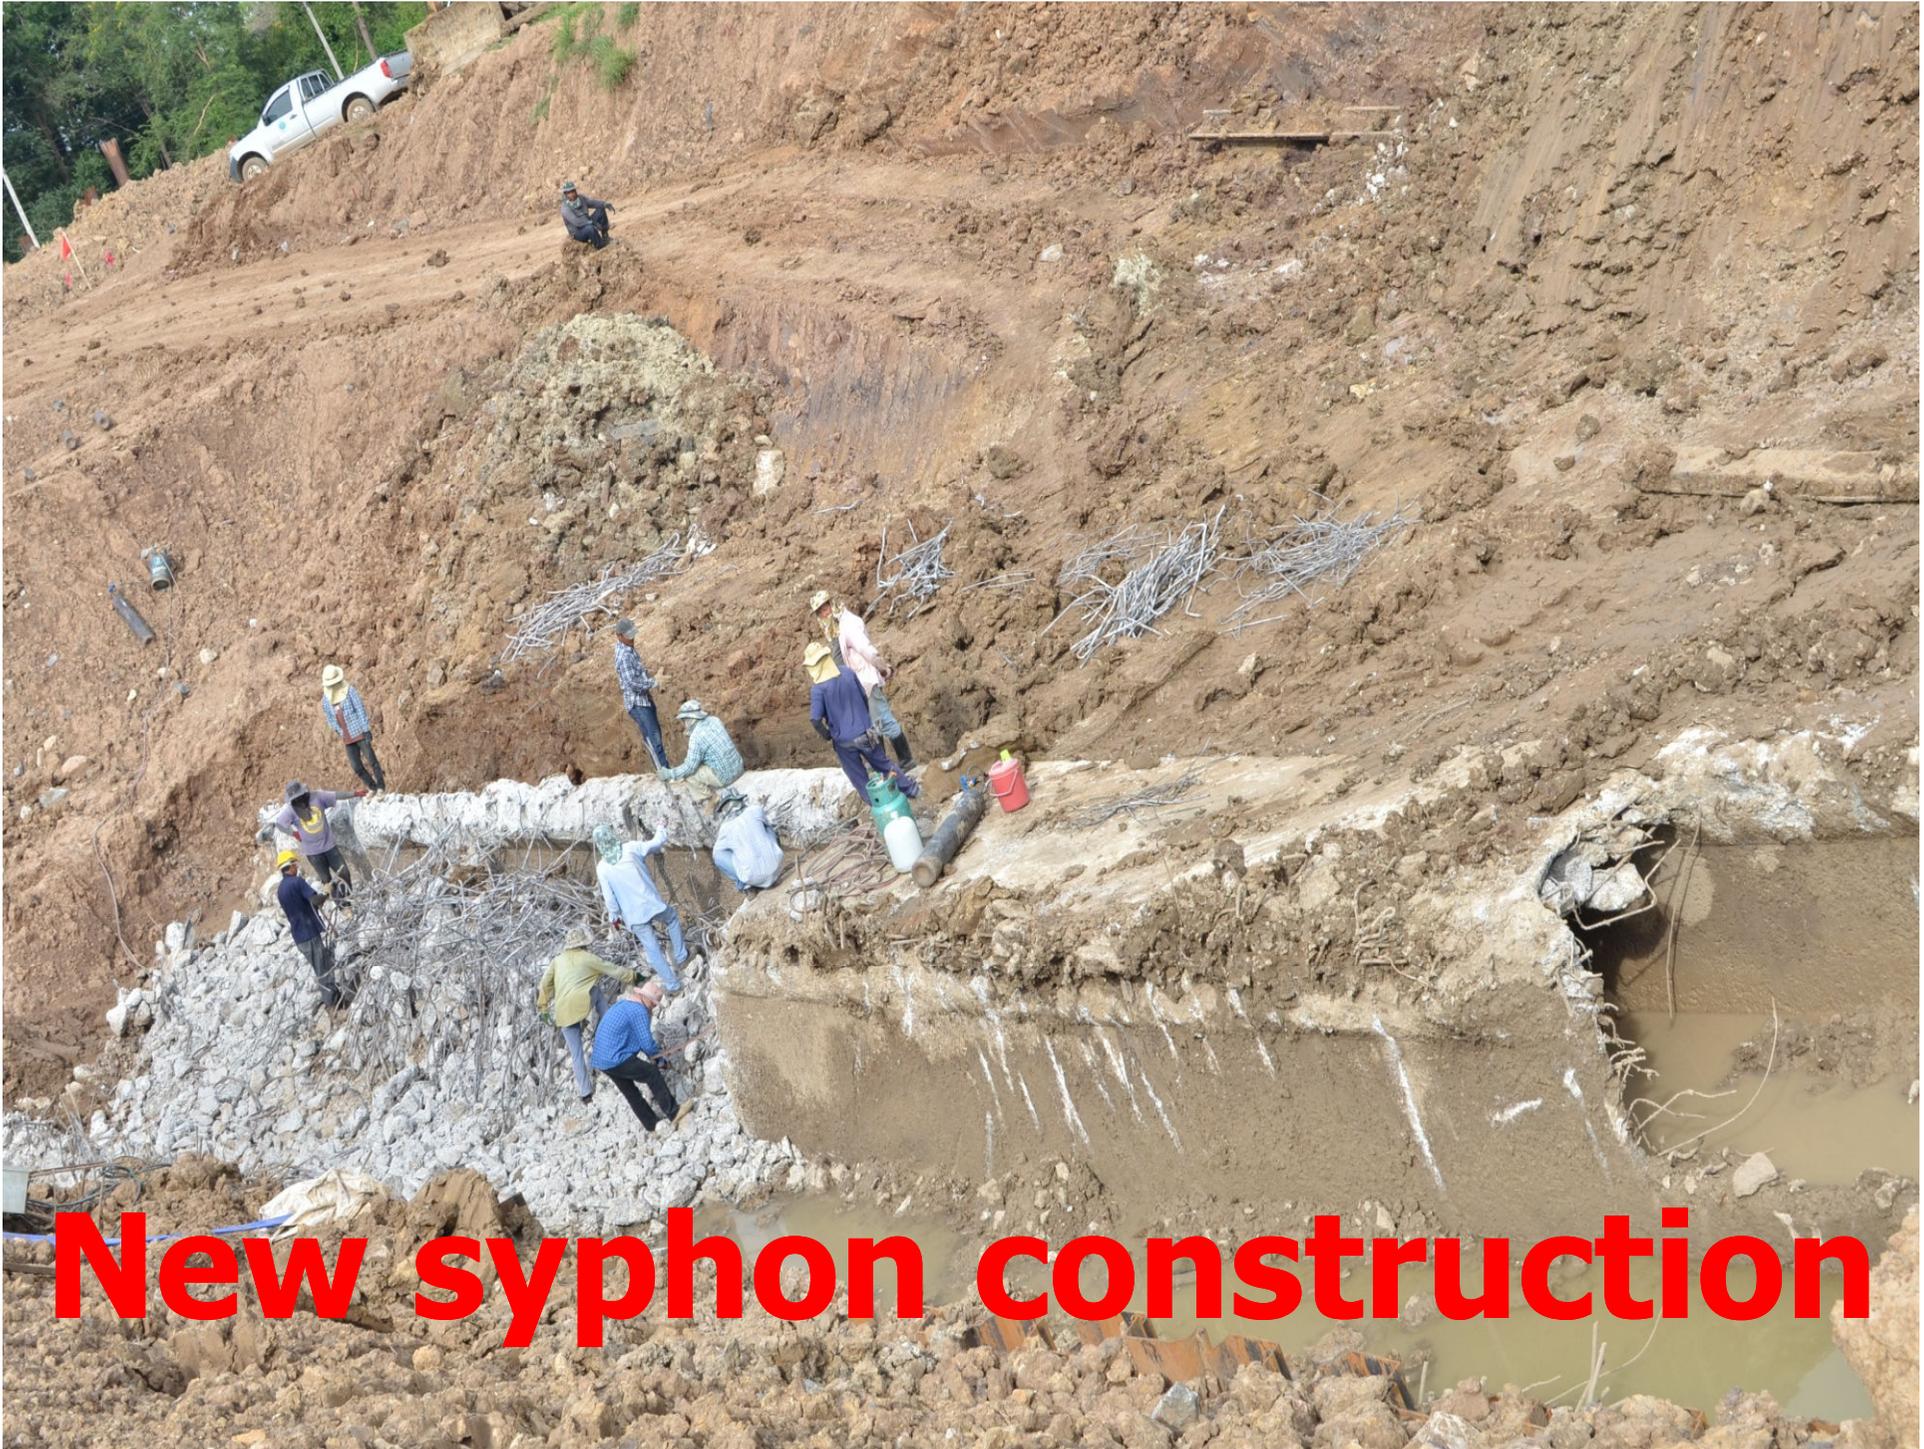
New syphon construction

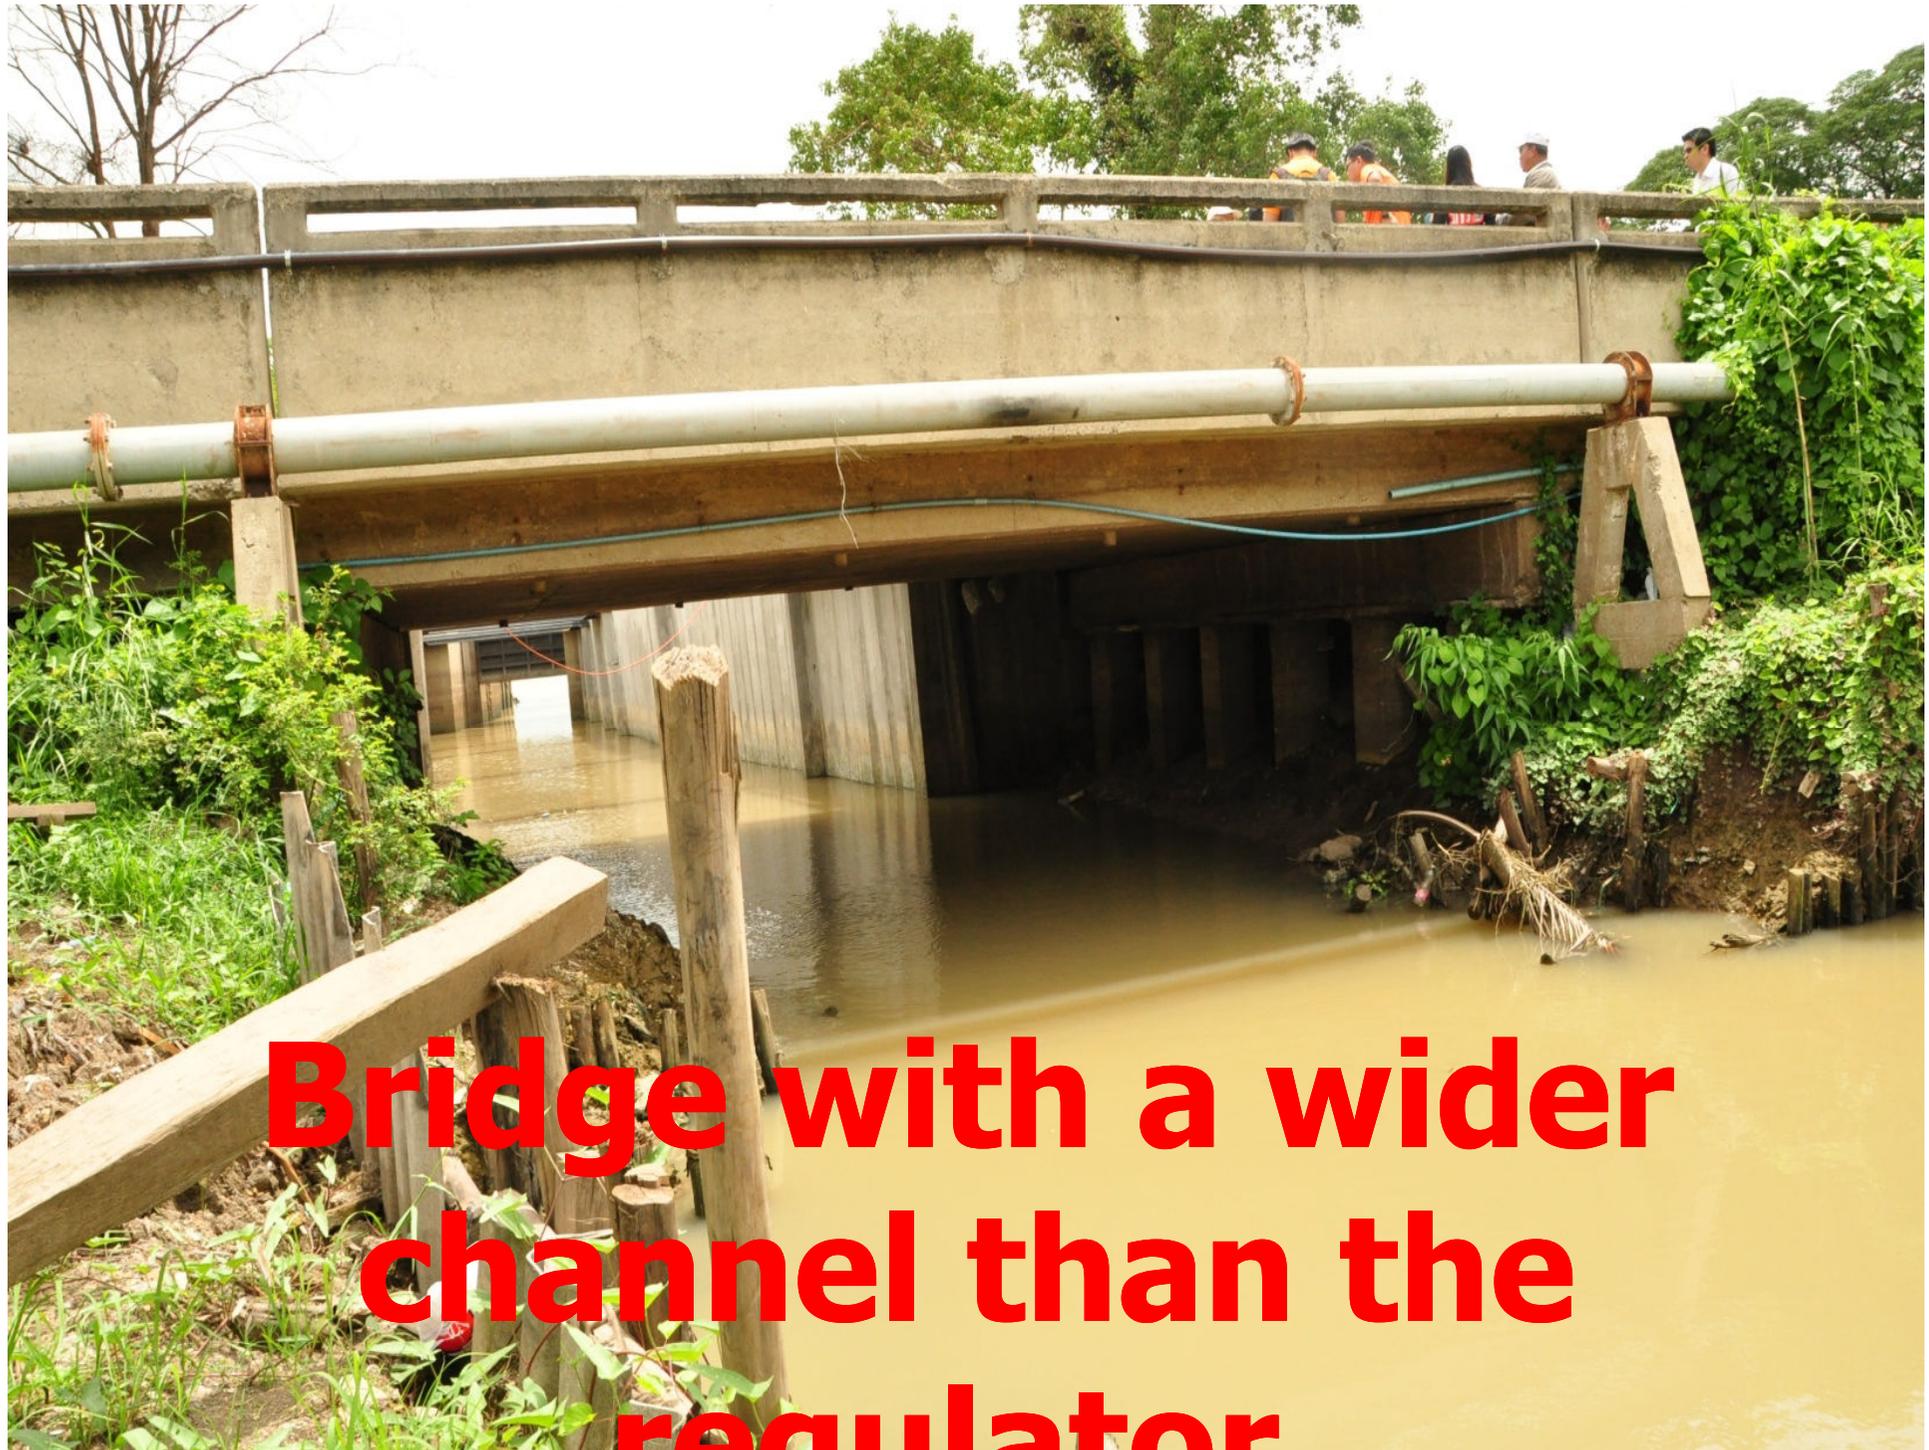
**Bridge with a wider
channel than the
regulator**

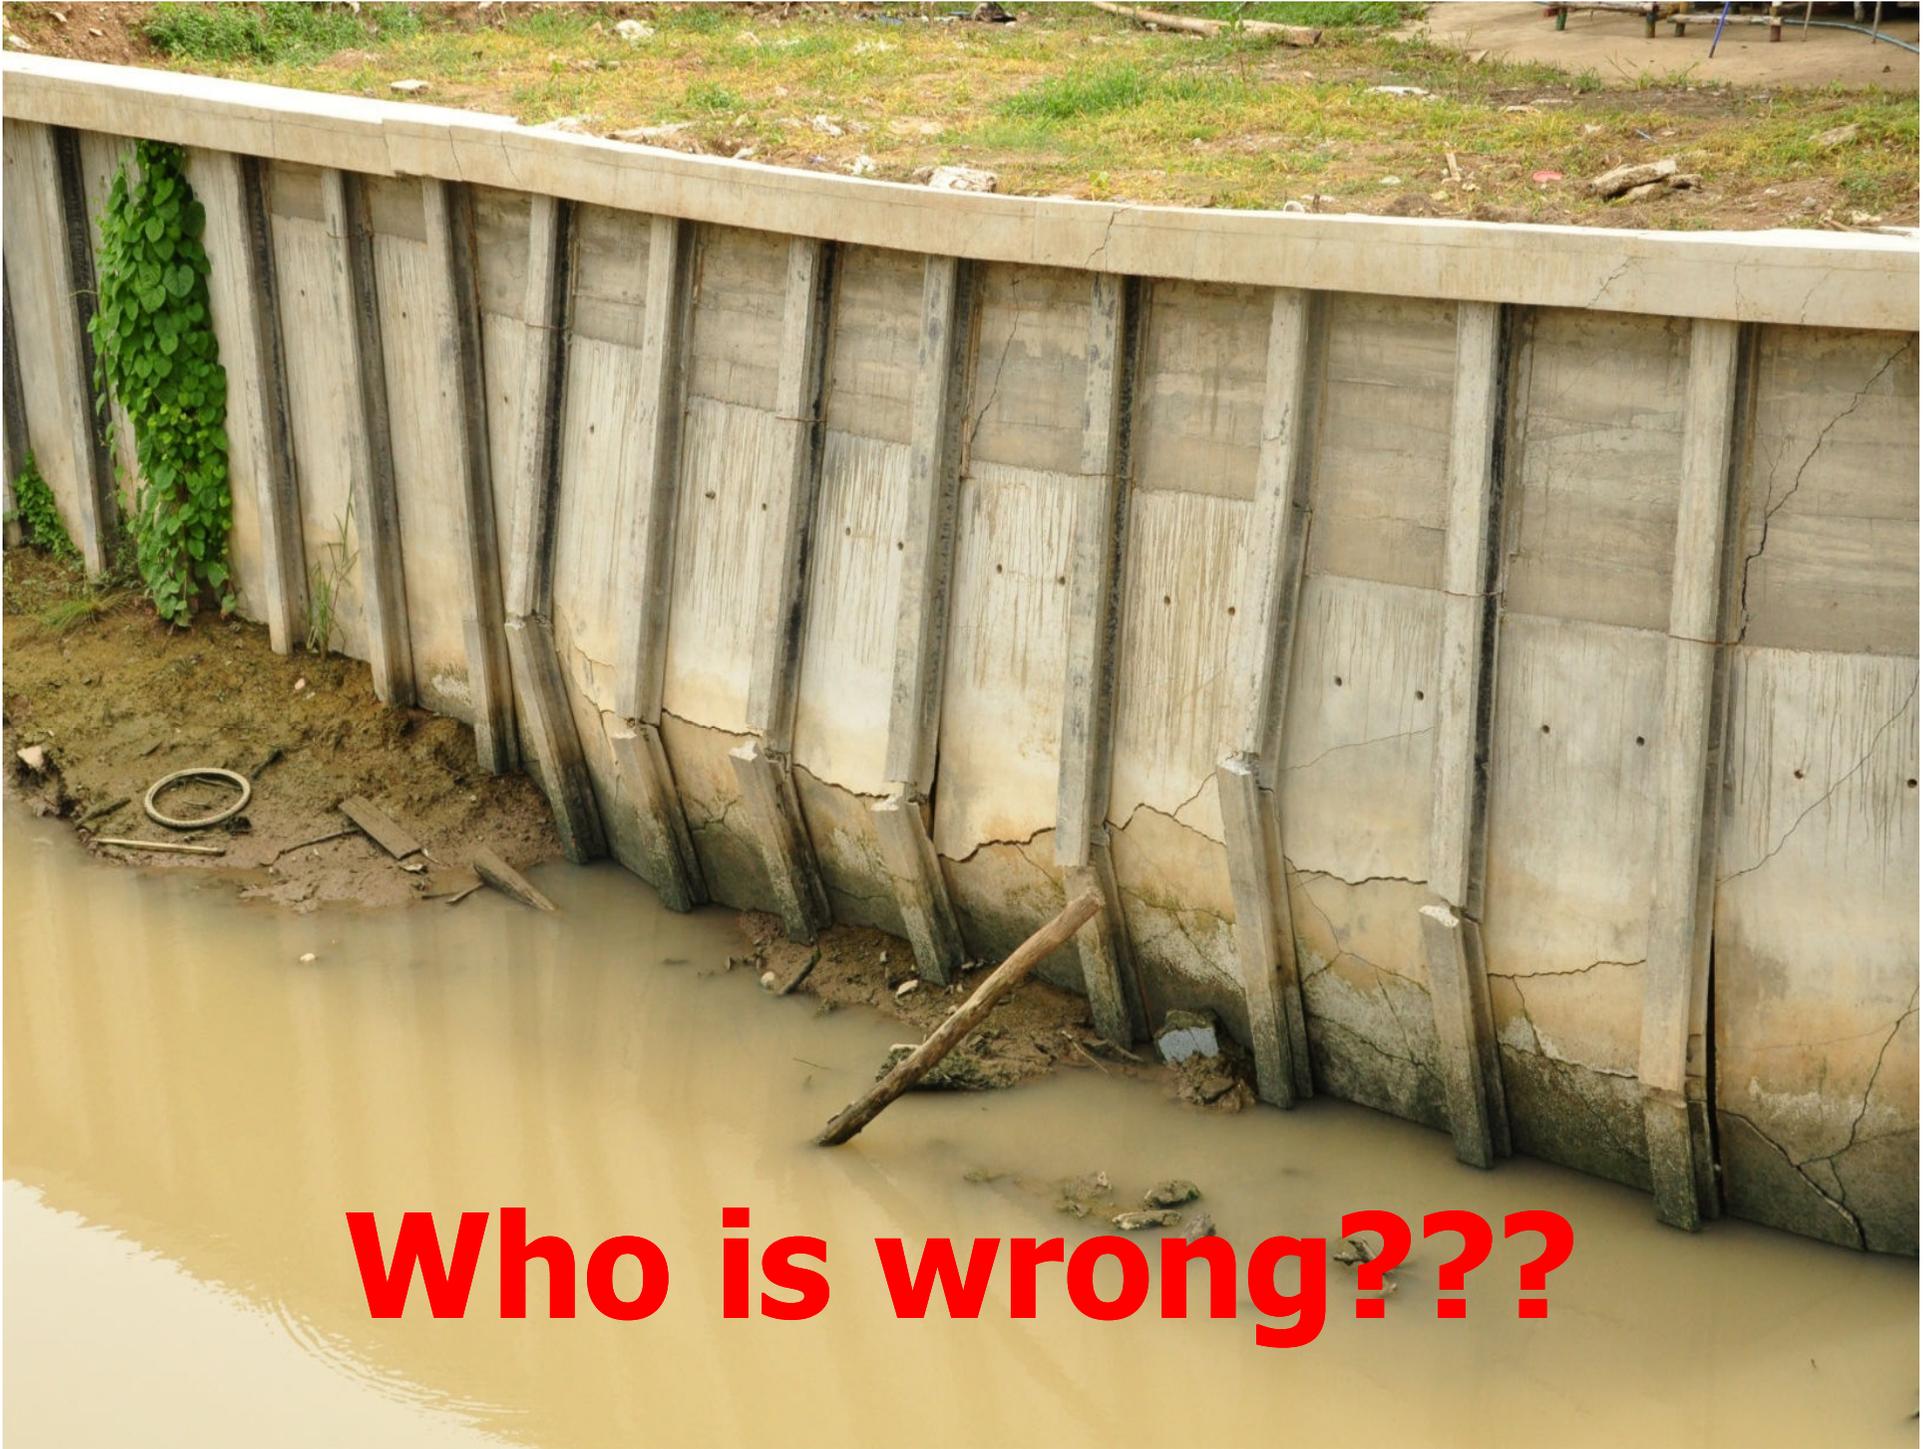
Who is wrong???

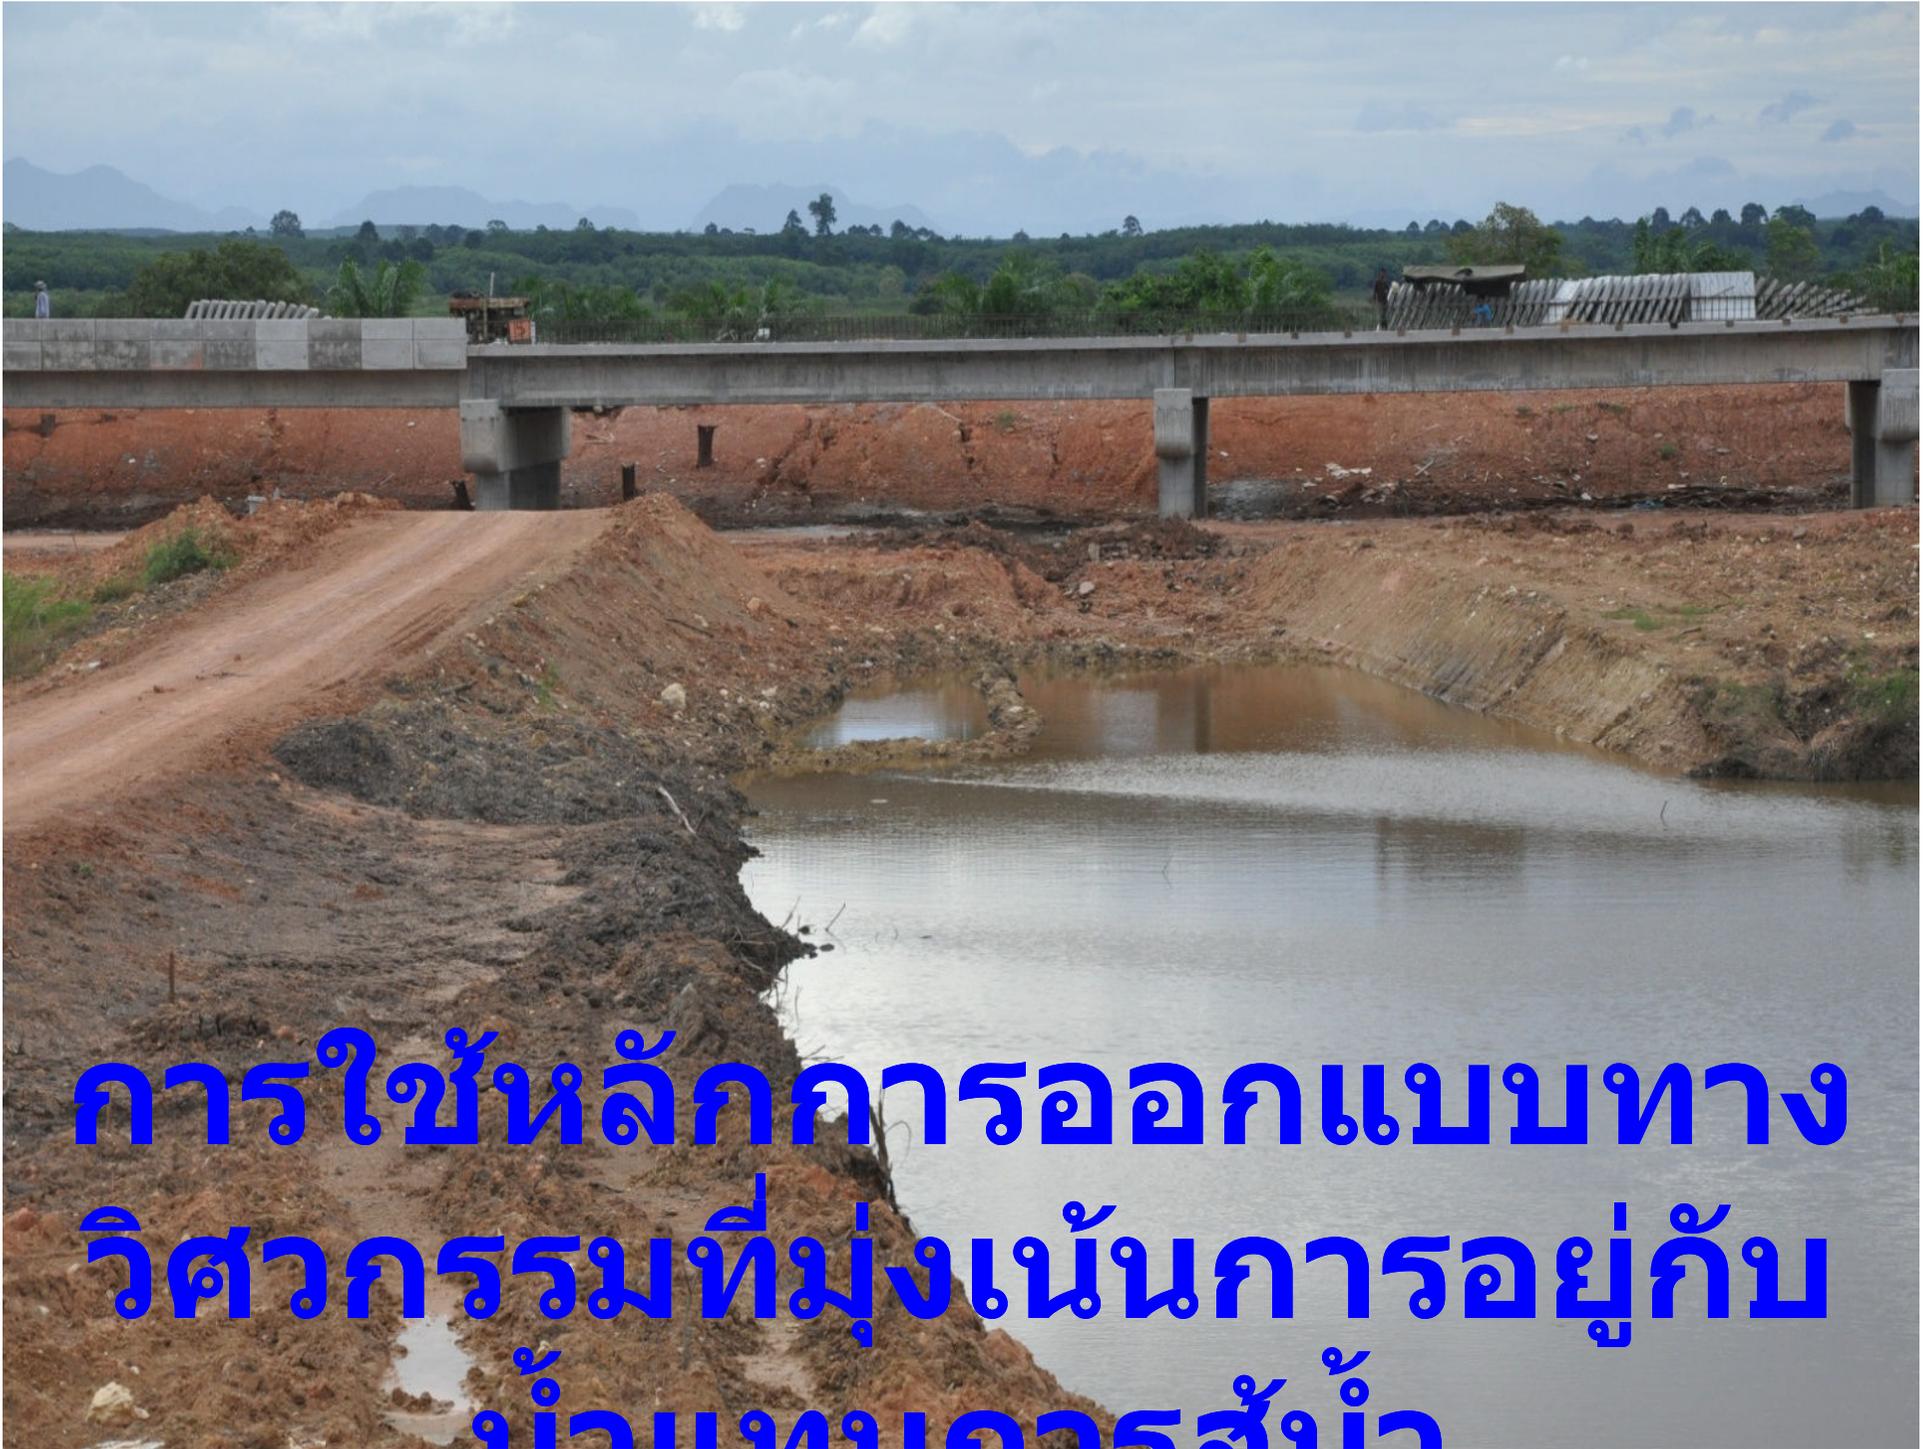
**Good practice: water can
flow through, and
construced bridges on**

**การใช้หลักการออกแบบทาง
วิศวกรรมที่มุ่งเน้นการอยู่กับ
น้ำแทนการสู้น้ำ**
