RAPID FLOOD MANAGEMENT ASSESSMENT

**Lesson Learn and Future Direction for Water Policy:
Structure and non-structure flood prevention**

River and Canal Dredging

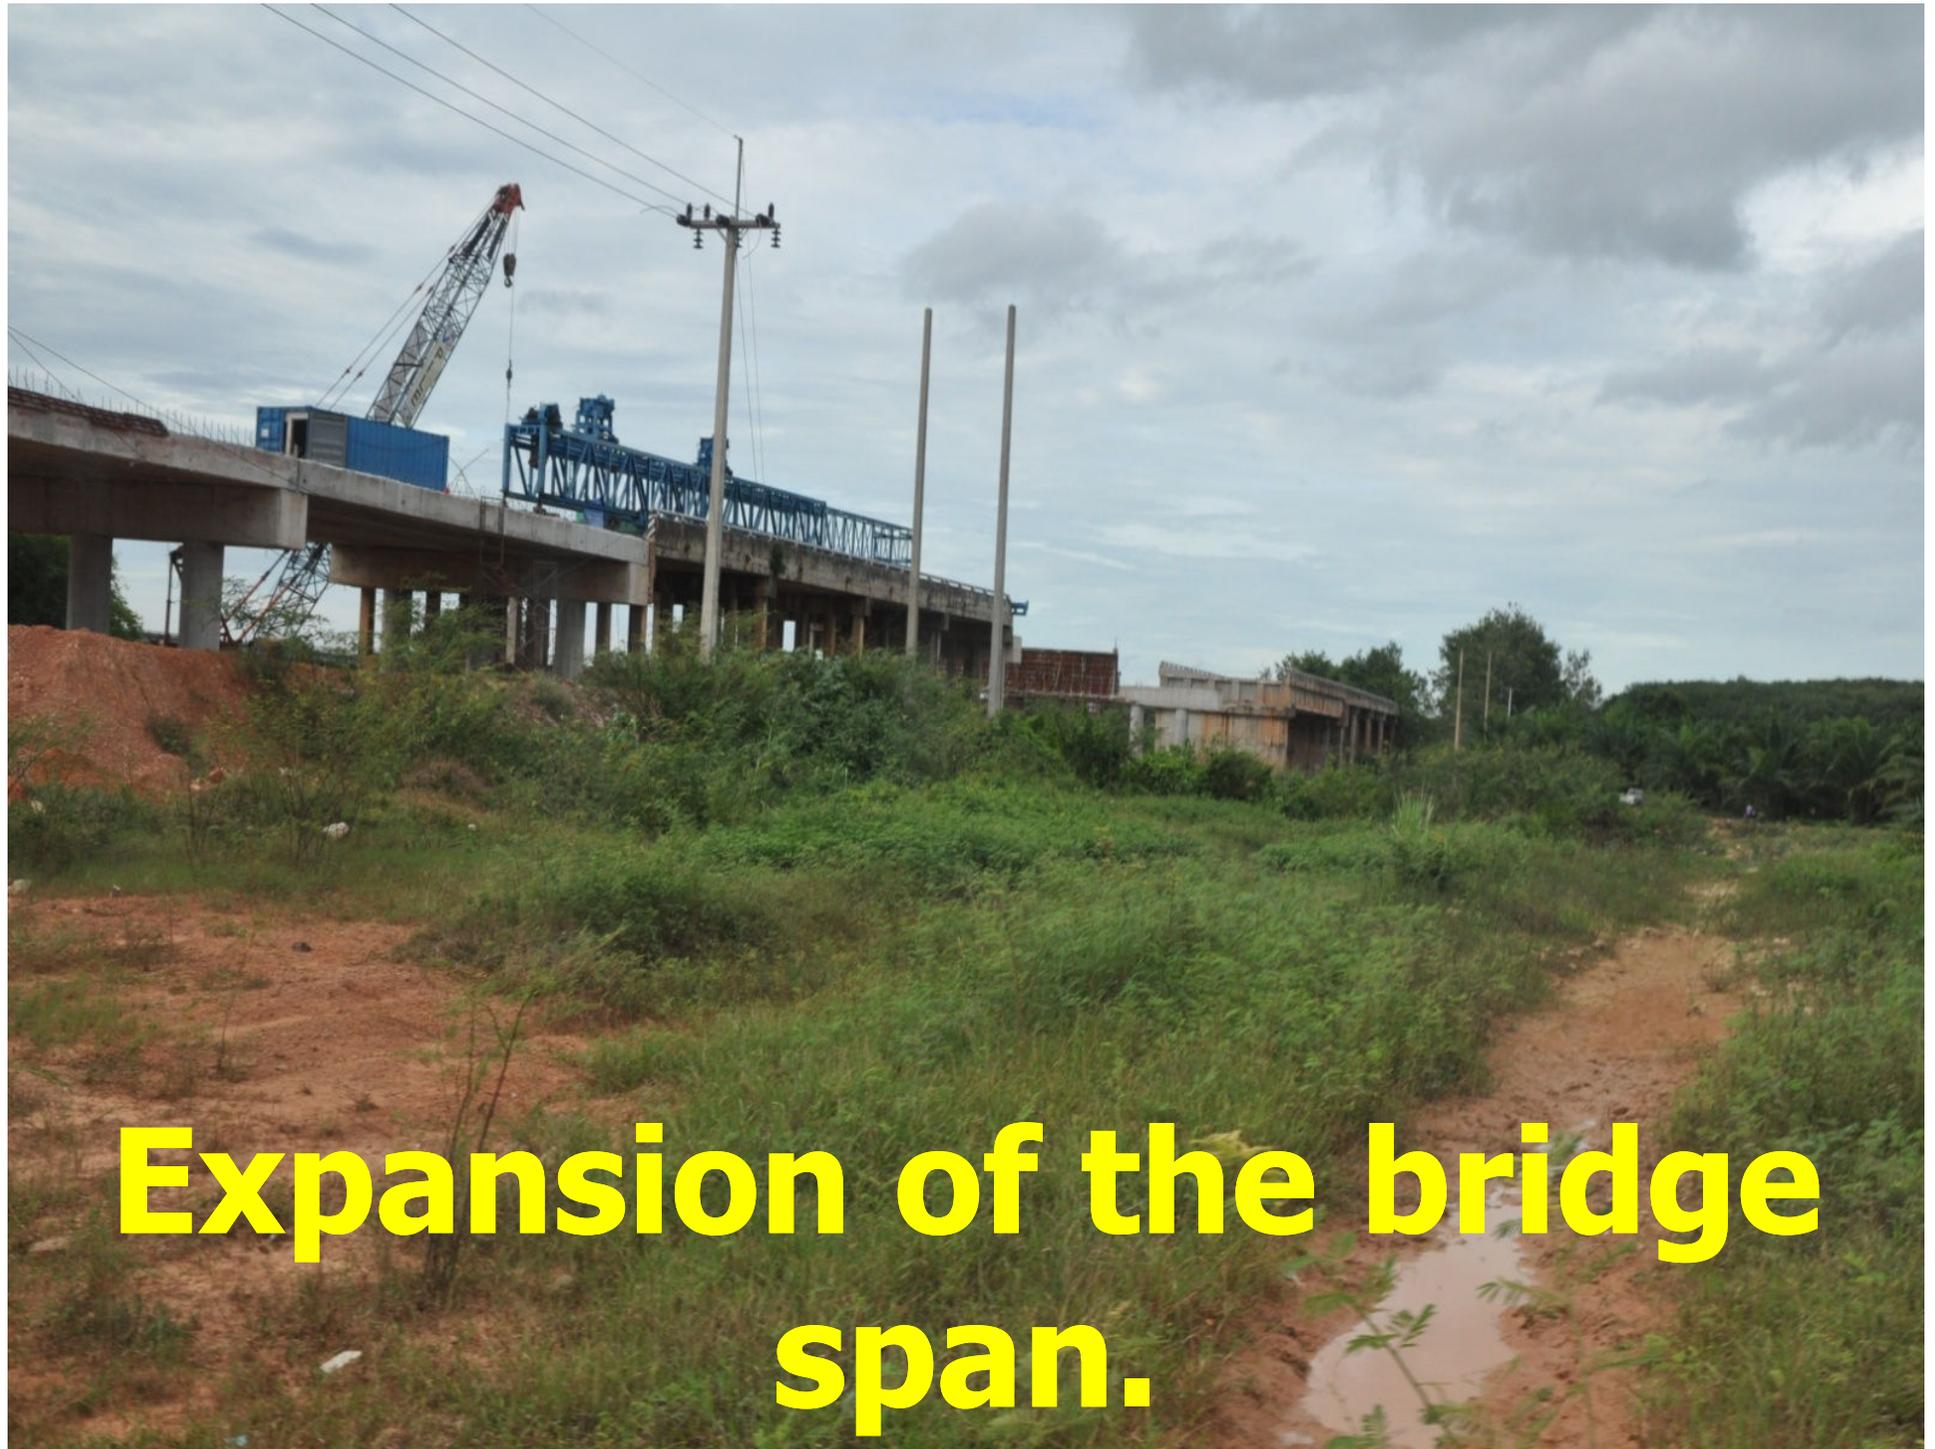
Expansion of the bridge span.

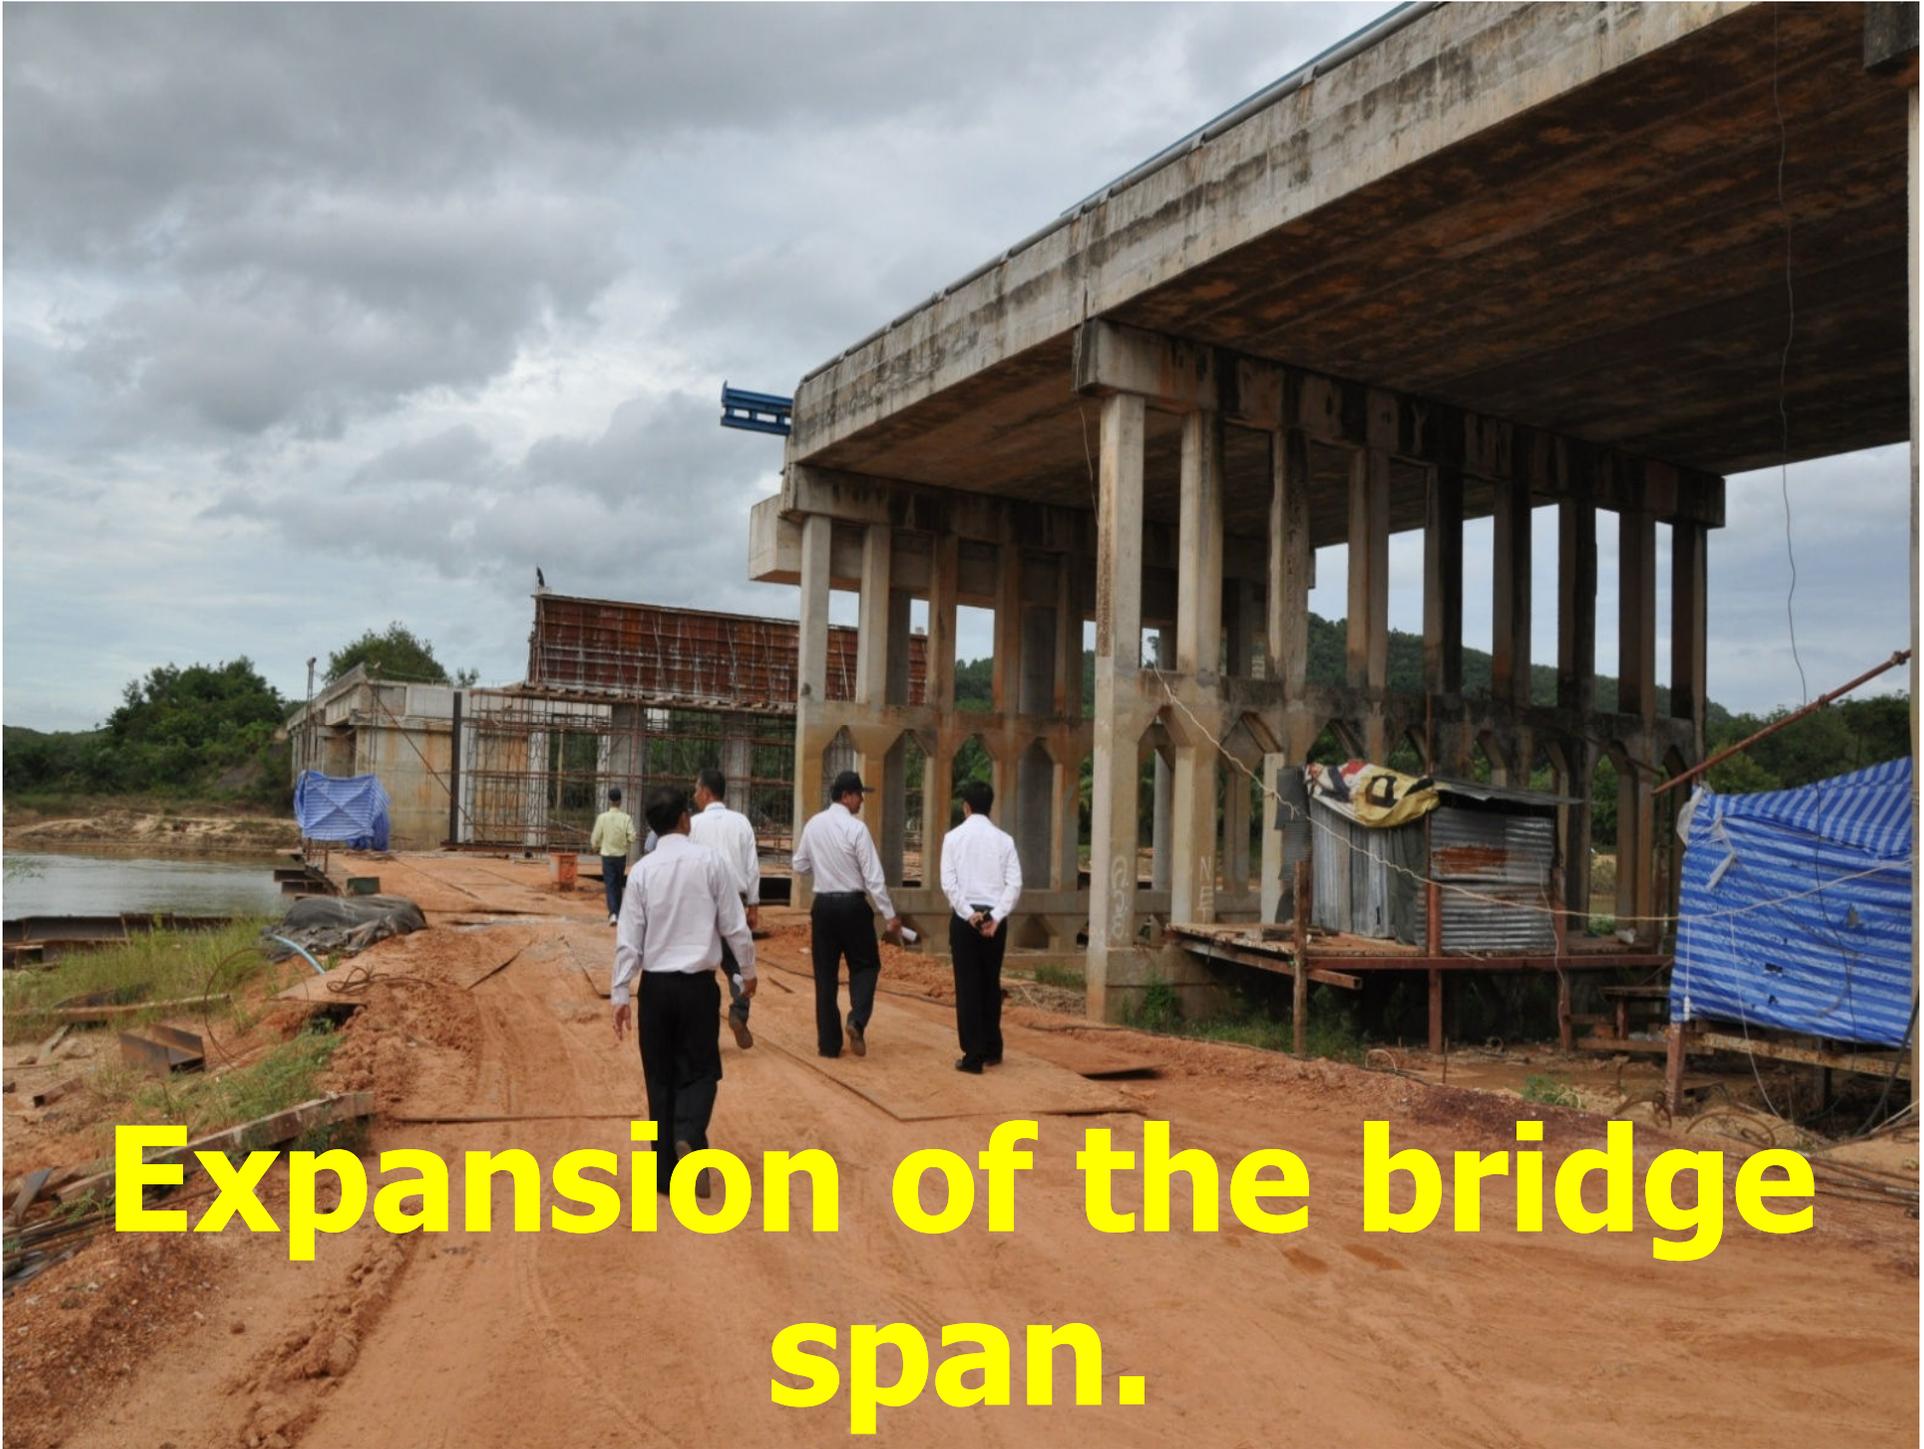
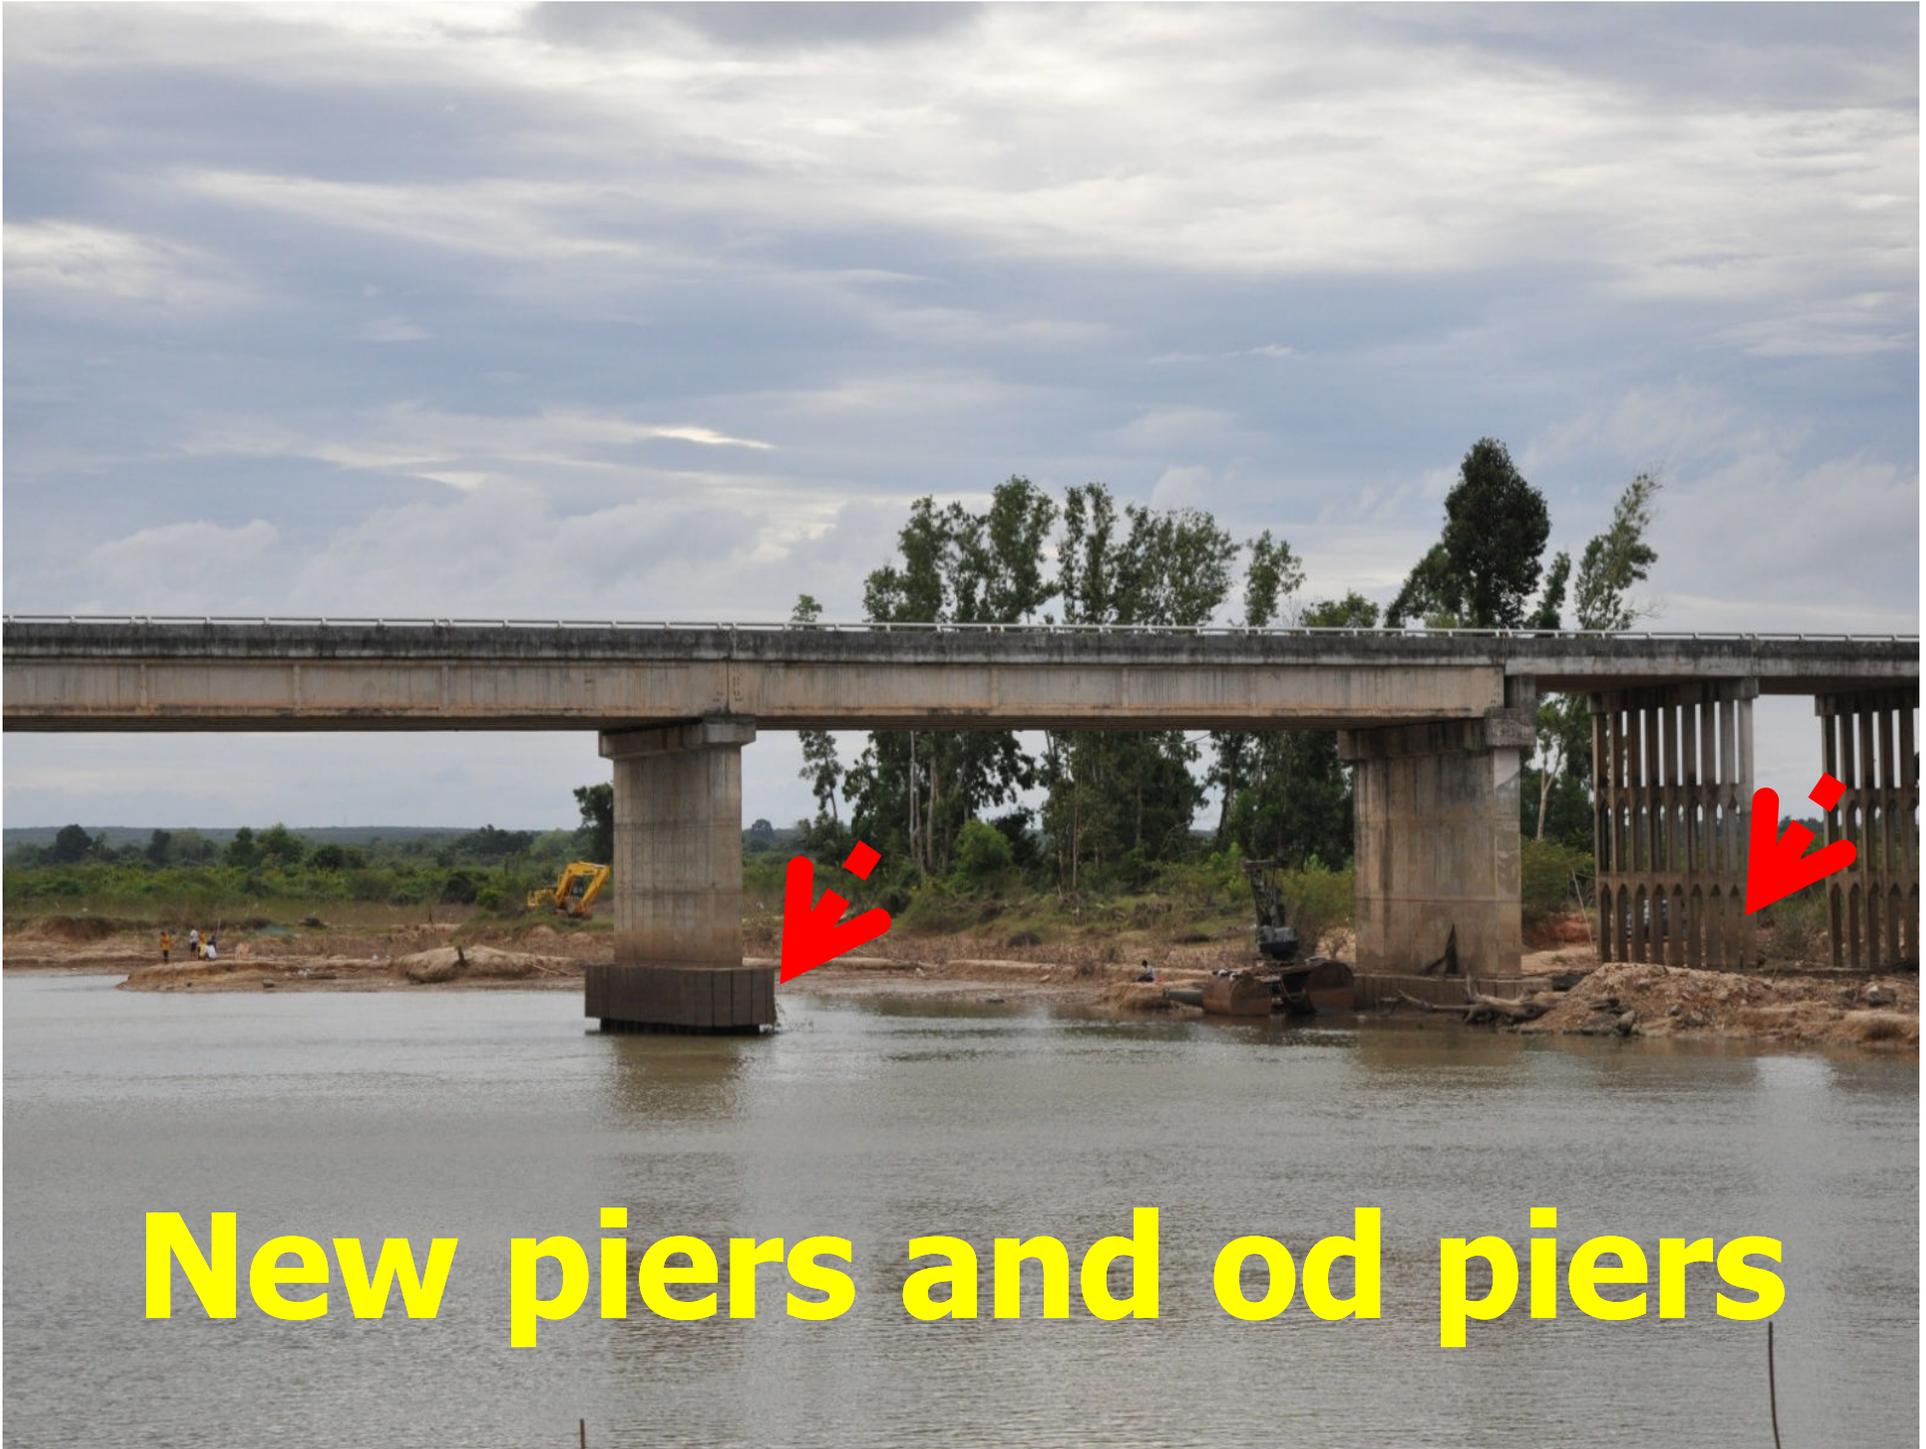
New piers and old piers

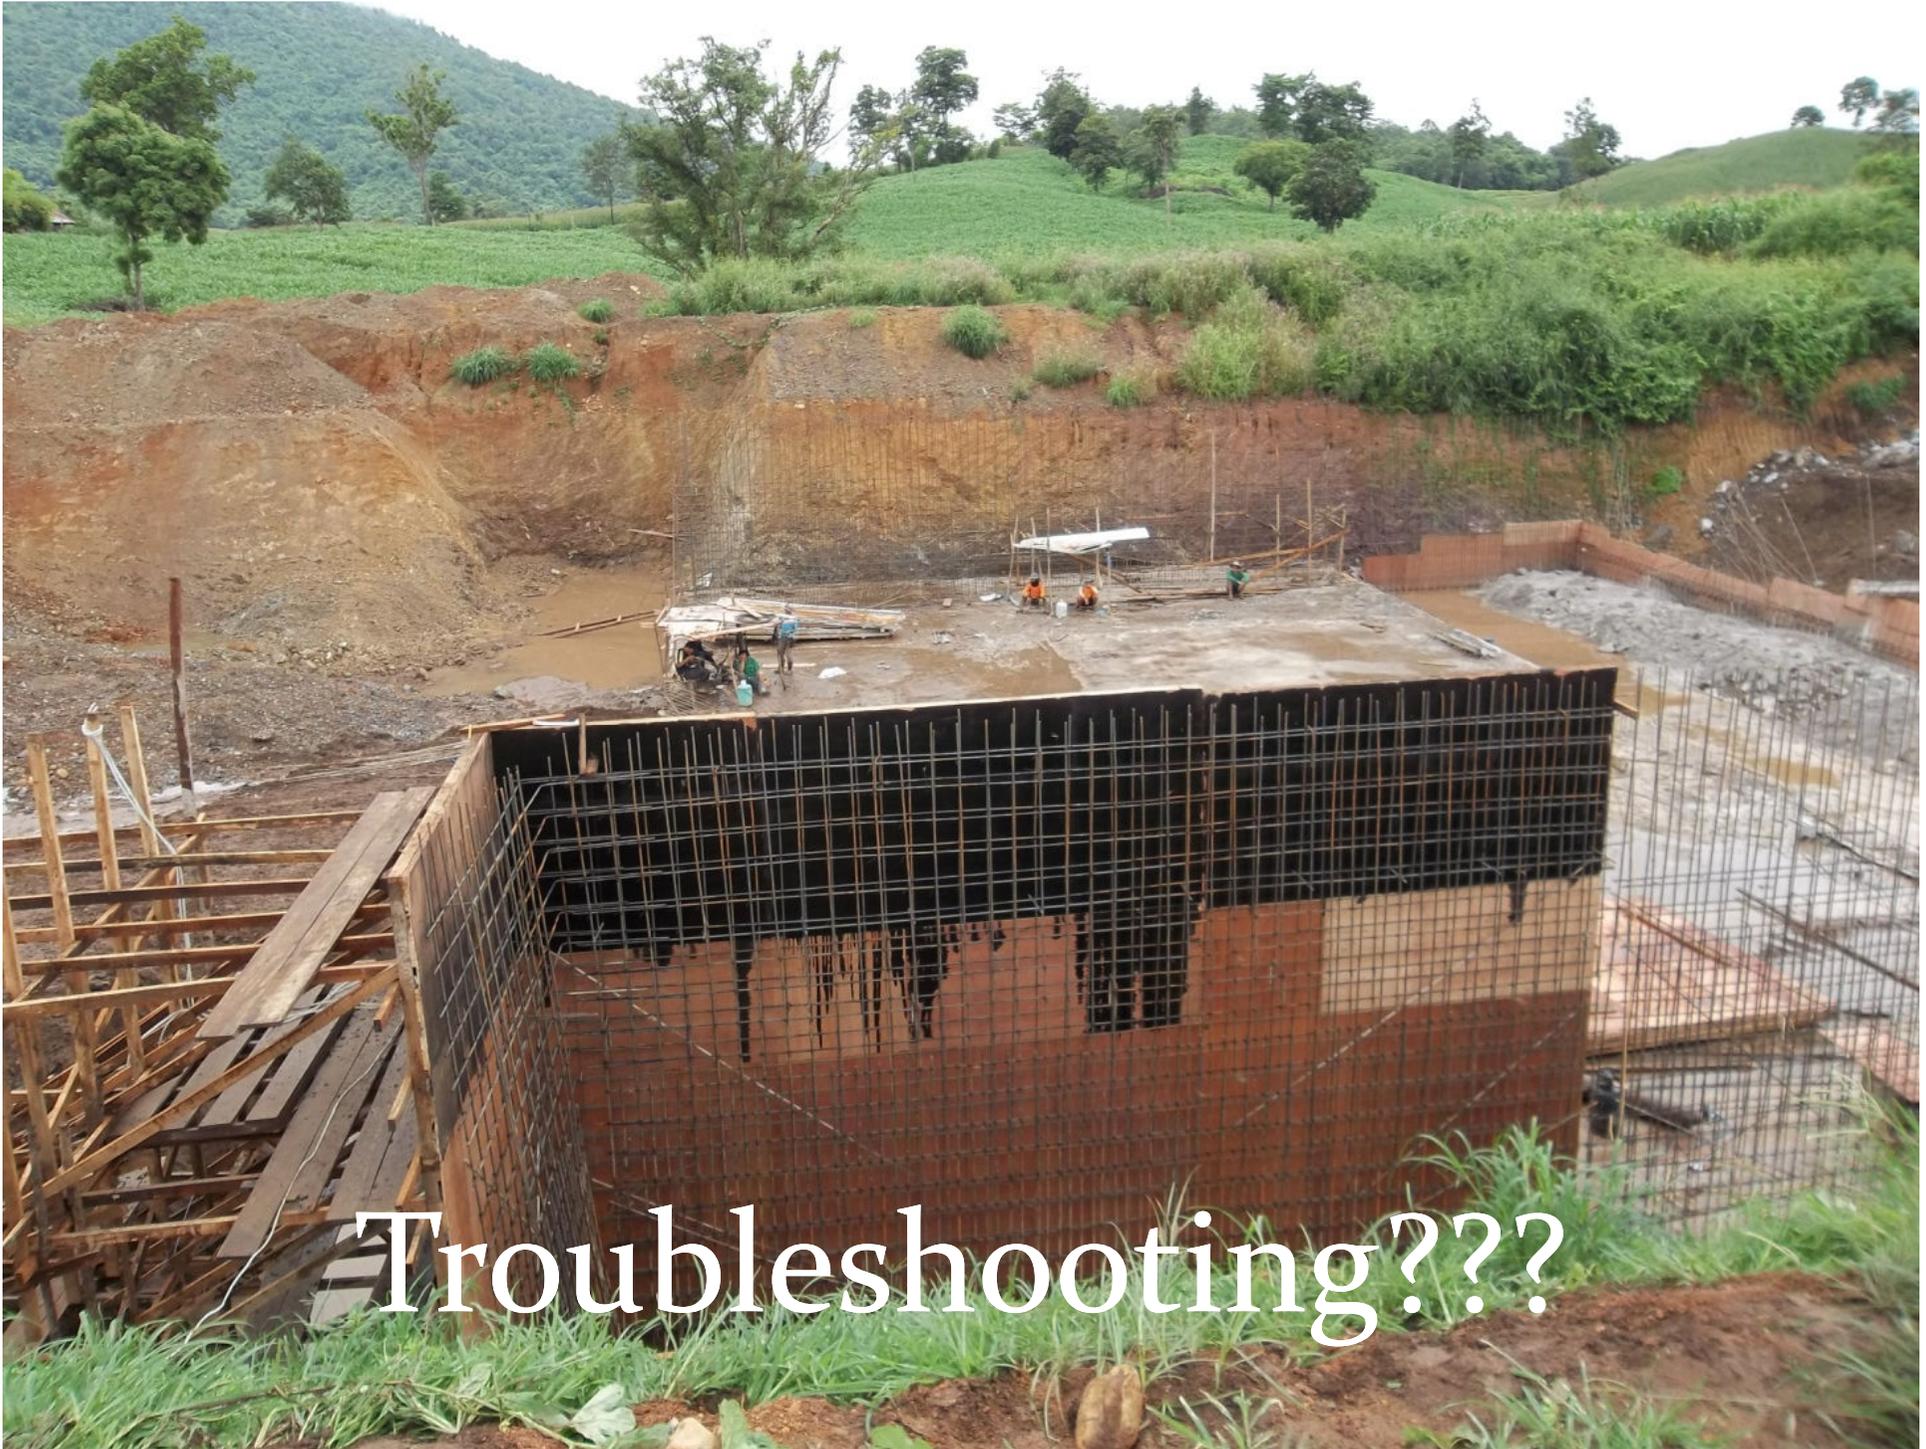
Troubleshooting???

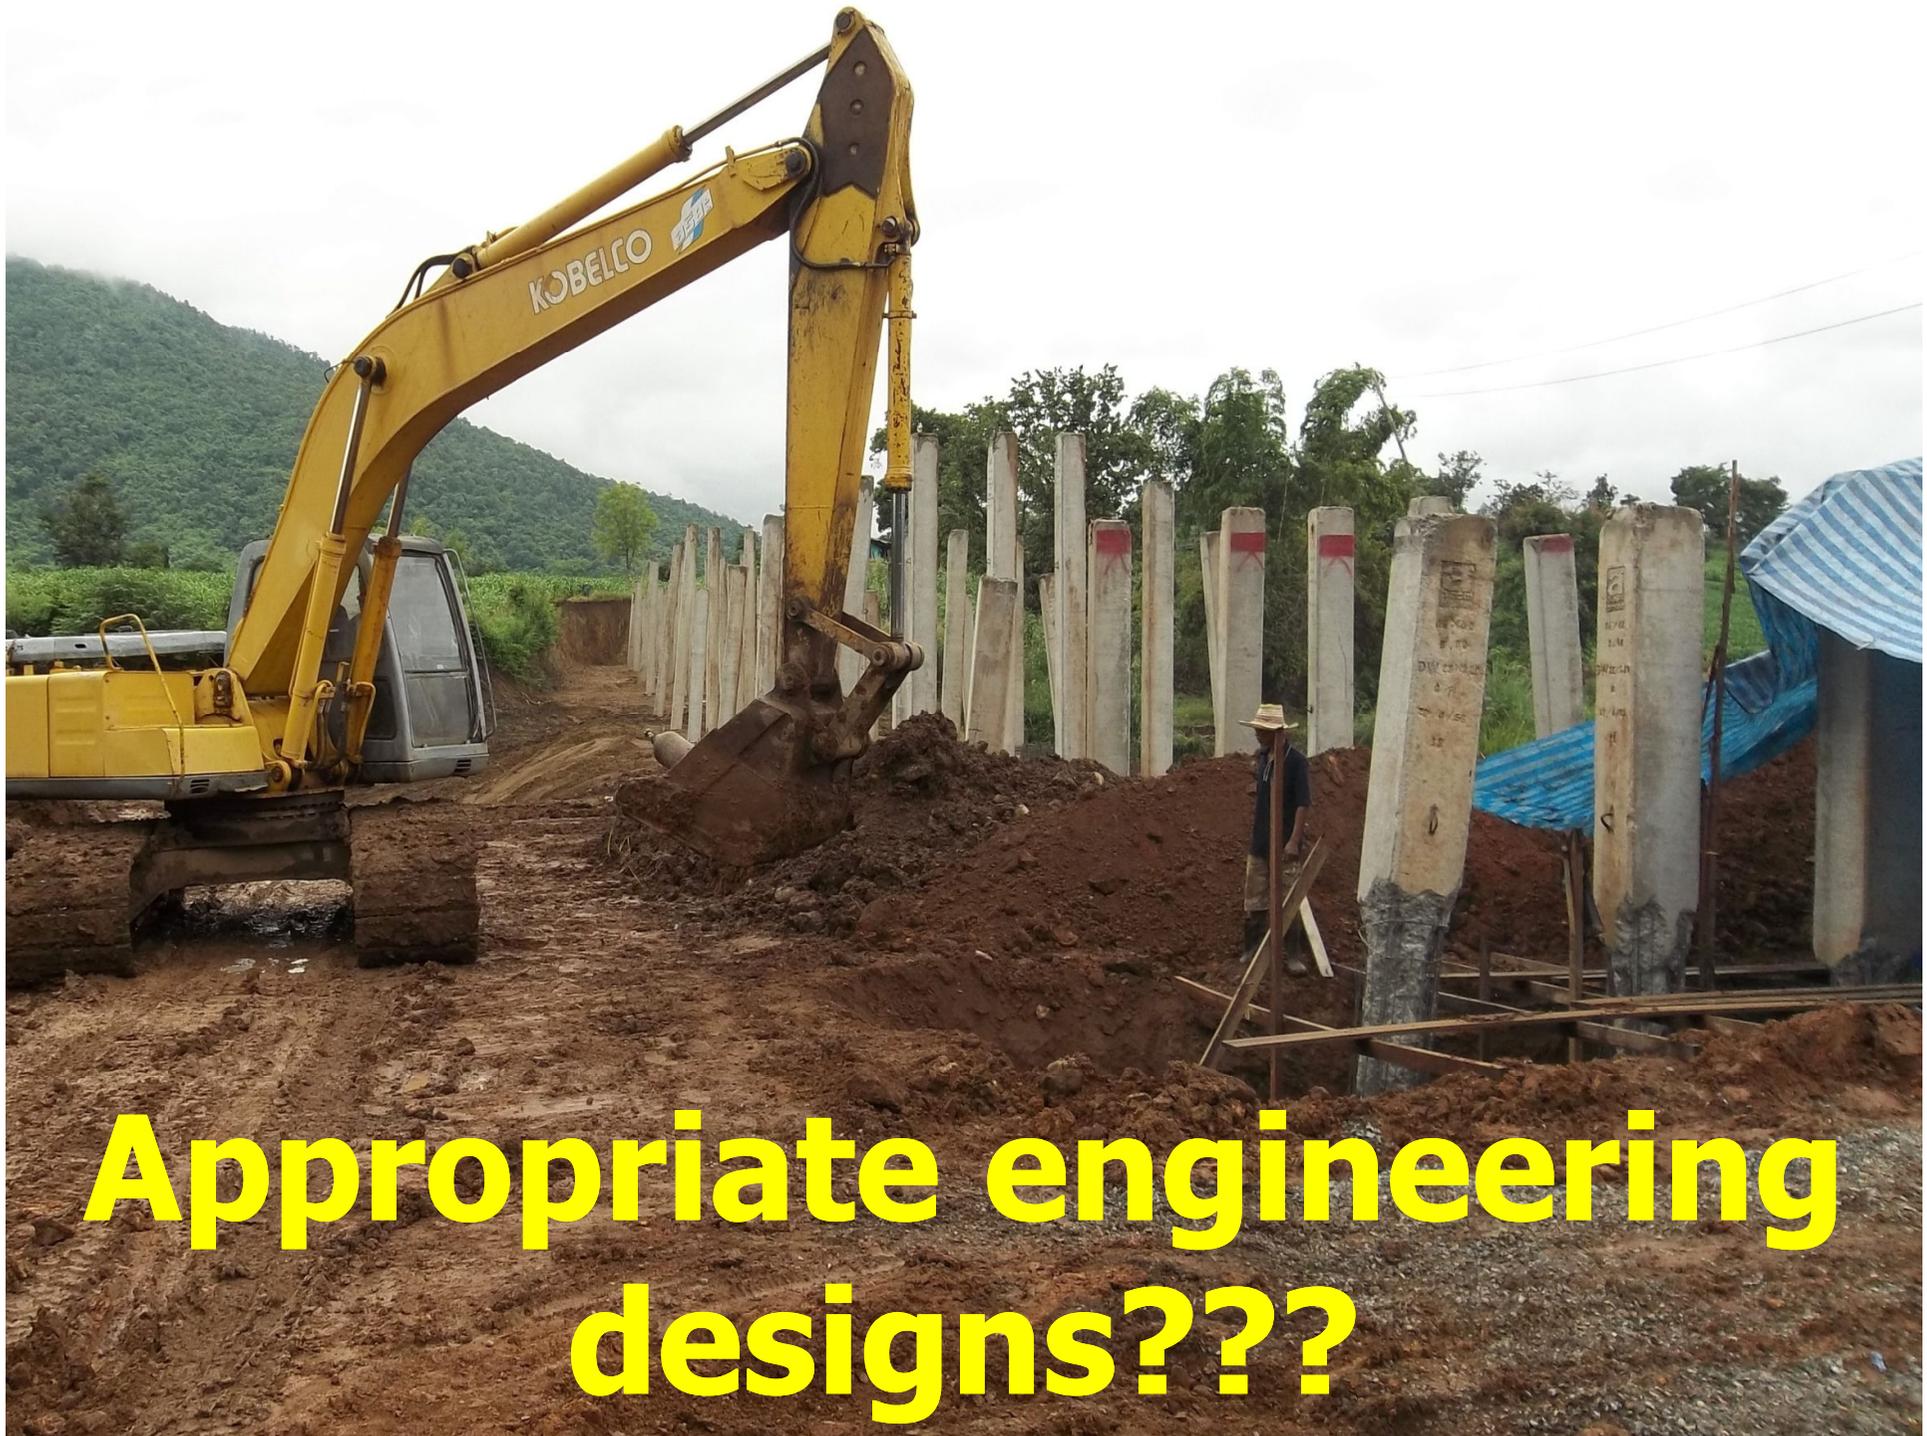
Appropriate engineering designs???

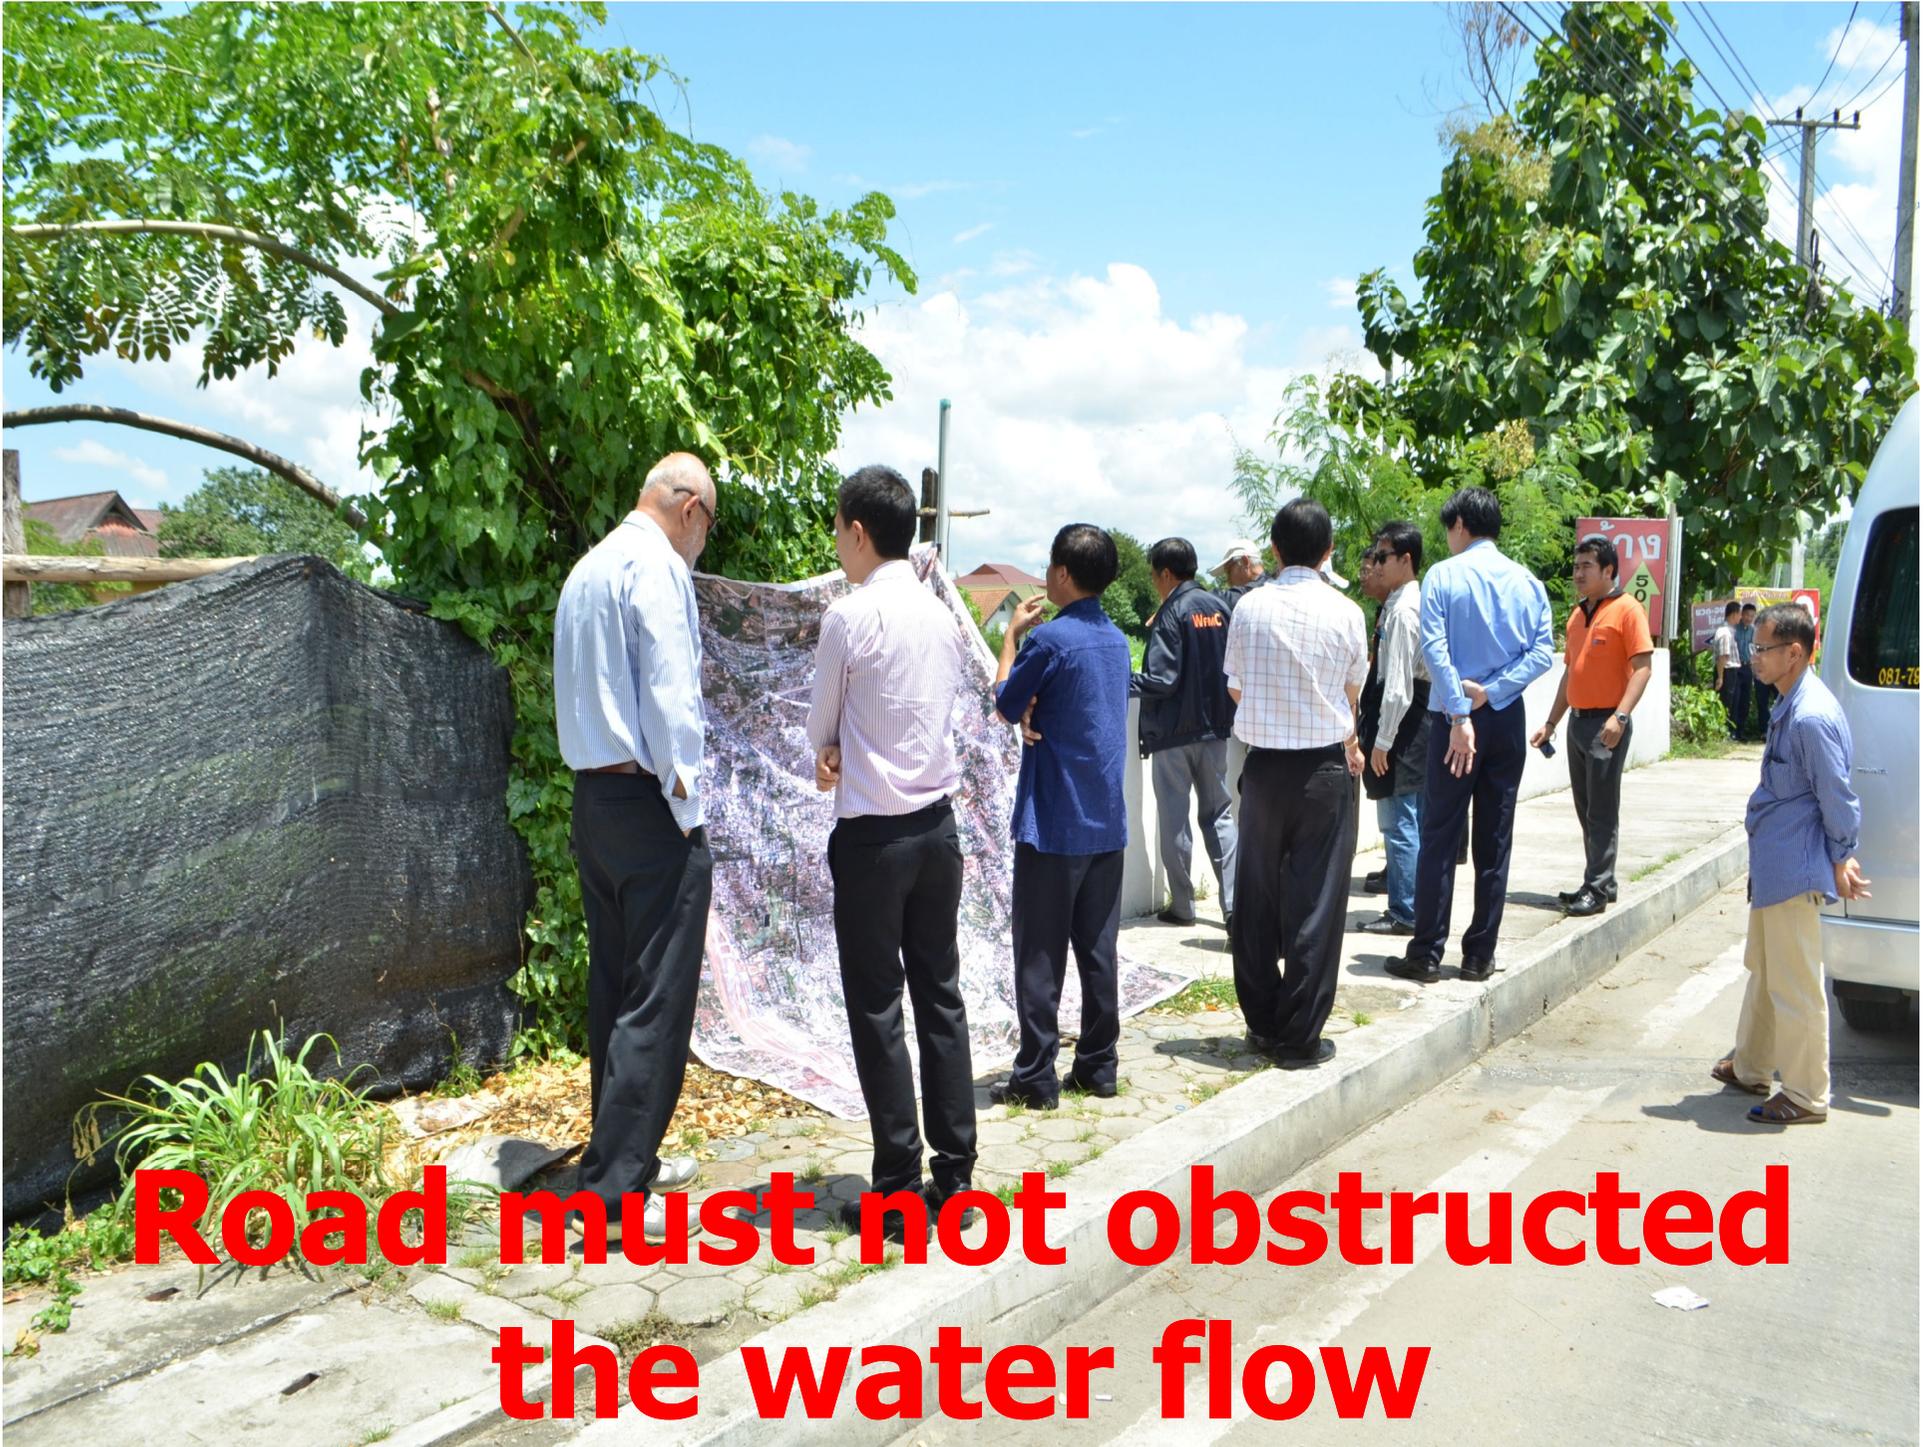
**Road must not obstruct
the water flow**

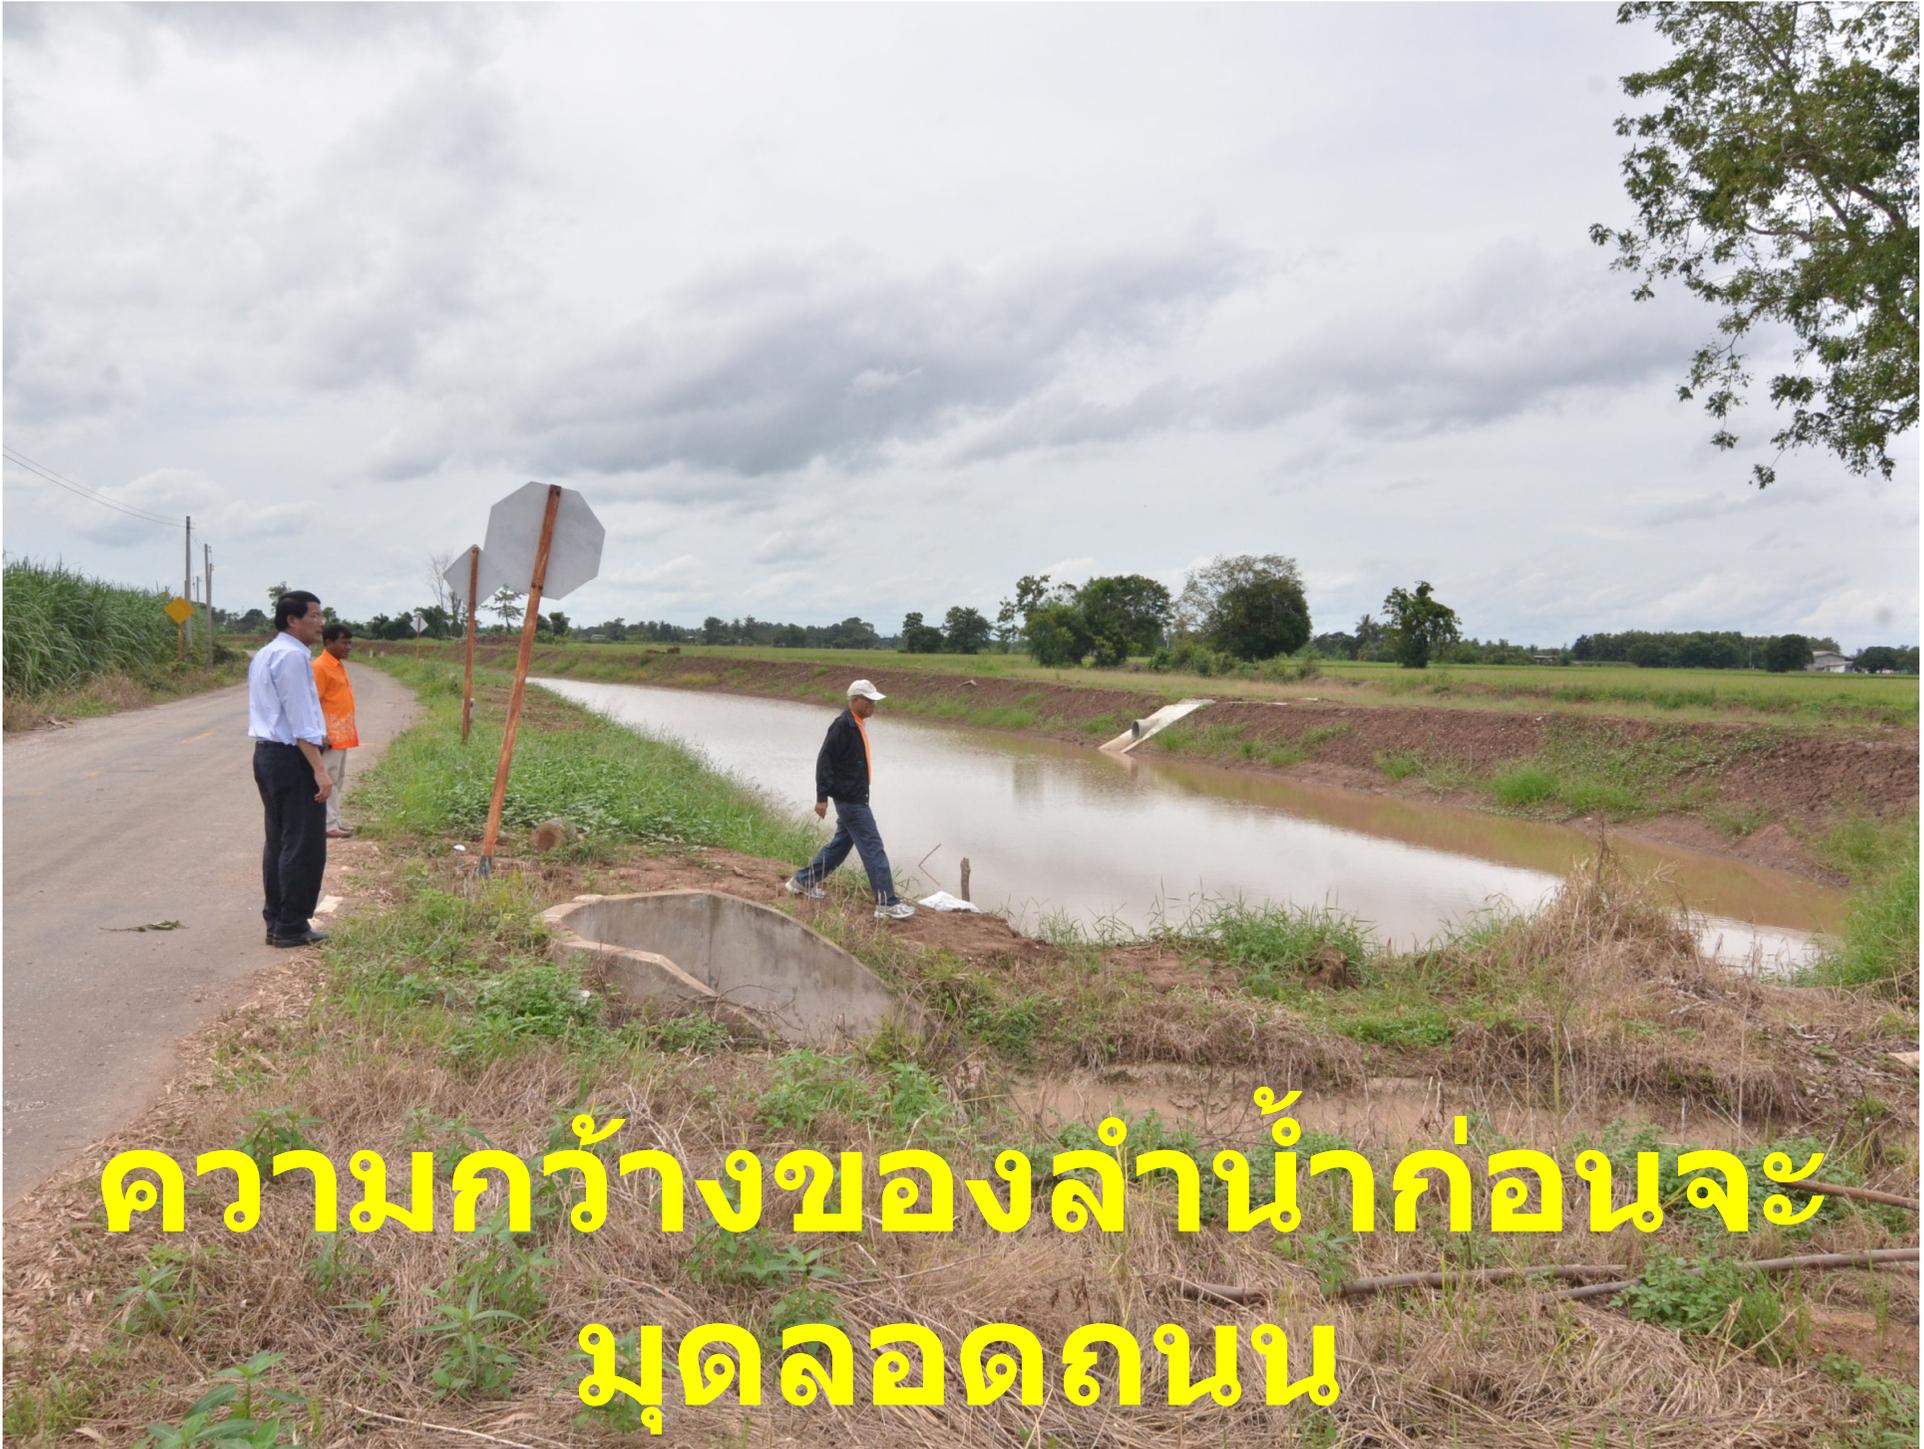
ความกว้างของลำน้ำก่อนจะ
มุดลอดถนน

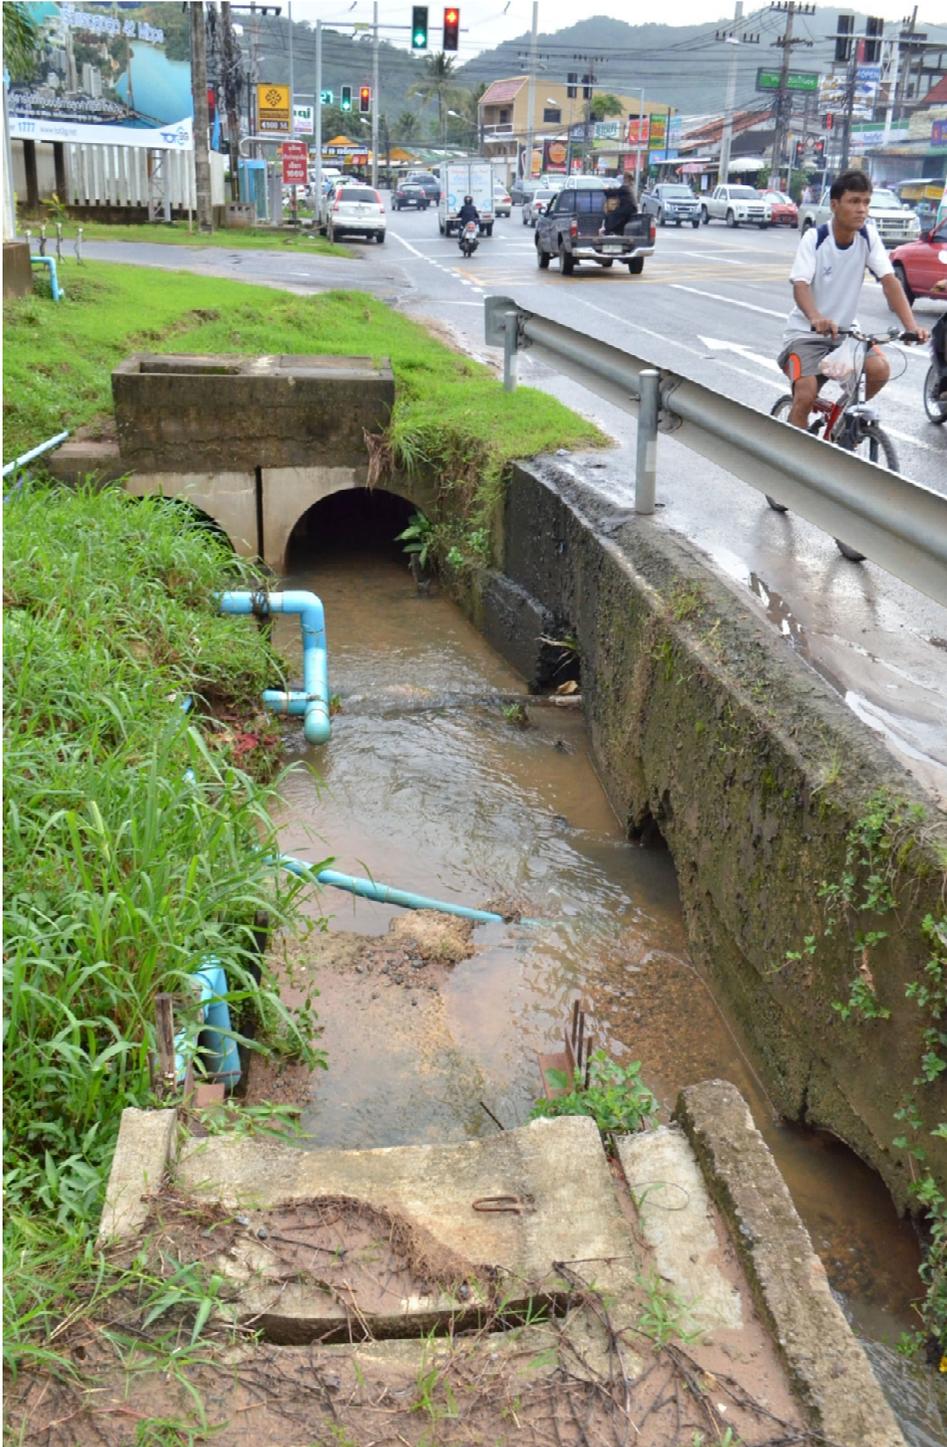
**ท่อลอดกลม
สำหรับให้น้ำ
ไหลผ่านใต้
ถนน มีดิน
ทรายอุดจน
เกือบตัน**
