RAPID FLOOD MANAGEMENT ASSESSMENT

**Lesson Learn and Future Direction for Water Policy:
Structure and non-structure flood prevention**

River and Canal Dredging

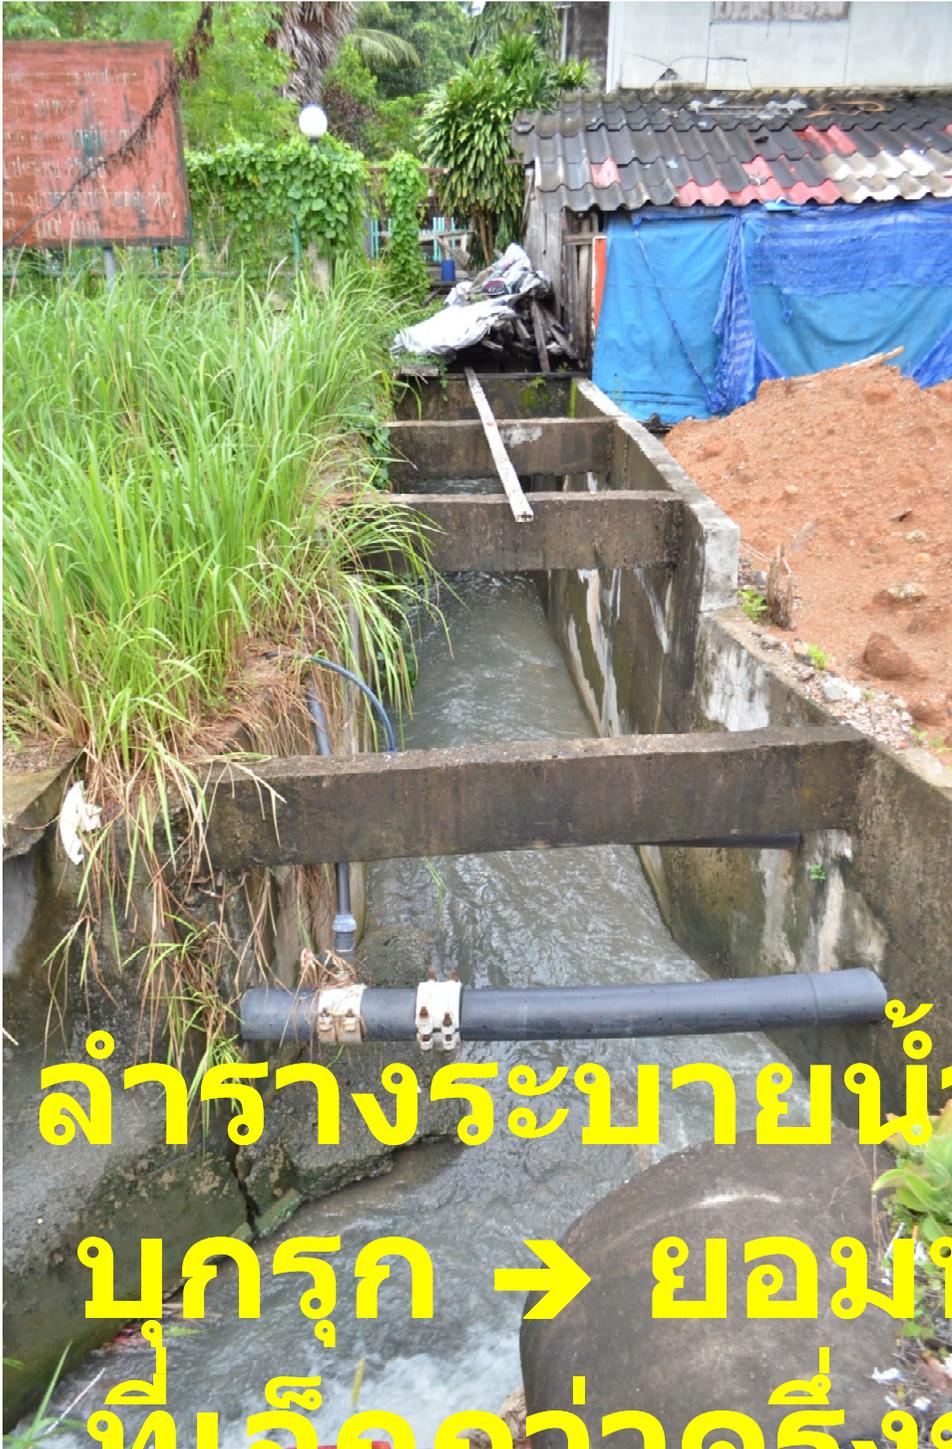
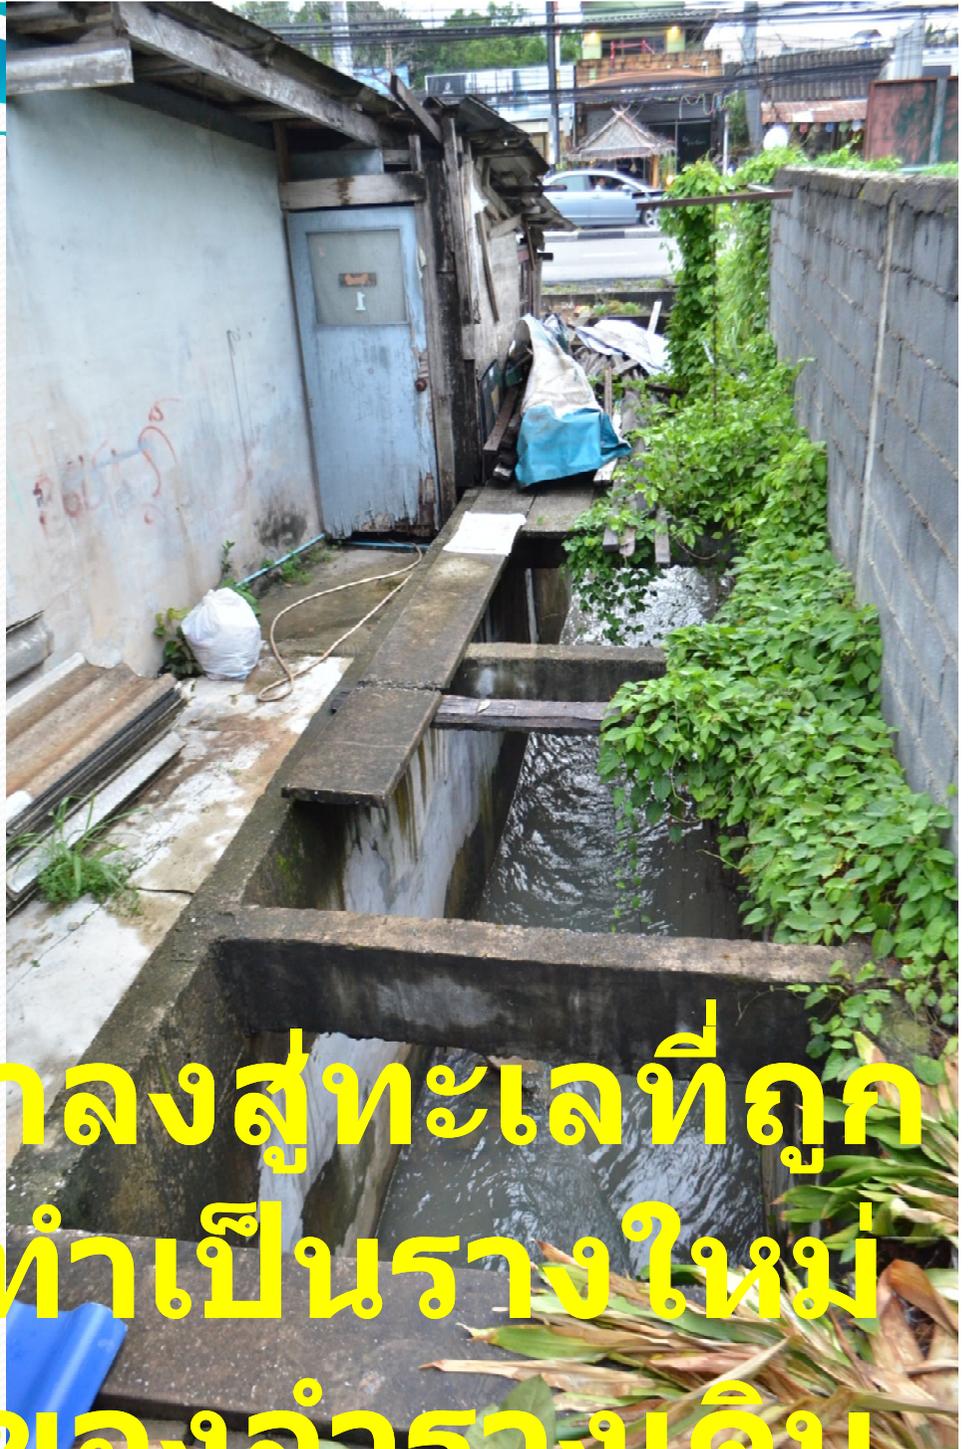
ลํารางระบายน้ำลงสู่ทะเลที่ถูกร
บกรุก → ยอมทำเป็นรางใหม่
ที่คิดว่าครึ่งหนึ่งของลํารางเดิม

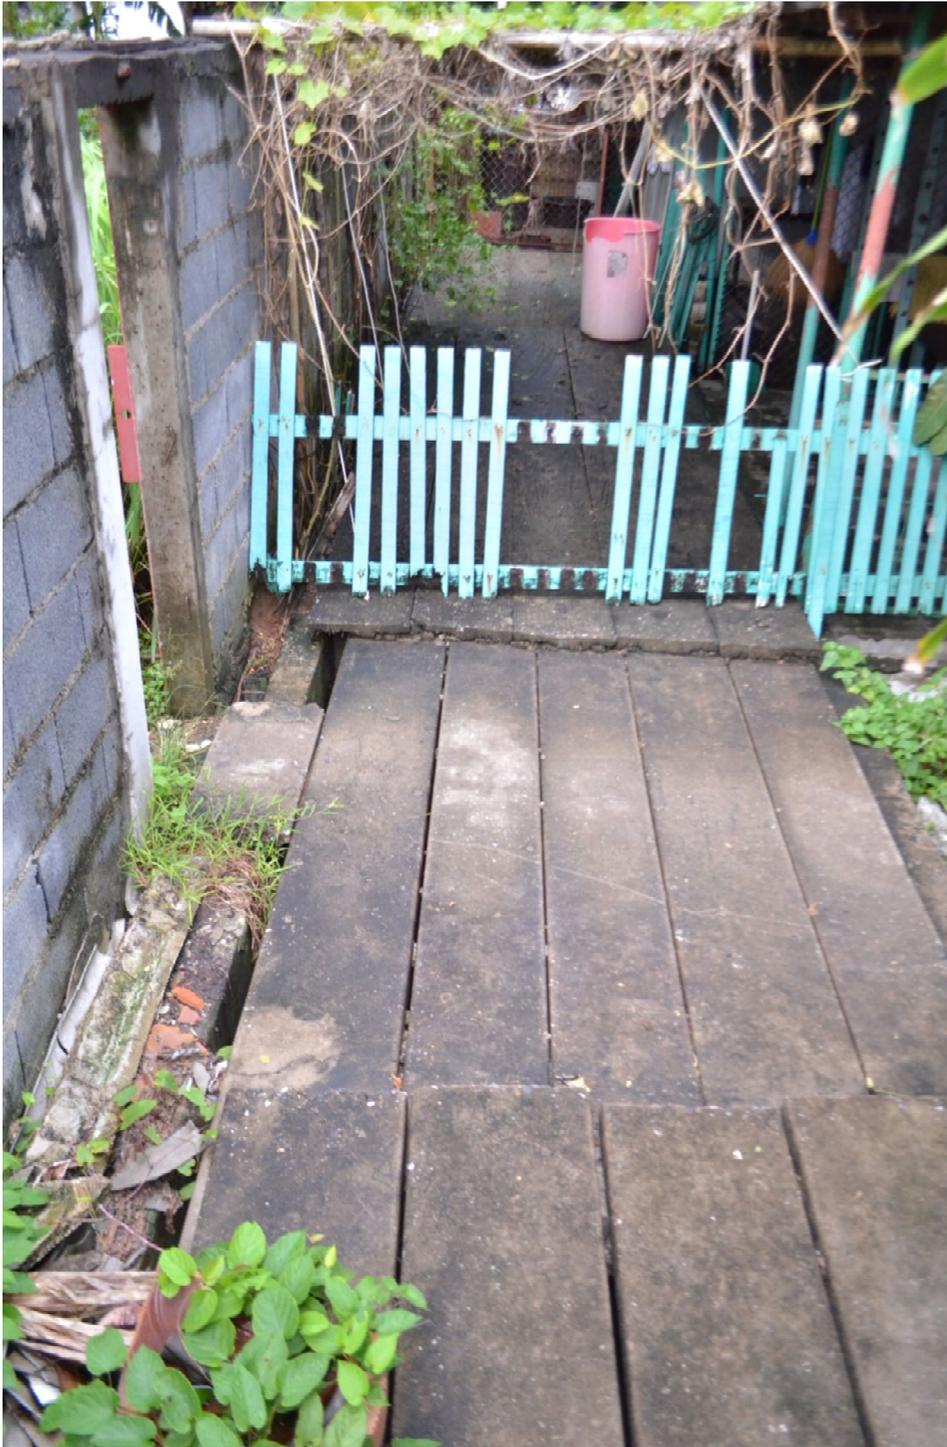
**สภาพลําราง
ถูกใช้เพื่อ
ประโยชน์อื่น**
